McKanes Bridge over Coxs River

Conservation Management Plan

Author:	Amie Nicholas
Date:	March 2021
Version:	5
Reference:	McKanes Bridge Conservation Management Plan
Division:	
Review Date:

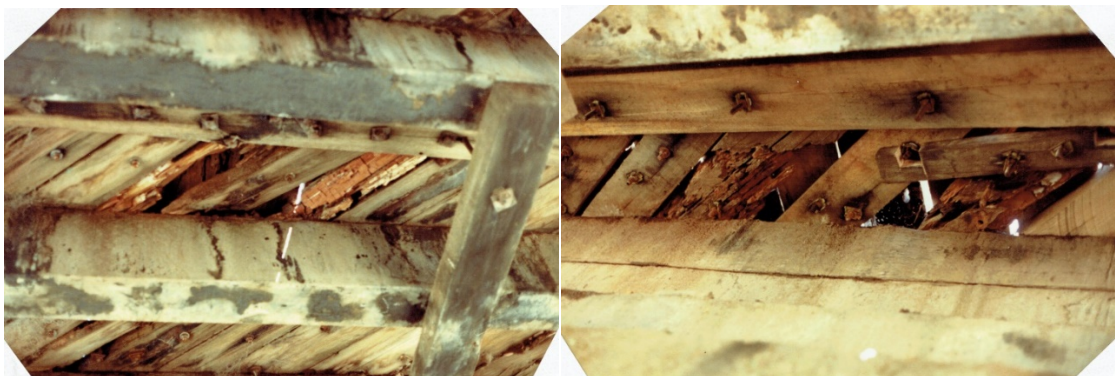
Figure 2-42: Poor condition of diagonal decking in 1981.

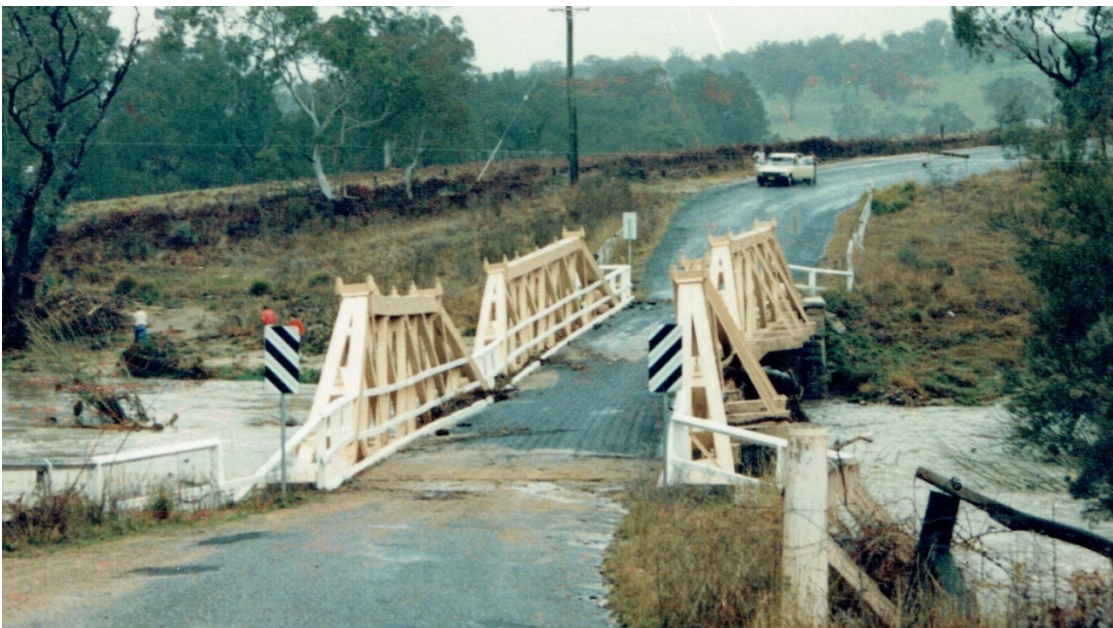
Figure 2-49: Photograph showing flood damage and distortion

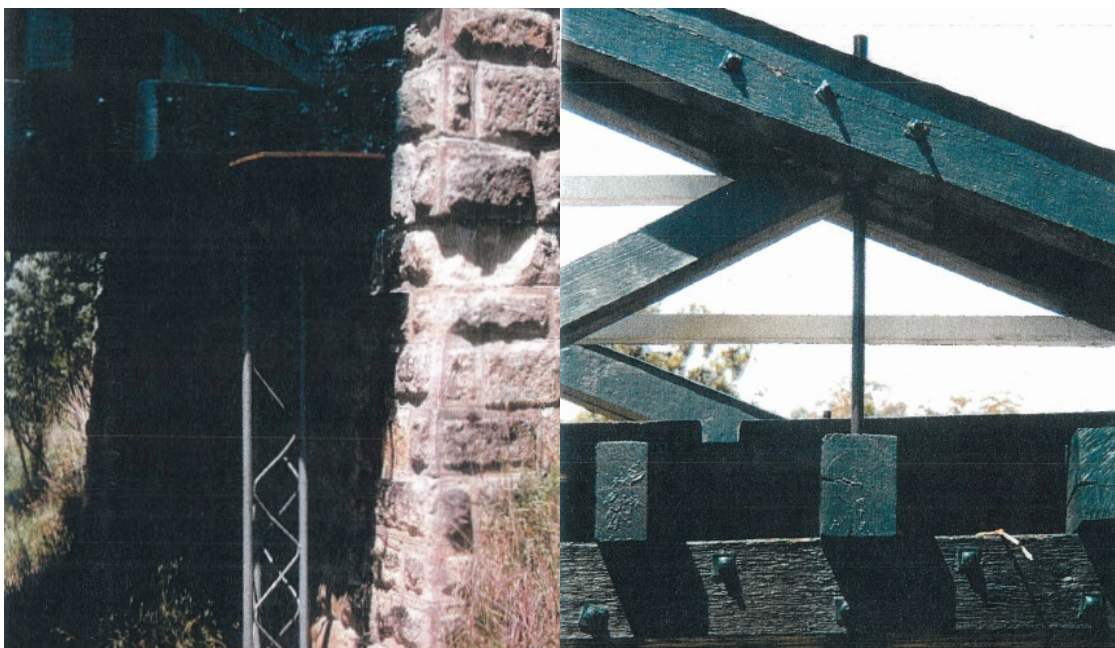
Figure 2-53: Photo of loose members and Tri-shore.

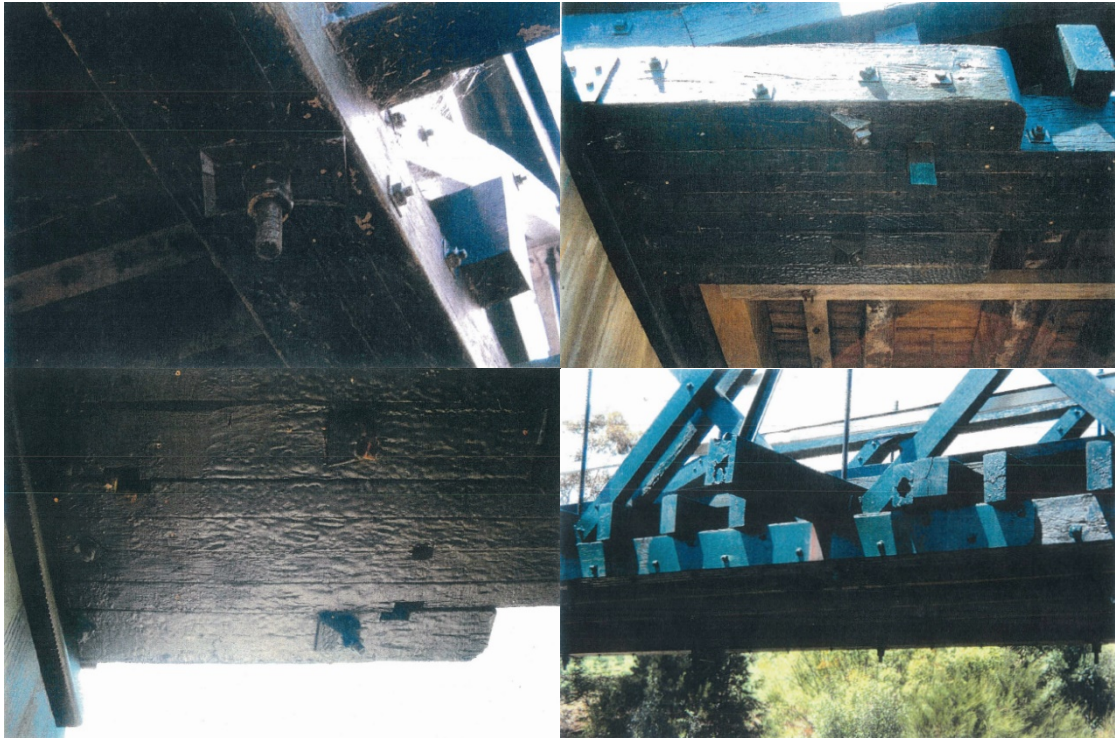
Figure 2-54: Photos of deterioration and damage in 1998.

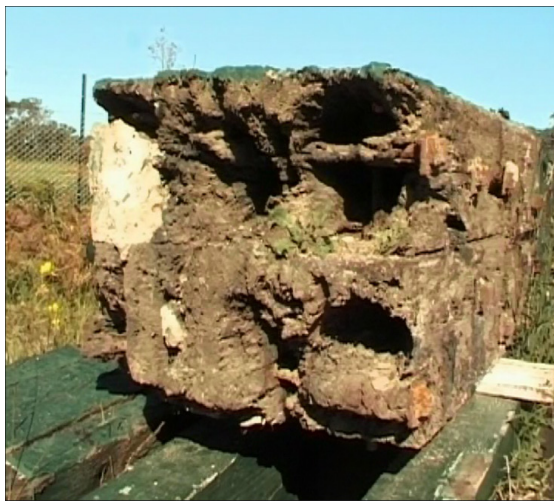
Figure 2-56: Deterioration of timbers removed from McKanes Bridge.

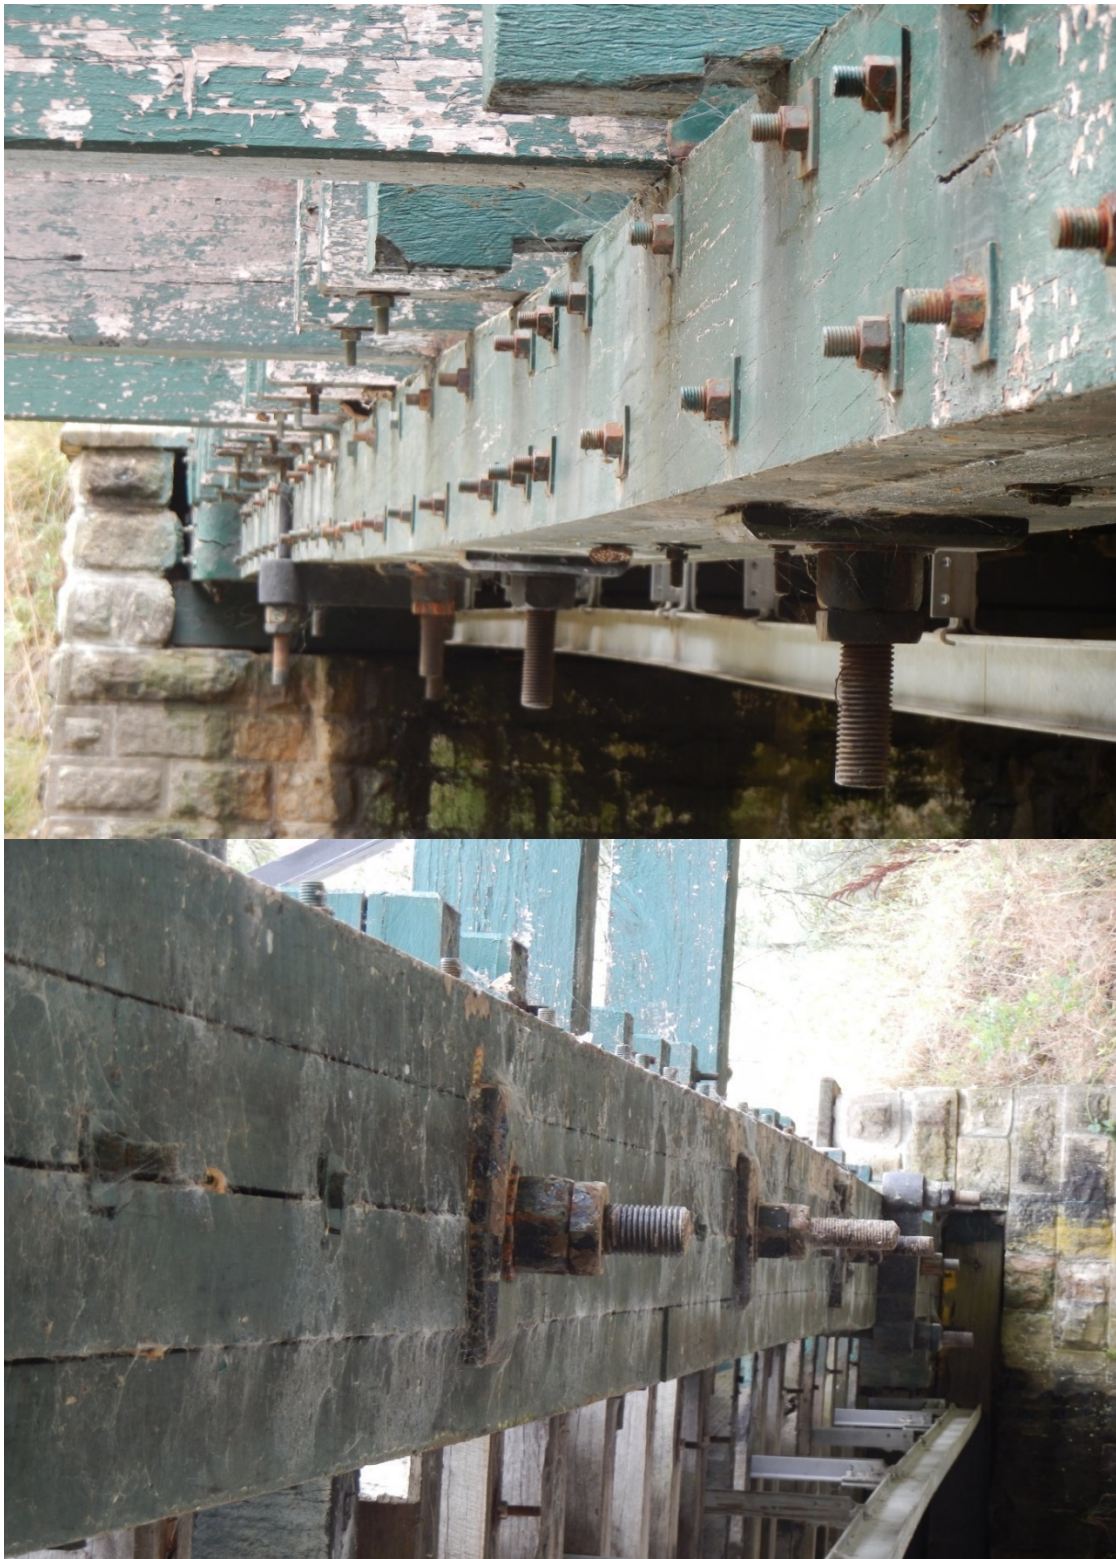
Figure 3-7: Signs of distress in modified laminated timber bottom chords.

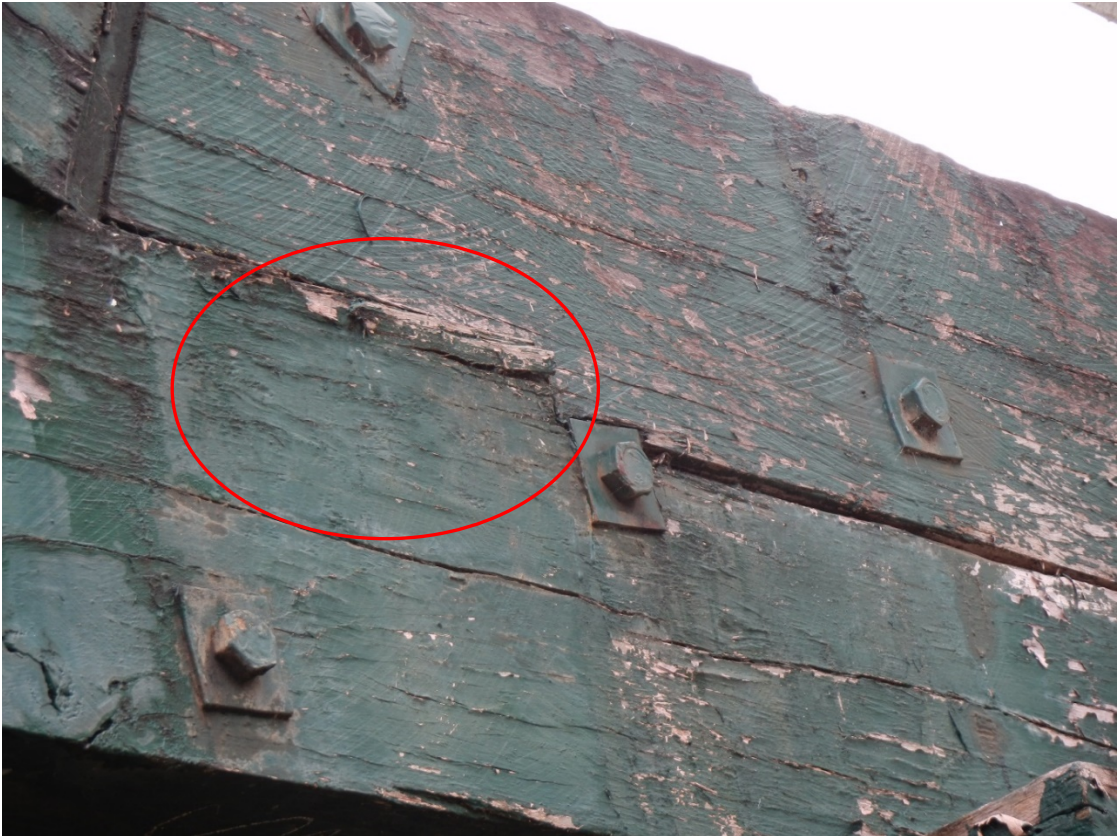
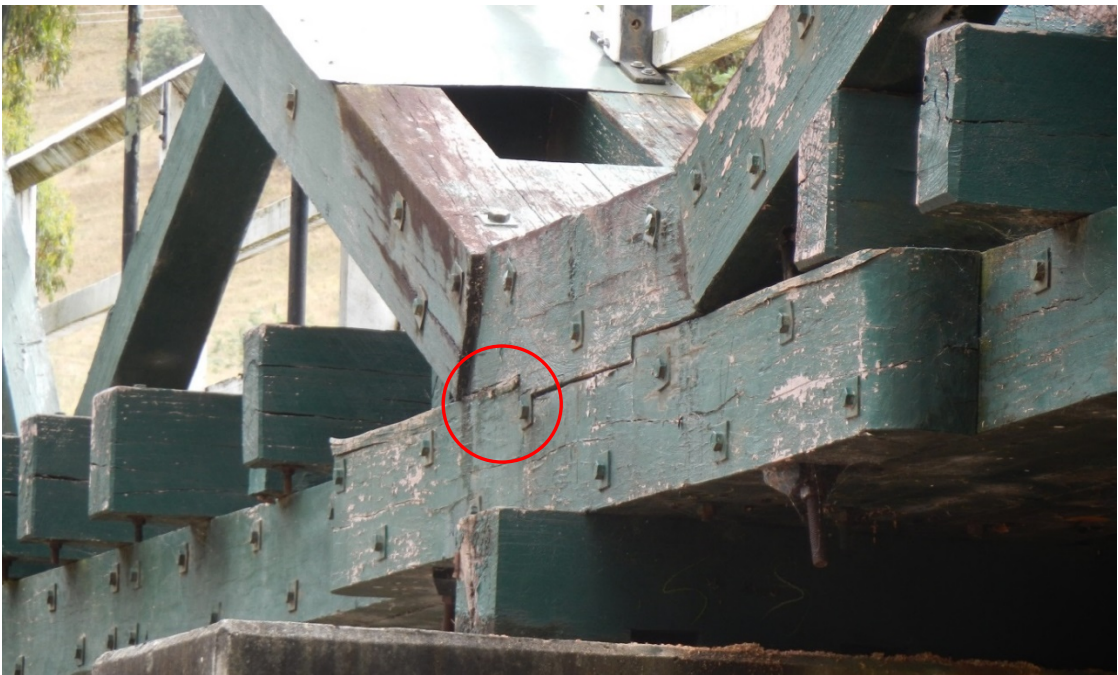
Figure 3-8: Crushing of timber at bottom chord to butting block connection.

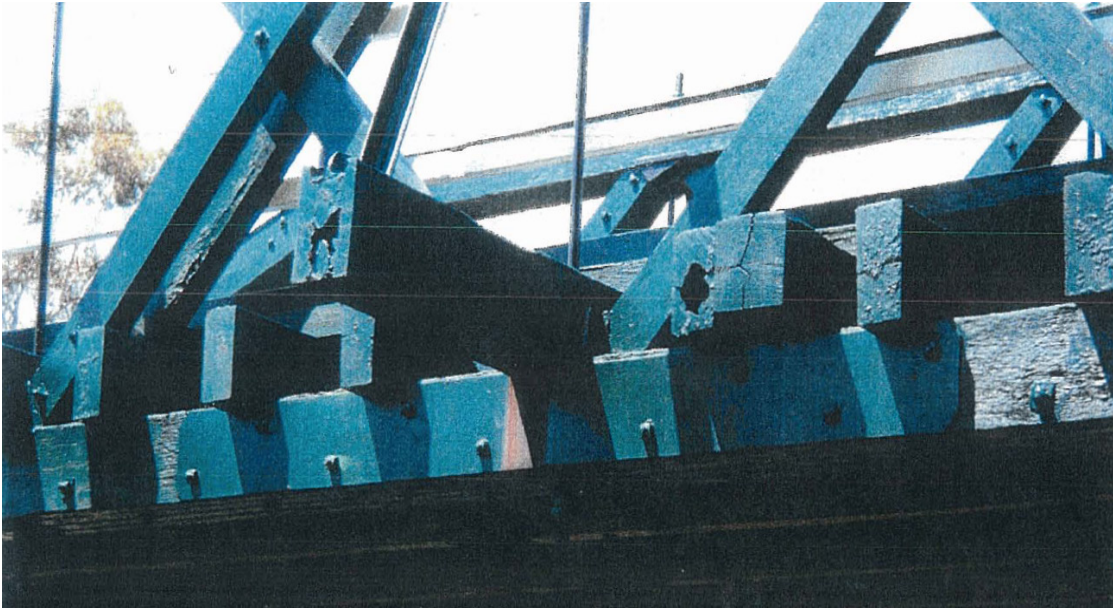
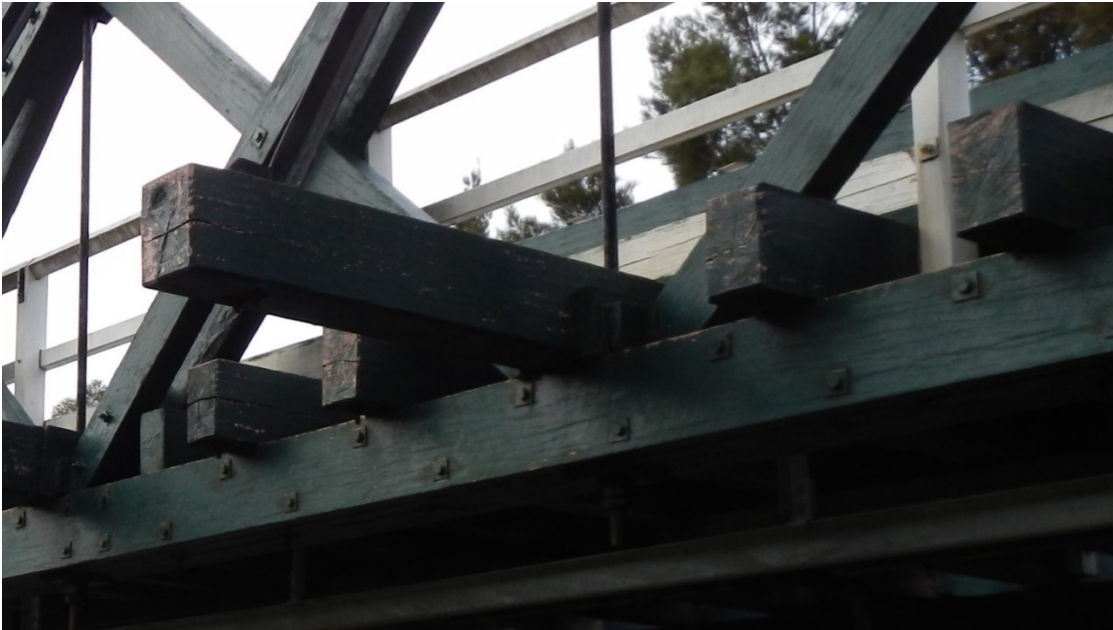
Figure 3-9: Comparison of bottom chord in 1998 (above) and 2013 (below) with no splice plate.¹⁰⁰

The other modification to the bottom chords, which occurred sometime after the 1986 flood, is the loss of notching at primary cross girder locations. All of these modifications combined detract substantially from the heritage integrity as well as the structural robustness of the bottom chords.

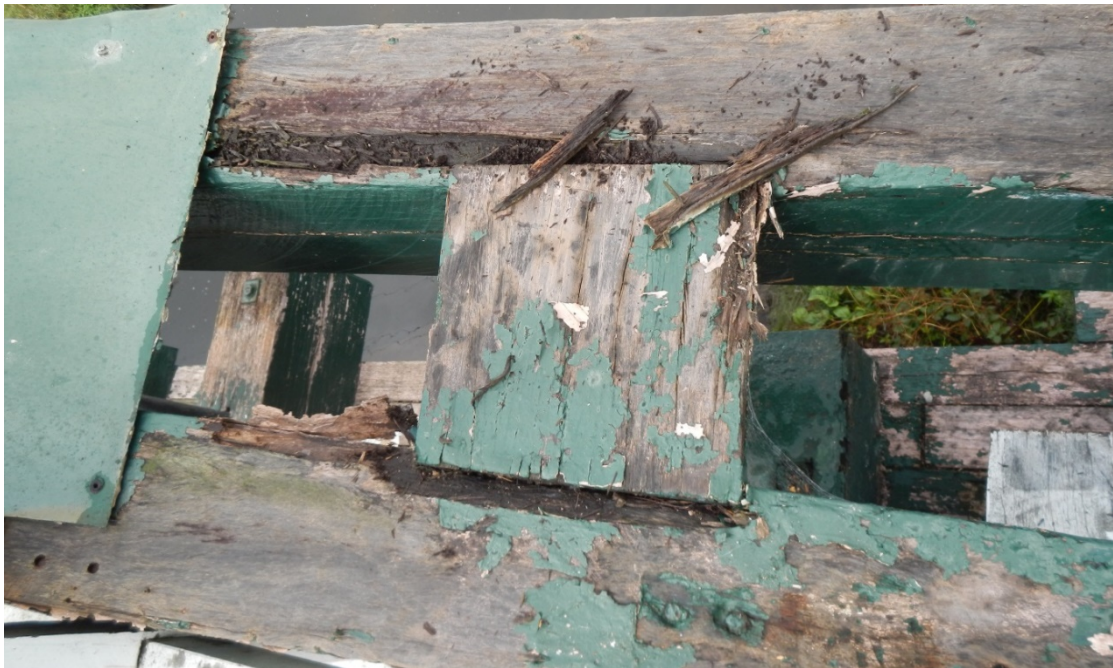
Figure 3-13: Deterioration of flitches of principals at spacer location.

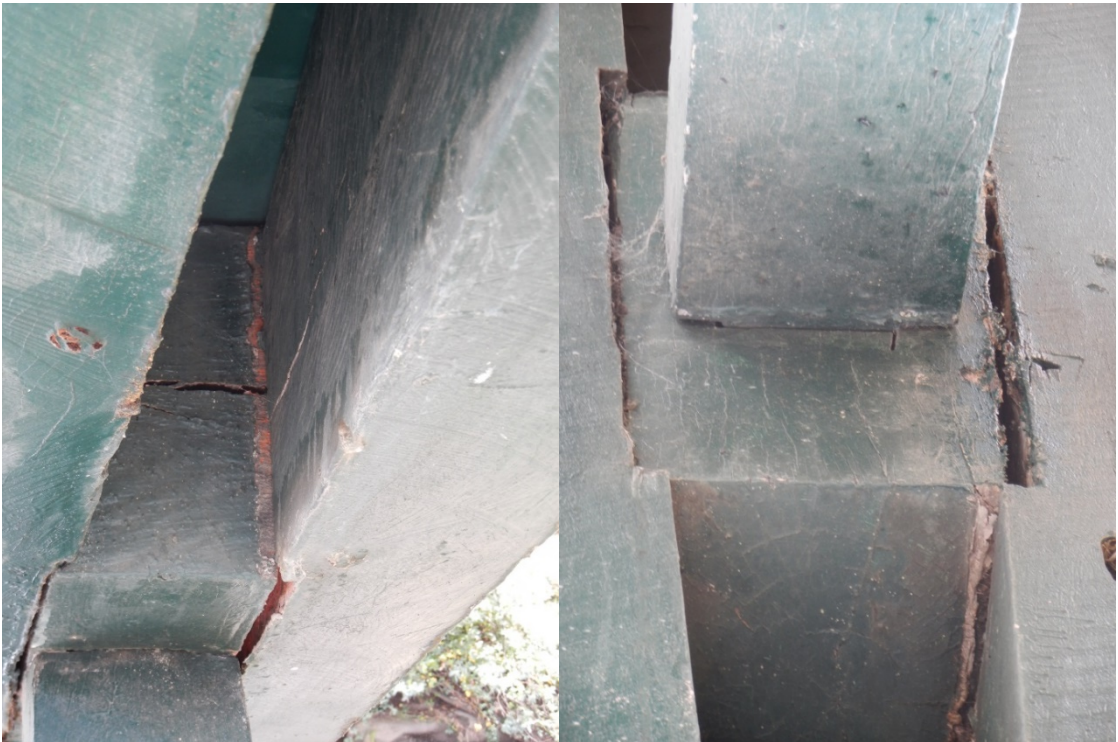
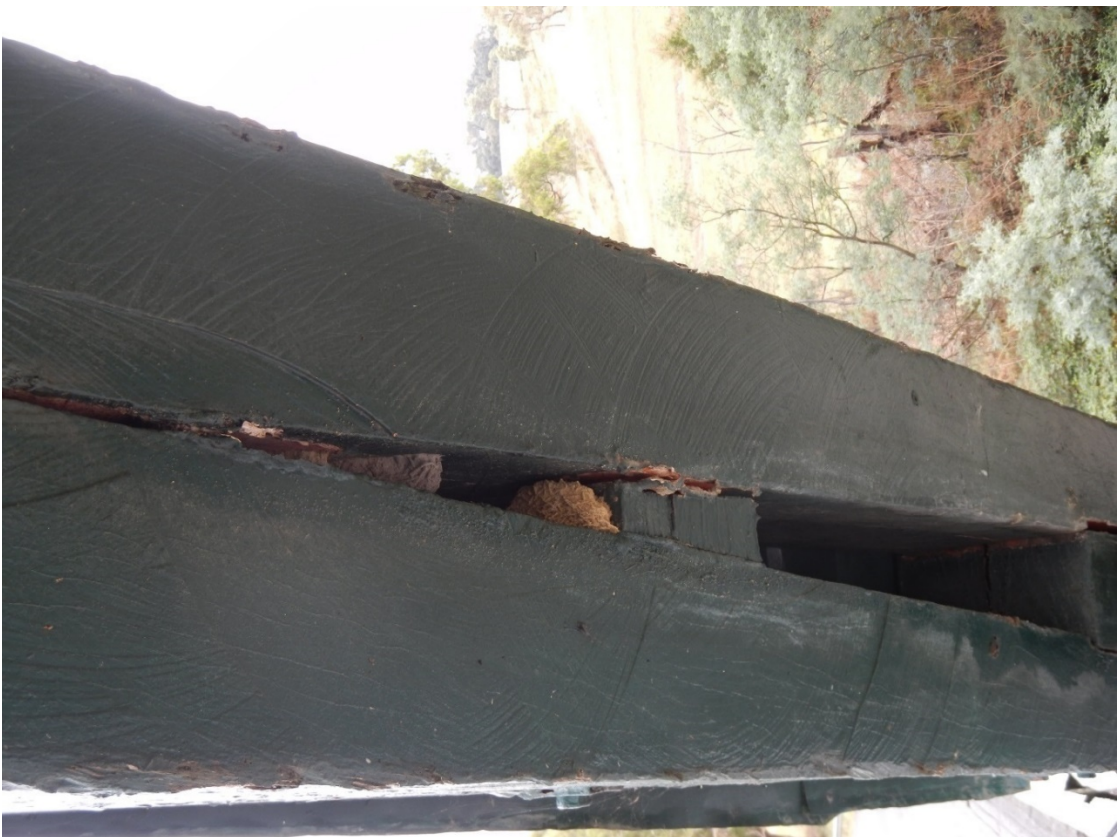
Figure 3-14: Opening of joints and loss of alignment in principals.

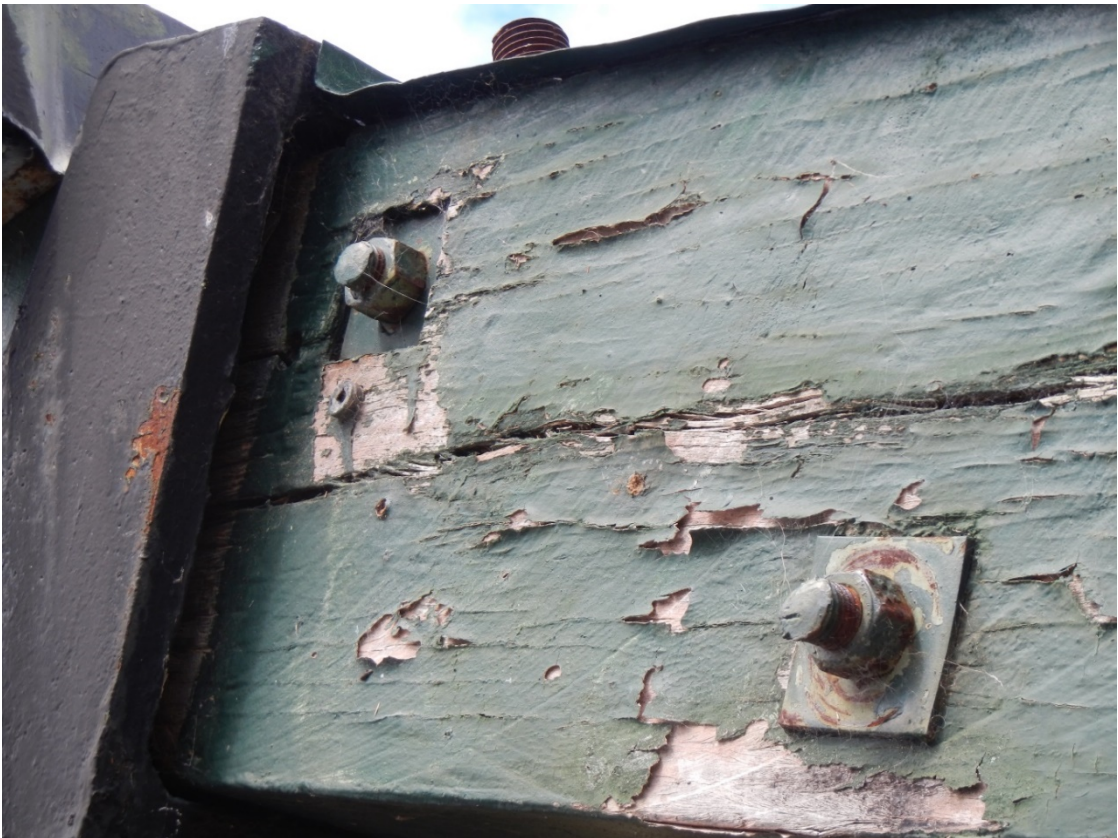
Figure 3-15: Splitting of timber at top of principals and loose fit into shoe.

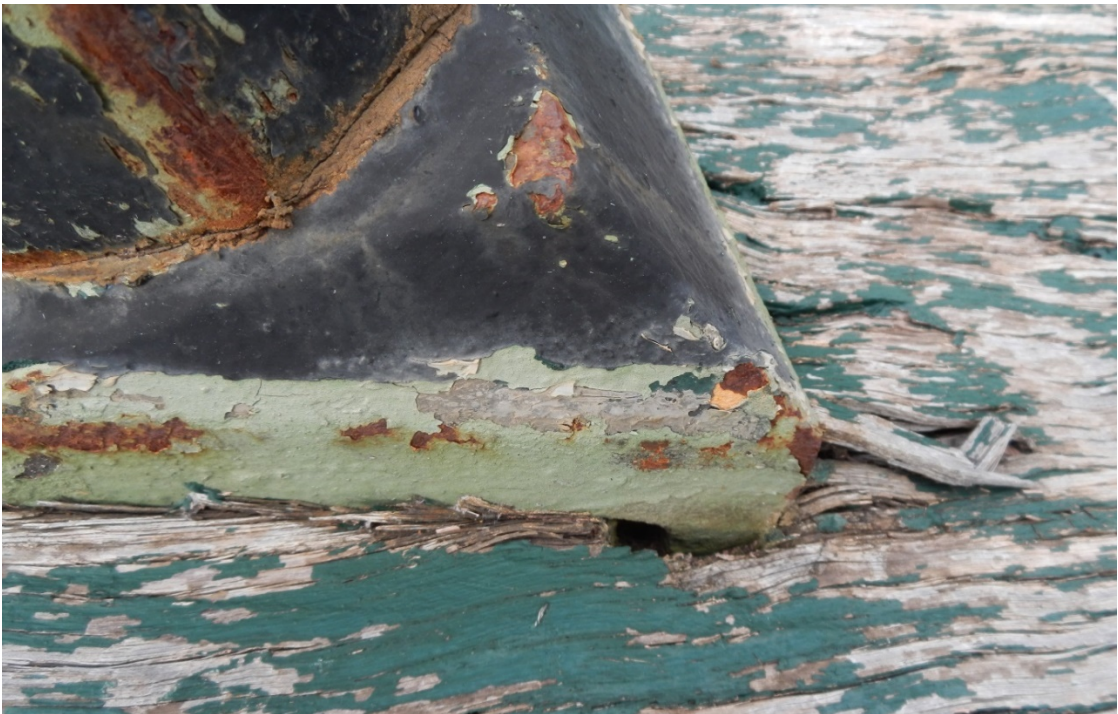
Figure 3-16: Crushing of timber spacer in principal at tension rod location.

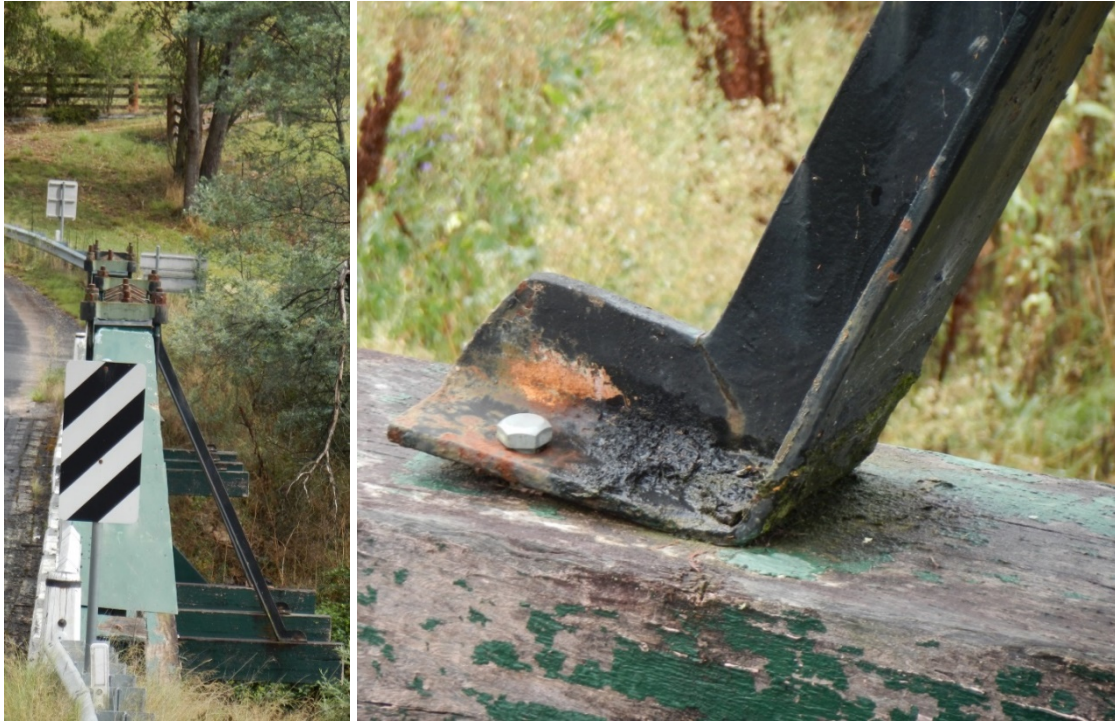
Figure 3-17: Loss of alignment of the trusses due to modifications.

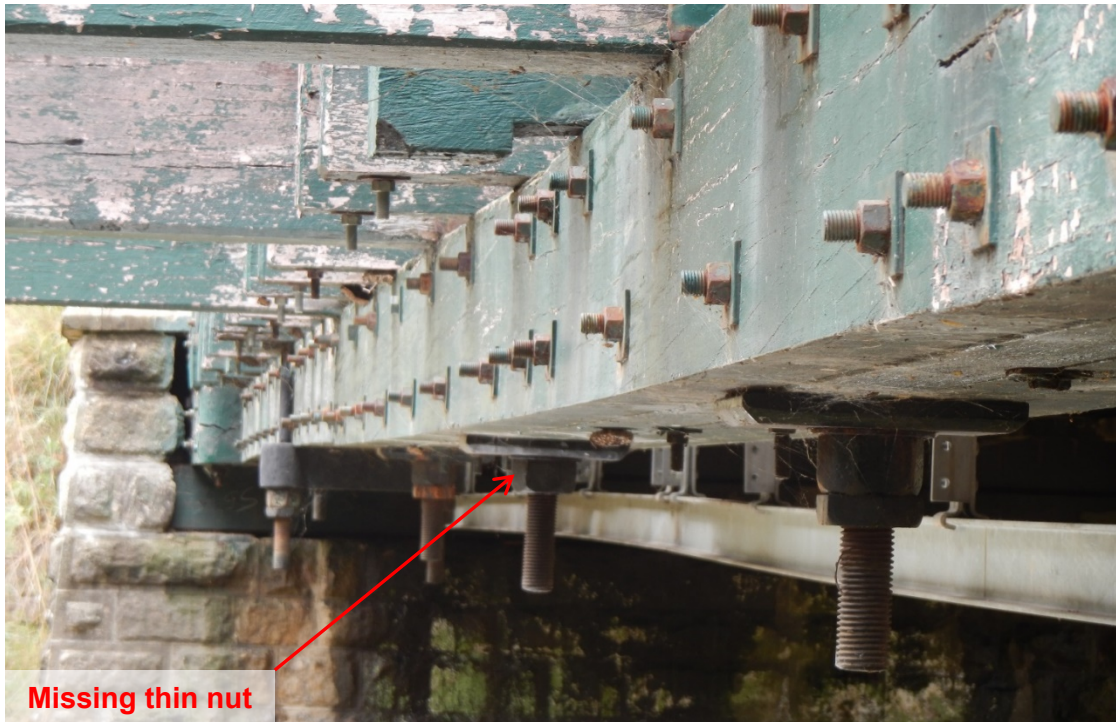
Figure 3-23: Photograph of typical arrangement of nuts with one missing.

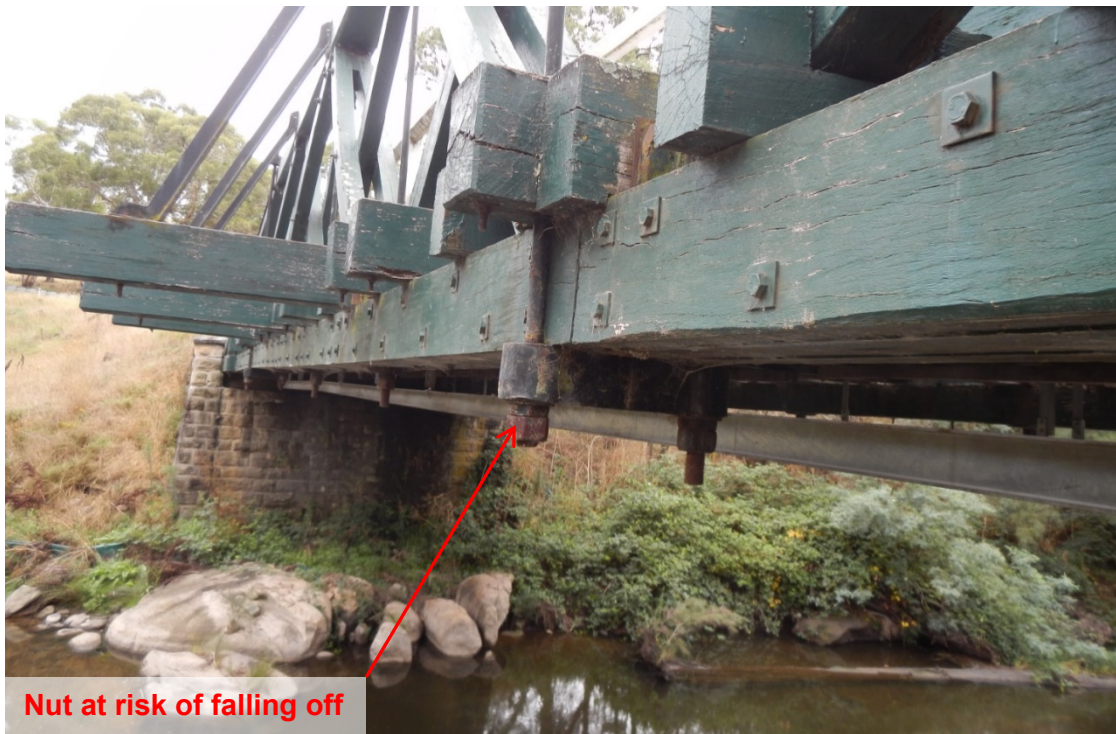
Figure 3-24: Photograph with nut order as designed but close to falling off.

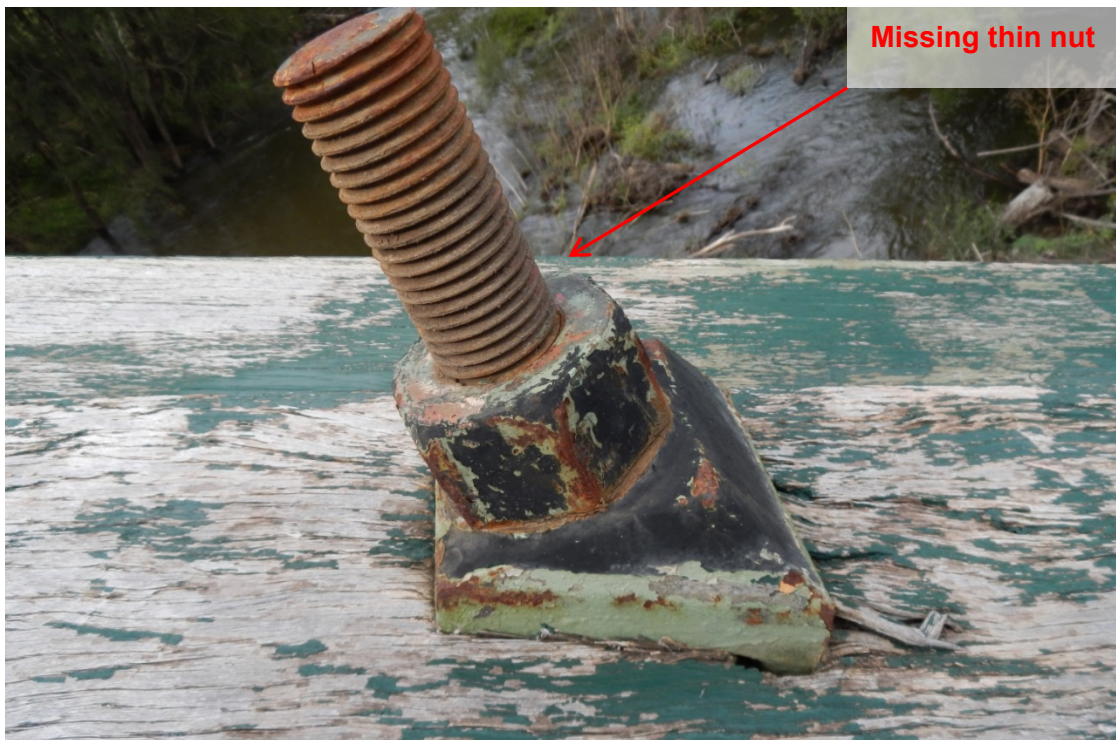
Figure 3-25: Photograph of top of short tension rod with thin nut missing.

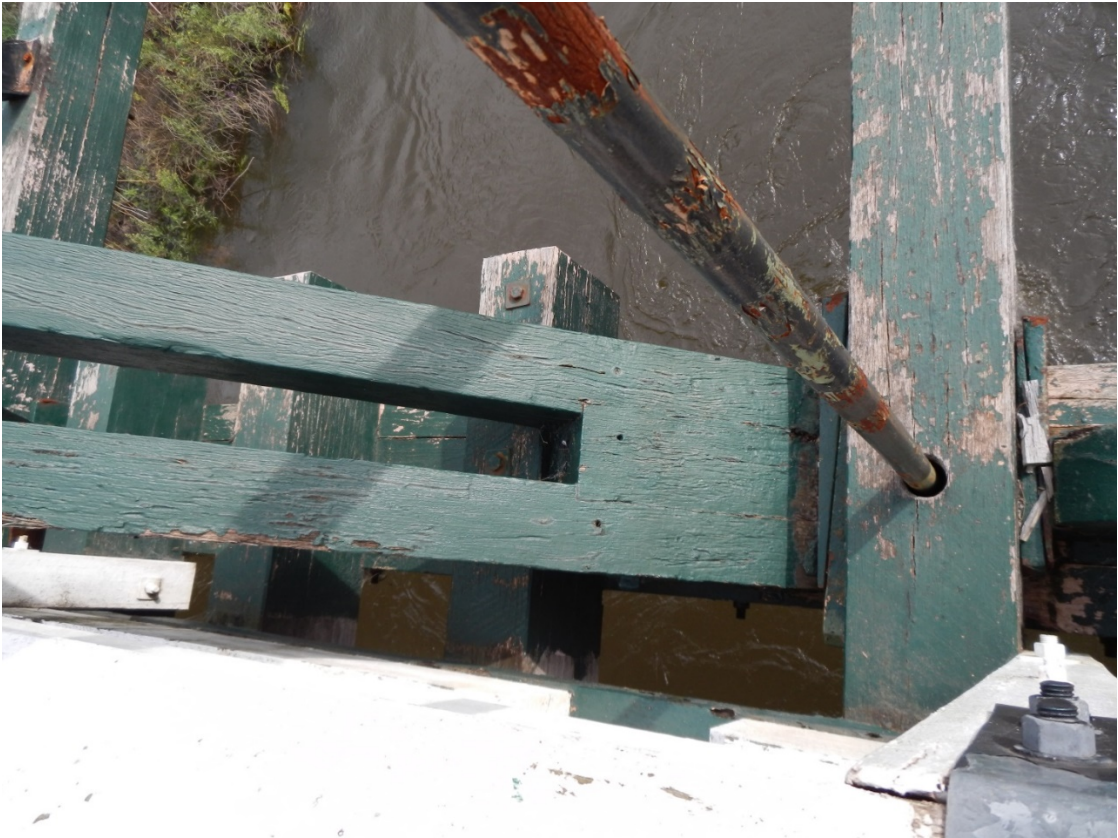
Figure 3-27: Photograph showing paint loss and corrosion of tension rod.

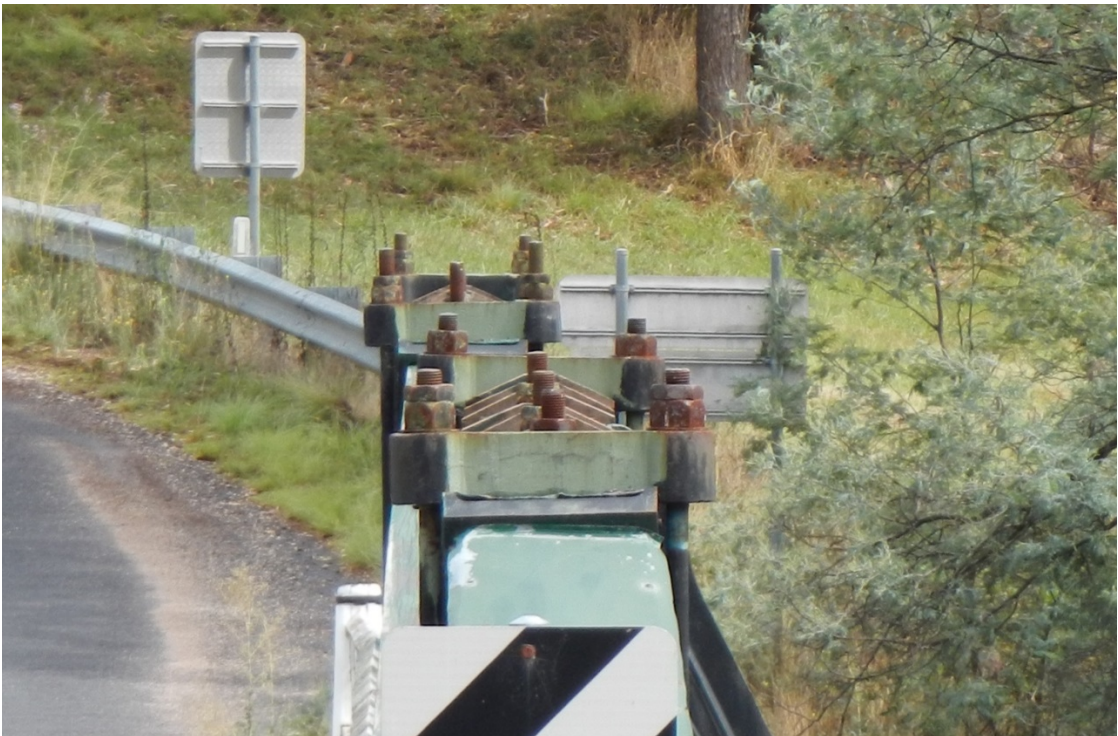
Figure 3-28: Photograph showing corrosion at tops of tension rods and nuts.

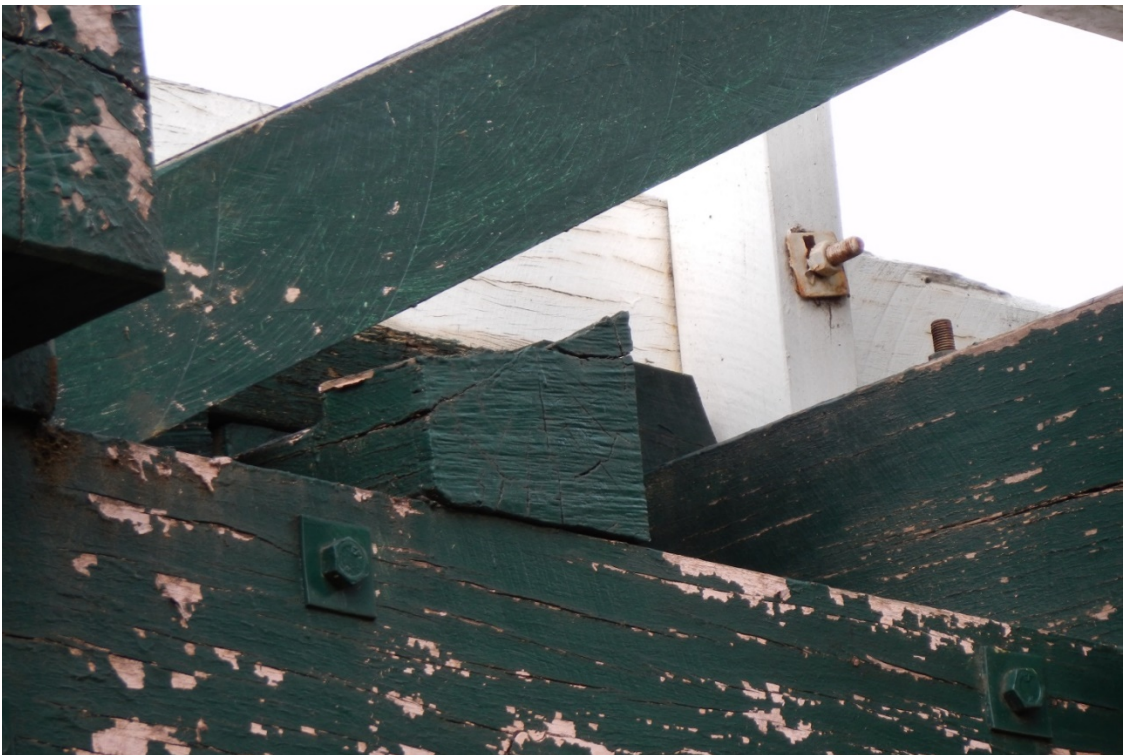
Figure 3-40: Part of secondary cross girder missing due to failure at notch.
