CONSERVATION MANAGEMENT PLAN

GILLIES BRIDGE OVER BLACK CREEK

Prepared for: Cessnock City Council – June 2017

Prepared by: Amie Nicholas
Heritage and Conservation Engineer

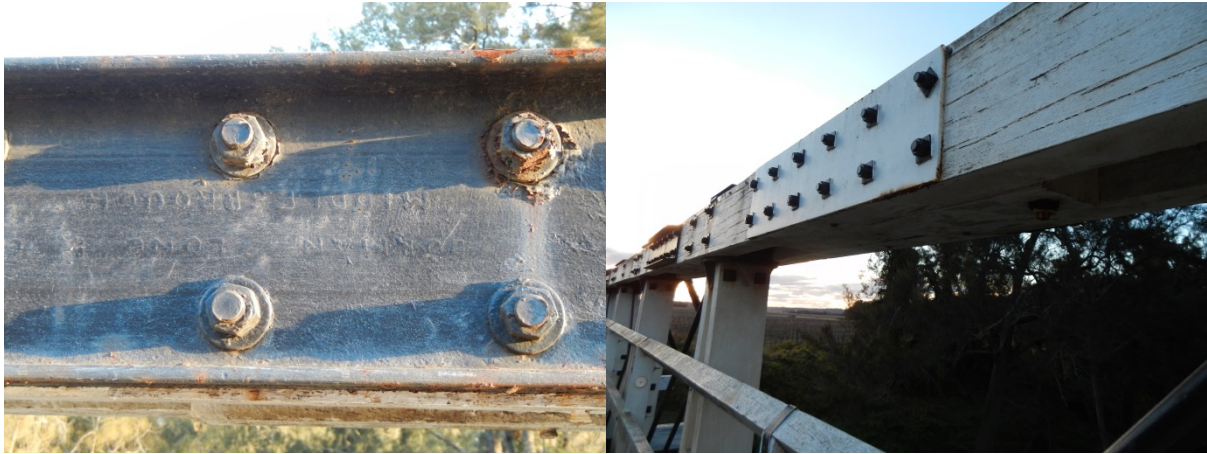
The primary modification of the top chord, which does not reflect the original design intent, is the addition of an extra splice on one of the trusses. One of the original 7.62m lengths of timber has been replaced with two shorter lengths on the outer flitch. Rather than using channel sections like the original splices, flat metal plates painted white have been provided on both sides with timber packing between. The date of this additional splice is not known. The 6mm notches for the washer blocks have also been eliminated and the timbers replaced with slightly smaller timbers thereby leaving a space between the washer block and the timber rather than necessitating a notch. Metal flashing has been added along the entire length in an attempt to protect the timber from water.

Figure 4.3: Left: Original Splice Plate with Foundry Mark; Right: Introduced splice plate (source: author 2013)

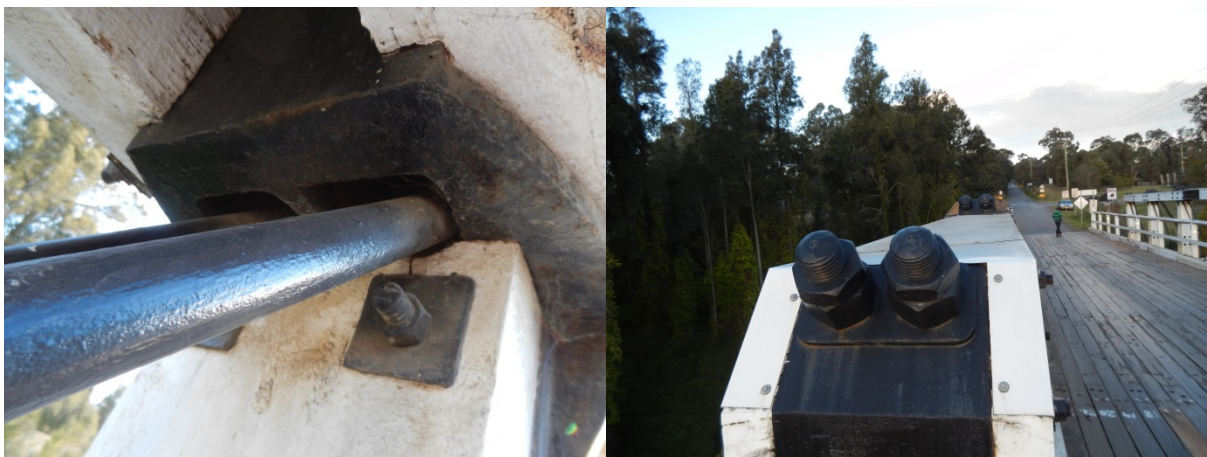
Figure 4.4: Left: Original timber notching at anchor blocks; Right: Introduced flashing (source: author 2013)

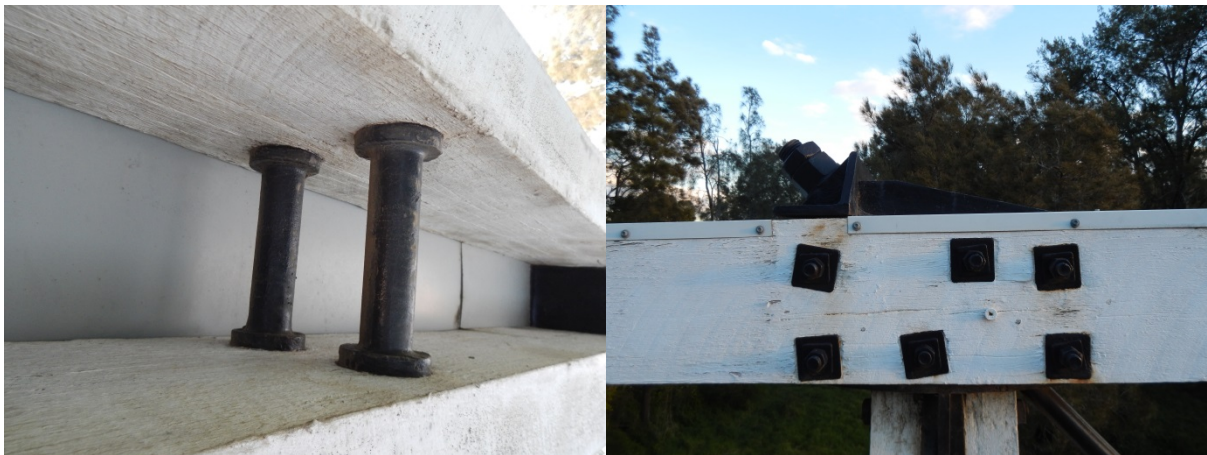
Figure 4.5: Left: Original metal spools; Right: no notching under washer blocks (source: author 2013)

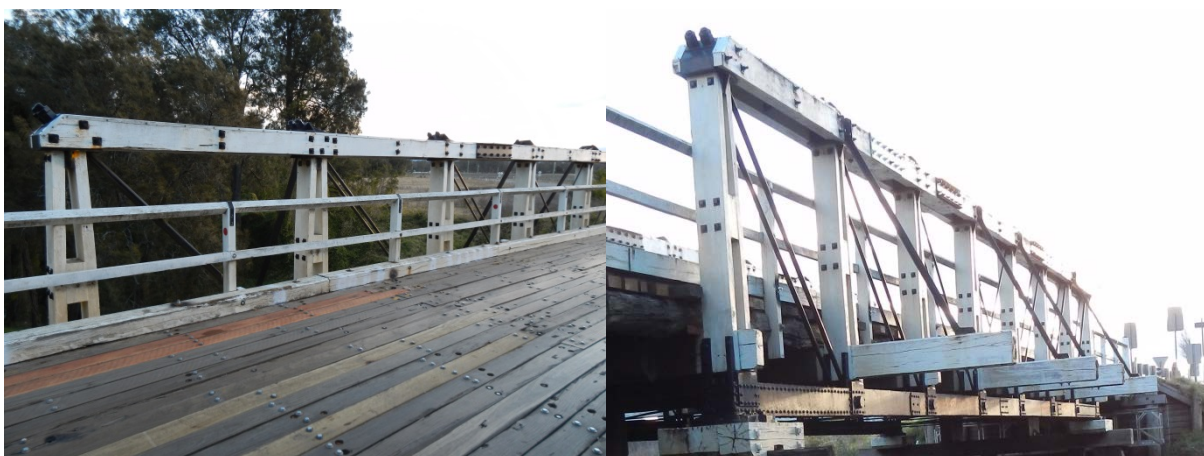
According to the Level 3 Inspection conducted on 20 January 2016 by Royal HaskoningDHV, the timber verticals are in good condition with little or no deterioration.¹¹¹ However, there is evidence of significant active termite activity on the northern truss, and it is likely that there would be further hidden deterioration at the bases, where water accumulates at the interface between the timber cross girder and the verticals and at the interface between the saddle plate and the verticals.

Figure 4.6: Left: Verticals viewed from bridge; Right: verticals viewed from off bridge (source: author 2013)

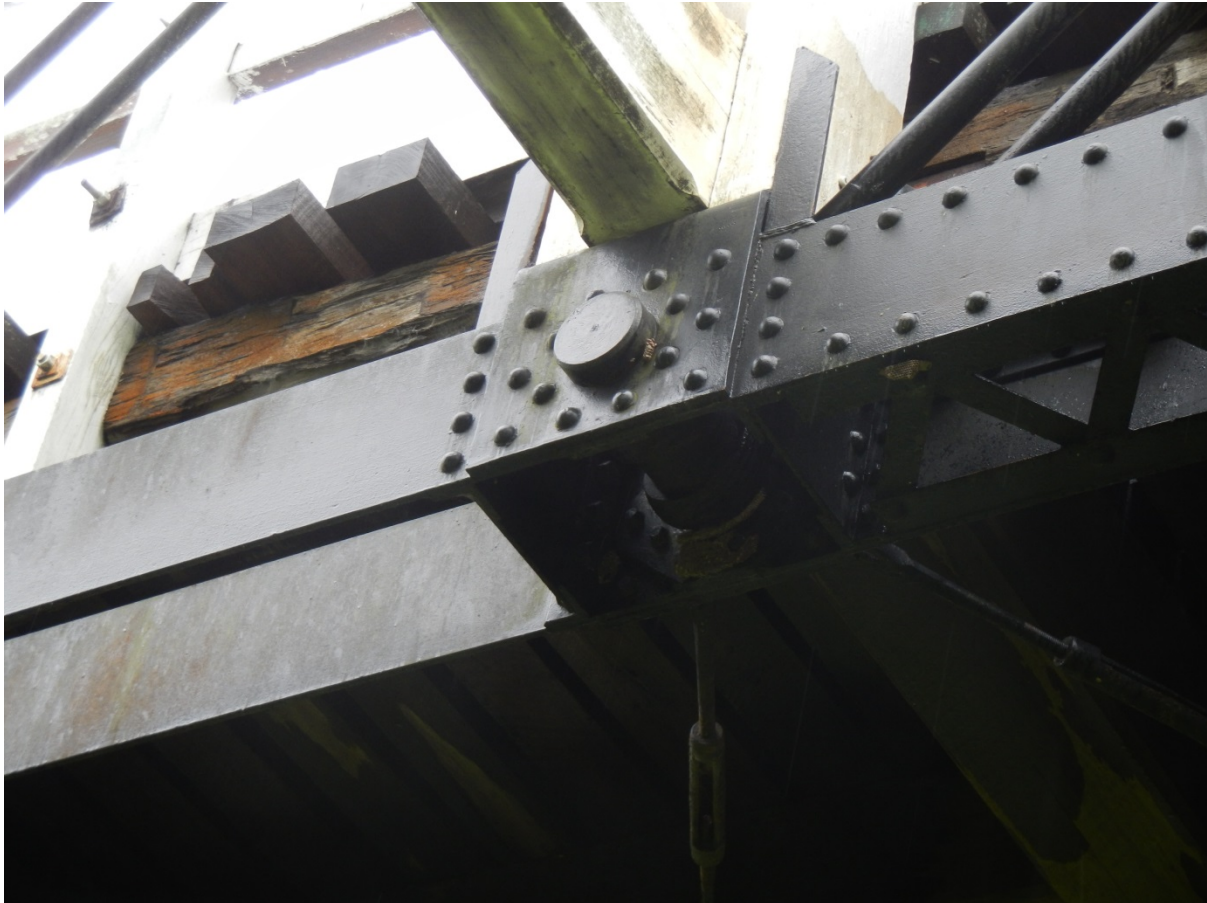
Figure 4.9: Photograph showing various bottom chord details at panel point (source: author 2017)

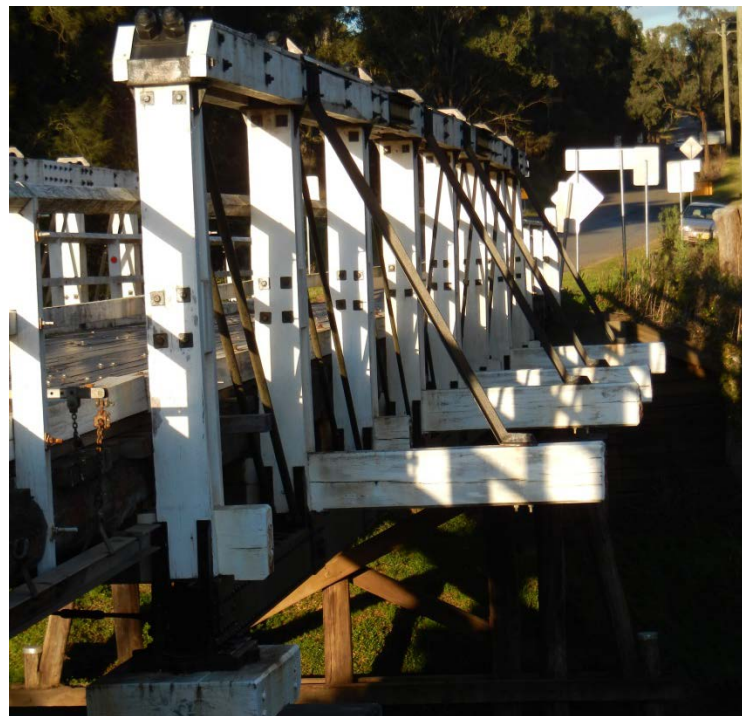
Figure 4.12 Photograph of Sway Braces (Source: Author, 2013)

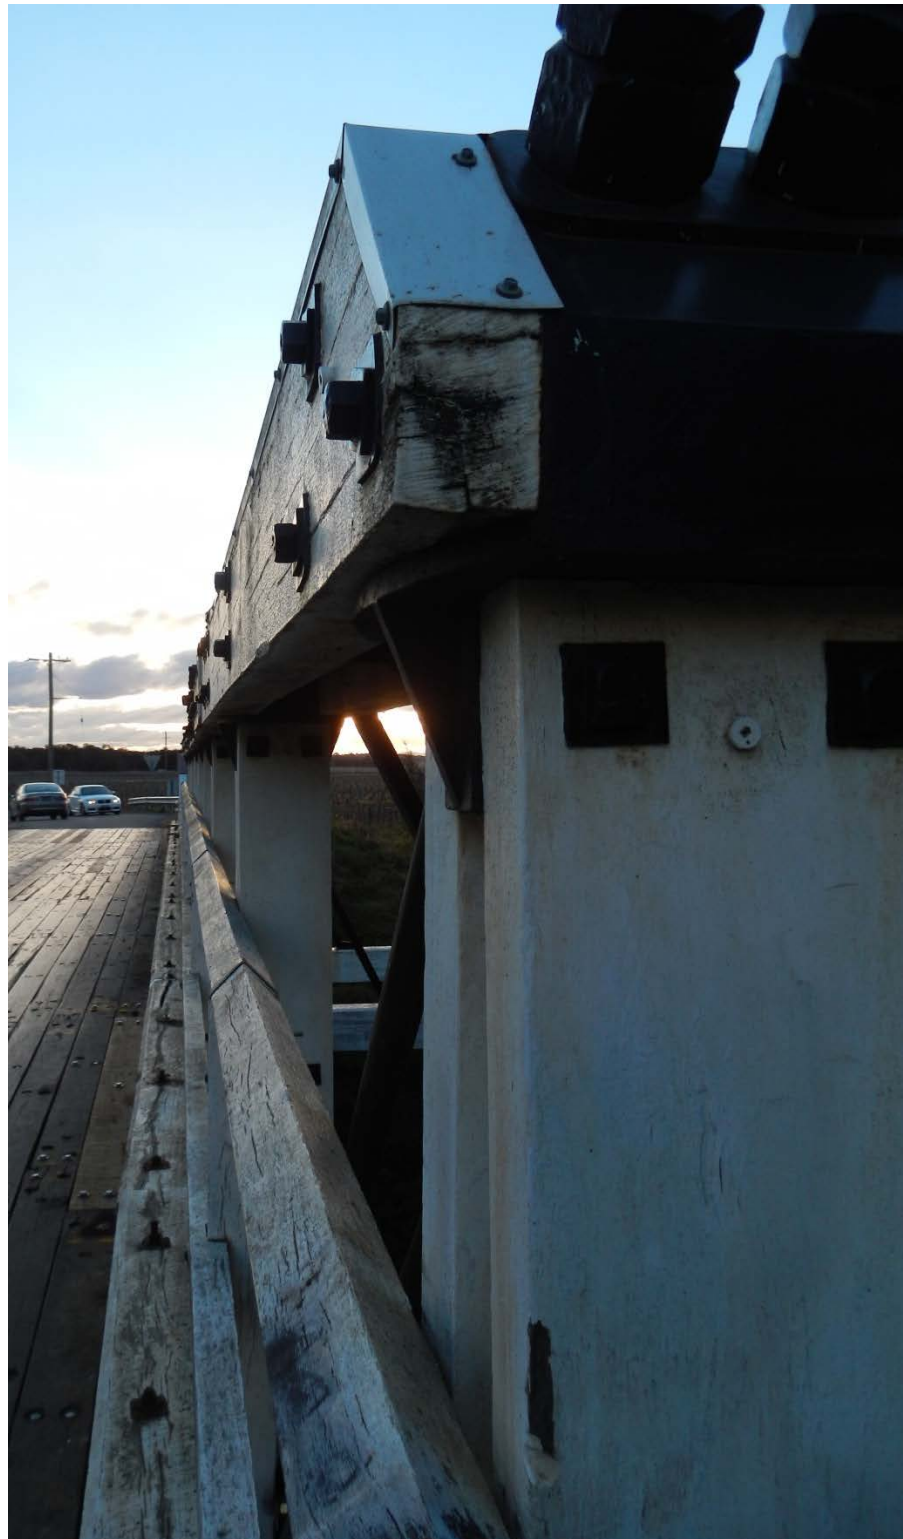
Figure 4.17 No notching of top rails around truss verticals (source: author)

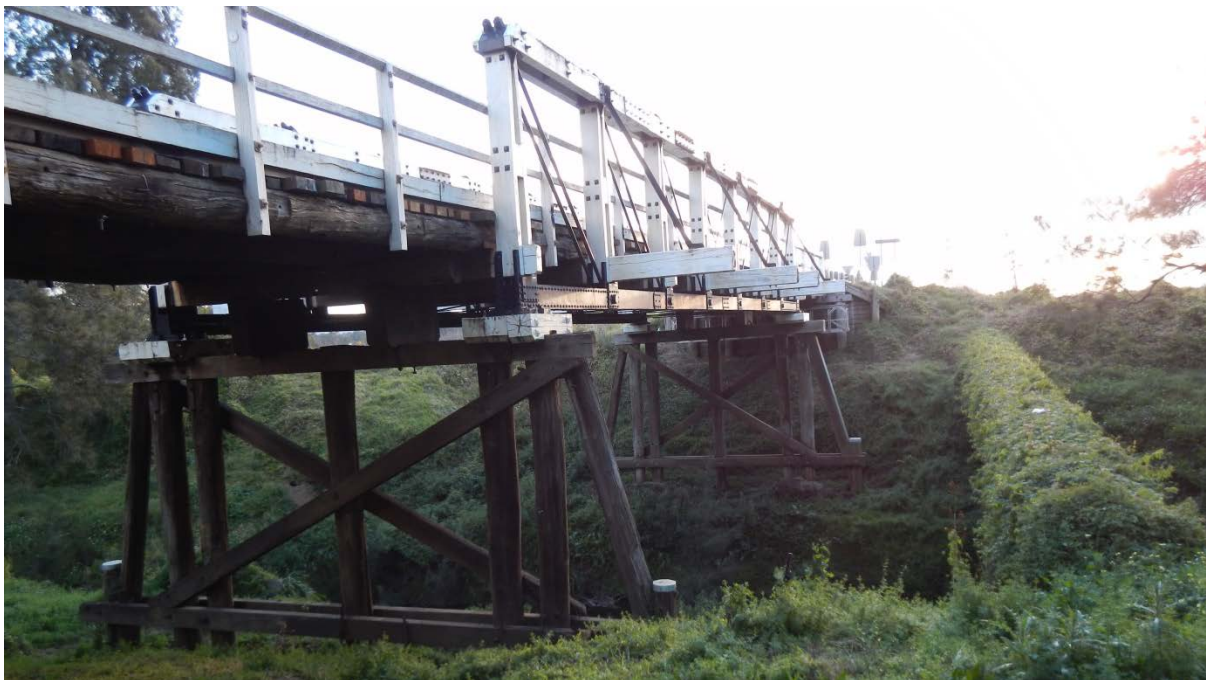
Figure 4.18 Photograph showing configuration of current piers and abutments (source: author)

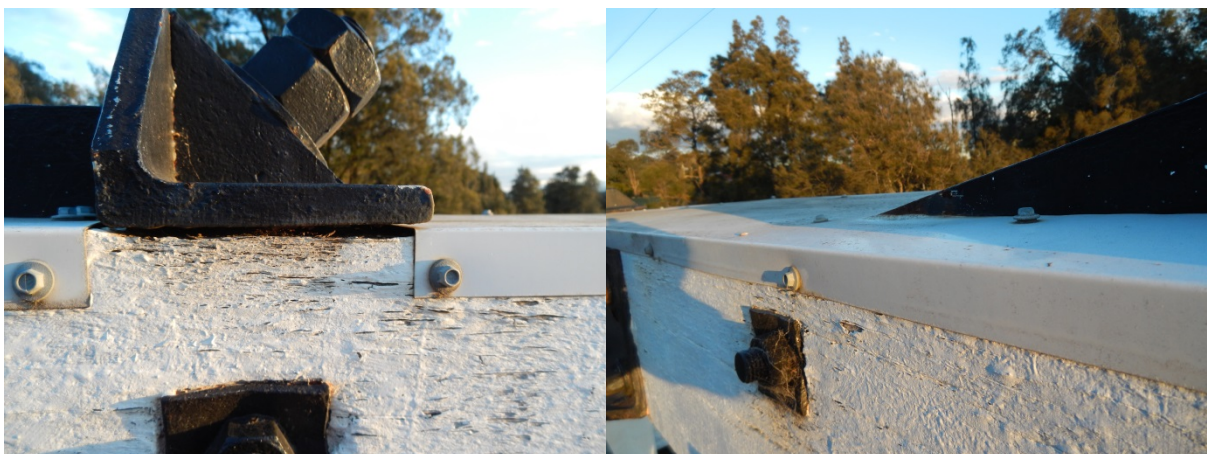
Figure 7.3 Photographs of metal flashing and attachments to top chord timber (source: Author, August 2013)

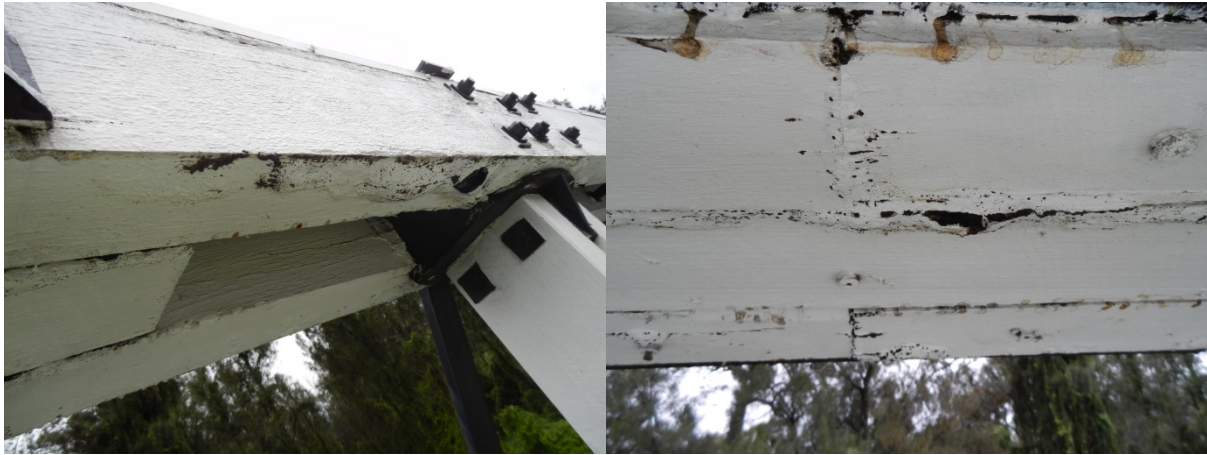
Figure 7.4 Photographs of damage due to non-breathable paint in top chords (source: Author, March 2017)

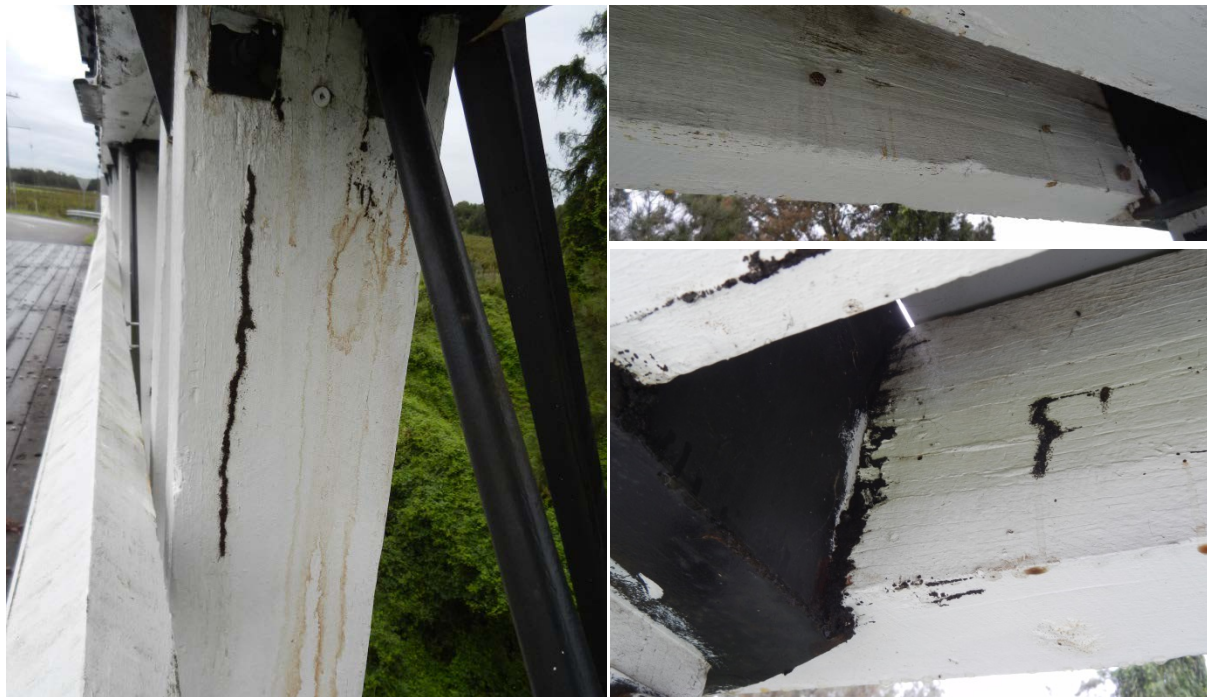
Figure 7.5 Photographs of termites and wasps in top chords and verticals (source: Author, March 2017)

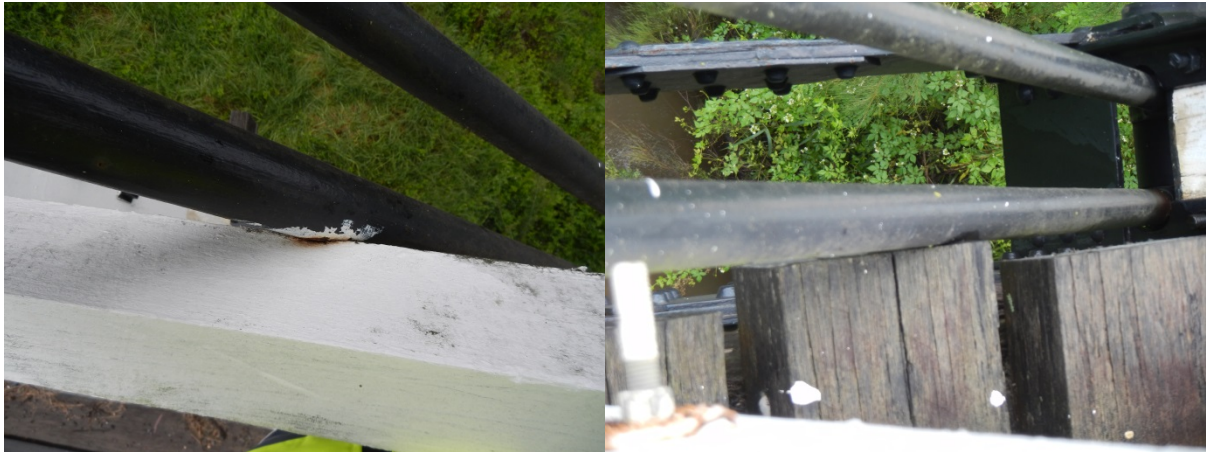
Figure 7.6 Photographs of damage to tension rods from decking and railing (source: Author, March 2017)

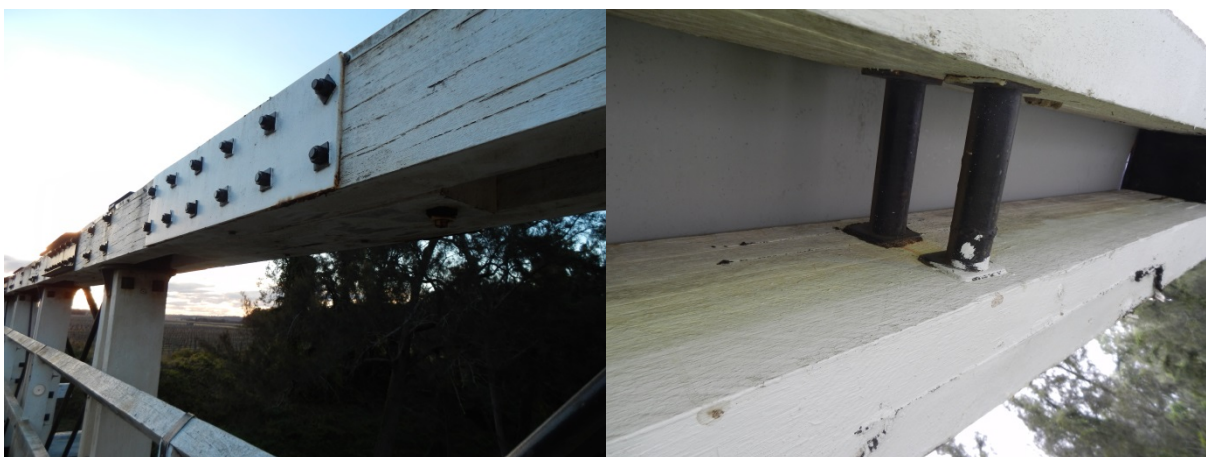
Figure 7.7 Photographs non-original details including splice on left and spools on right (source: Author)

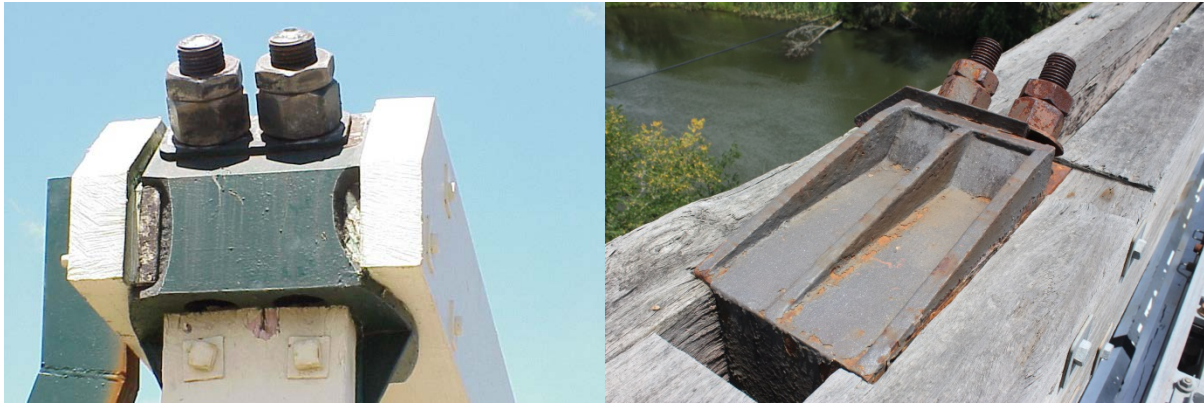
Figure 7.9 Photographs of broken anchor blocks and washer blocks on other de Burgh trusses (source: RMS)

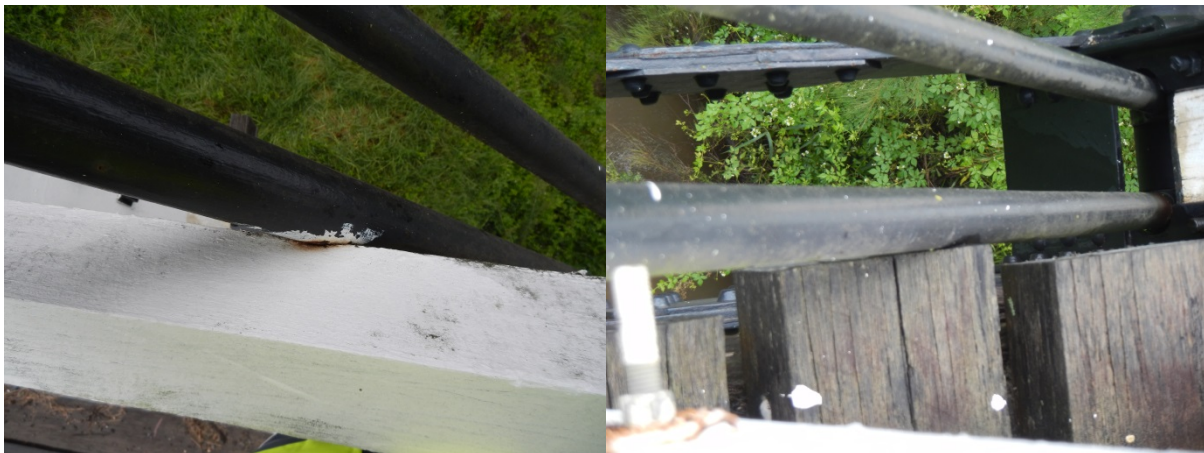
Figure 7.10 Photographs of deterioration of tension rods at Gillies Bridge due to clashes (source: author)

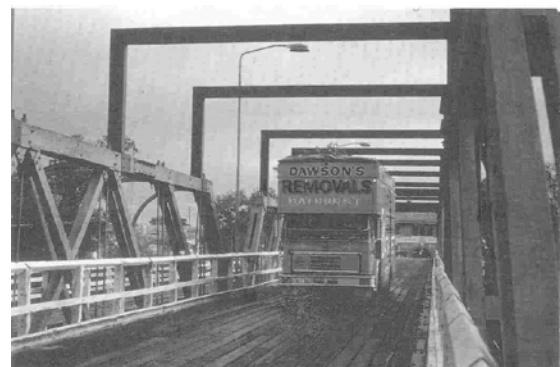
Figure 7.11 Overhead portal bracing (source: RMS)

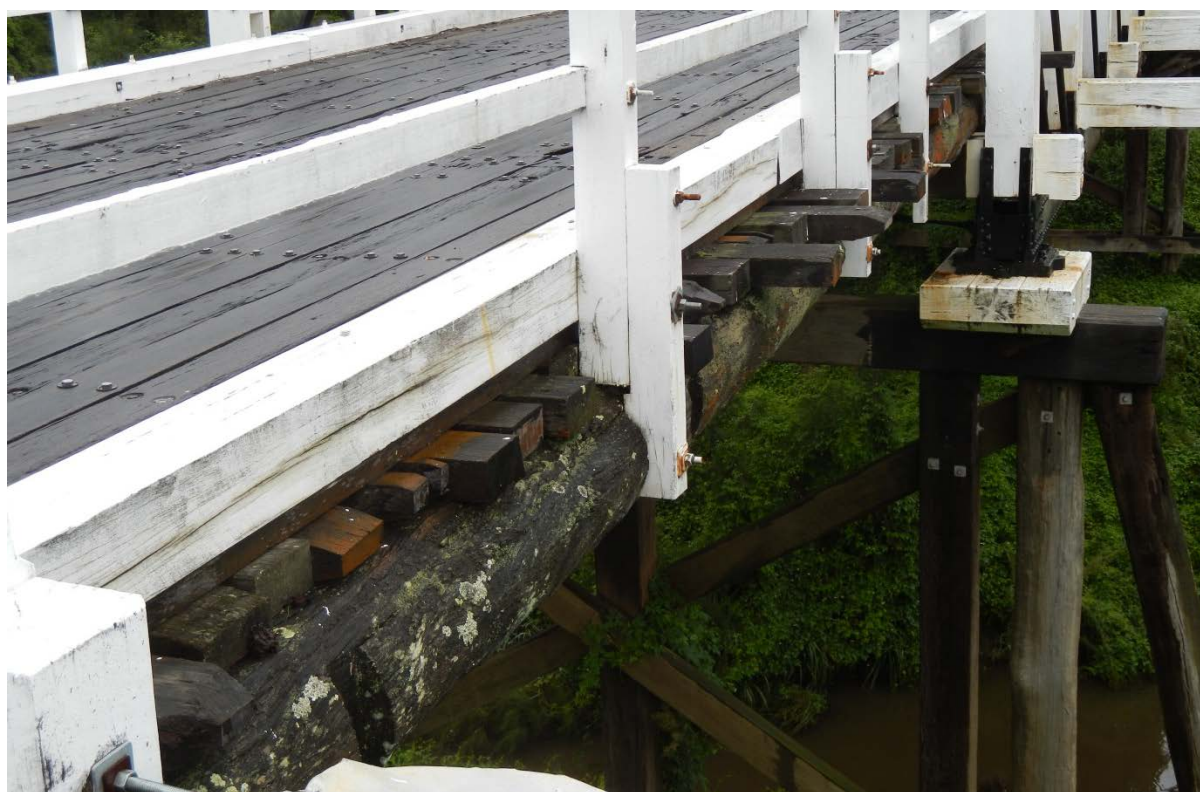
Figure 7.12 Photograph of current approach span configuration (source: author, March 2017)
