Transport for NSW

Monkerai Bridge

Conservation Management Plan

Author: Amie Nicholas
Date: October 2020
Version: 2
Reference: Monkerai Bridge Conservation Management Plan
Division:
Review Date:

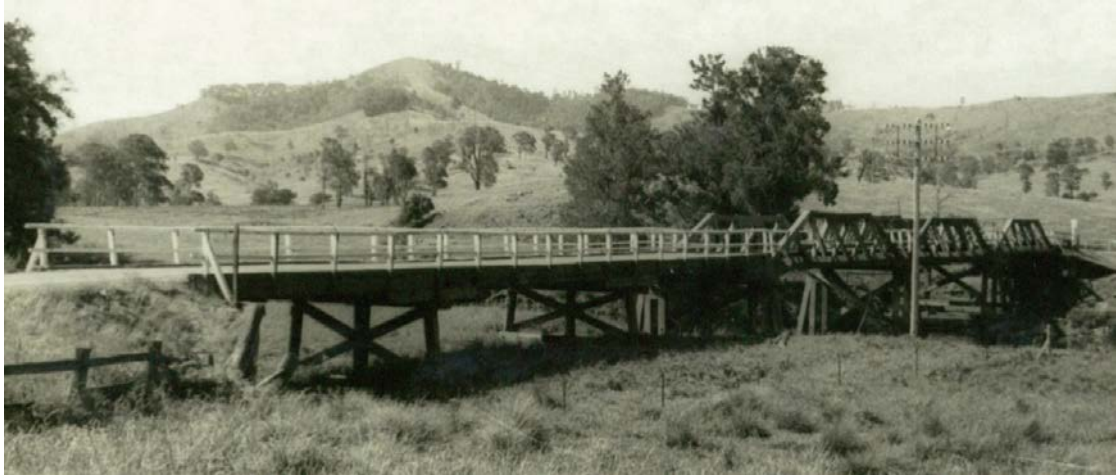
Figure 2-41: Before elimination of truss sags in 1967.

A memo of October 1967 records installation of Bailey Bridging to assist in the “restoration of camber and uprightness in each truss” as well as replacement of all tension rods with larger diameter tension rods, presumably in accordance with Maintenance Manual #6, 1962:⁹⁸

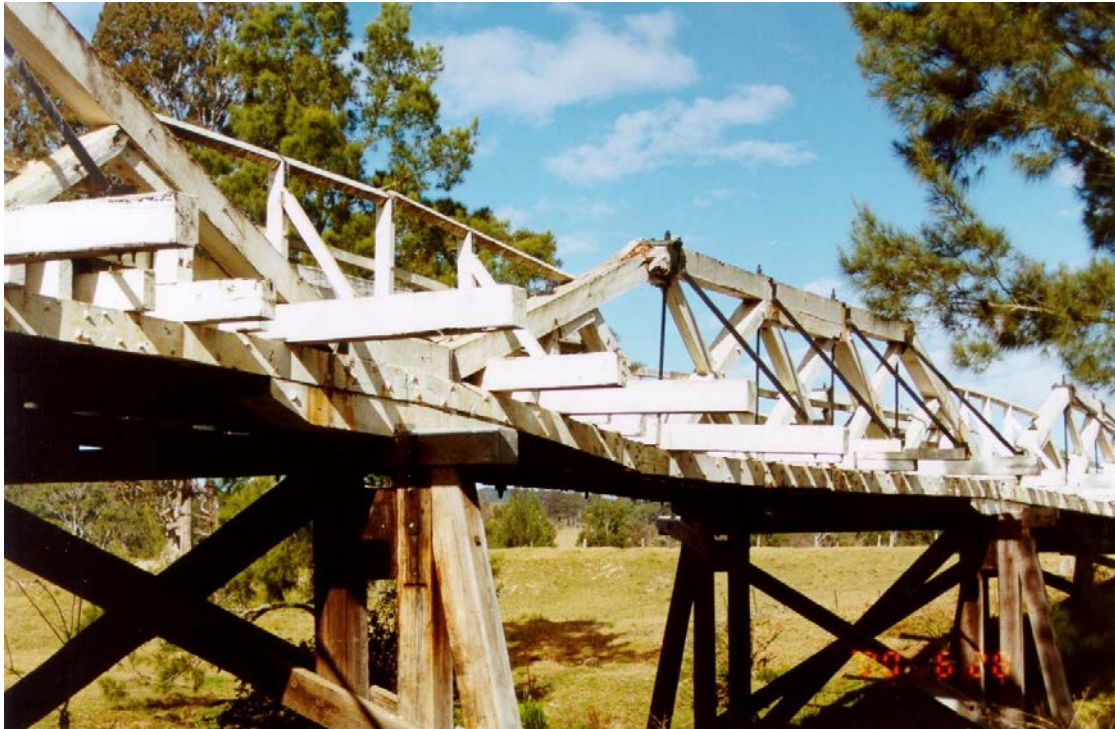
Figure 2-44: Failure of Principal and Bottom Chord in June 2000.

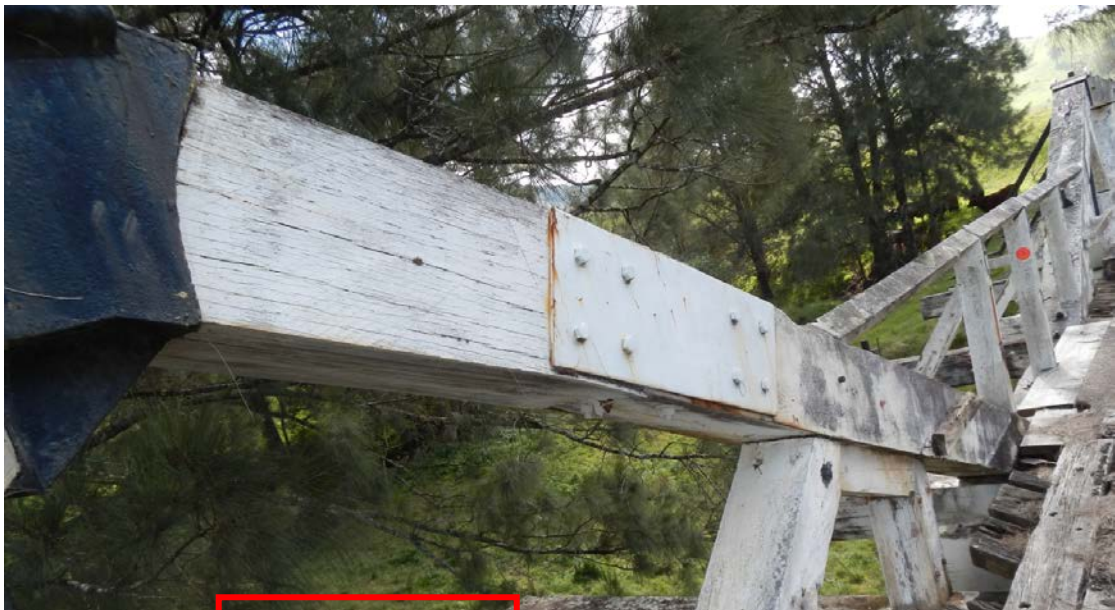
Figure 3-2: Photo of metal side plate and additional bolts on principal.

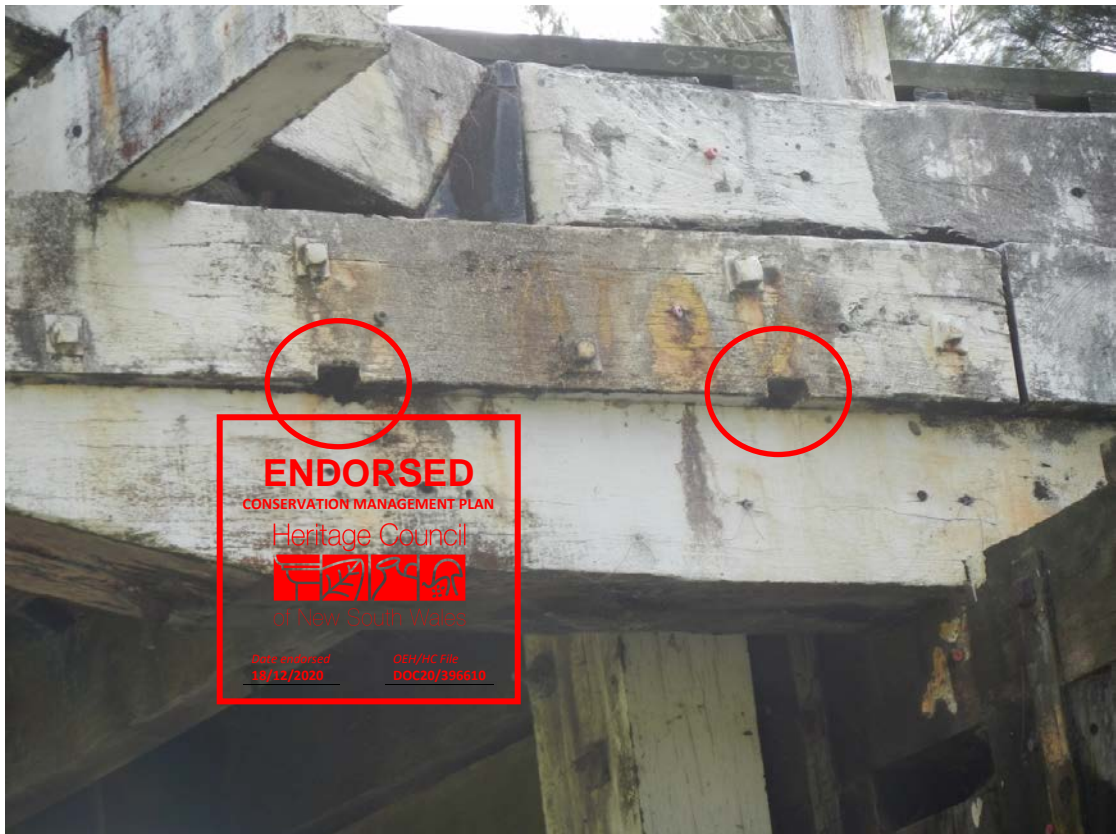
Figure 3-6: Photo of notches for missing shear keys in bottom chord.

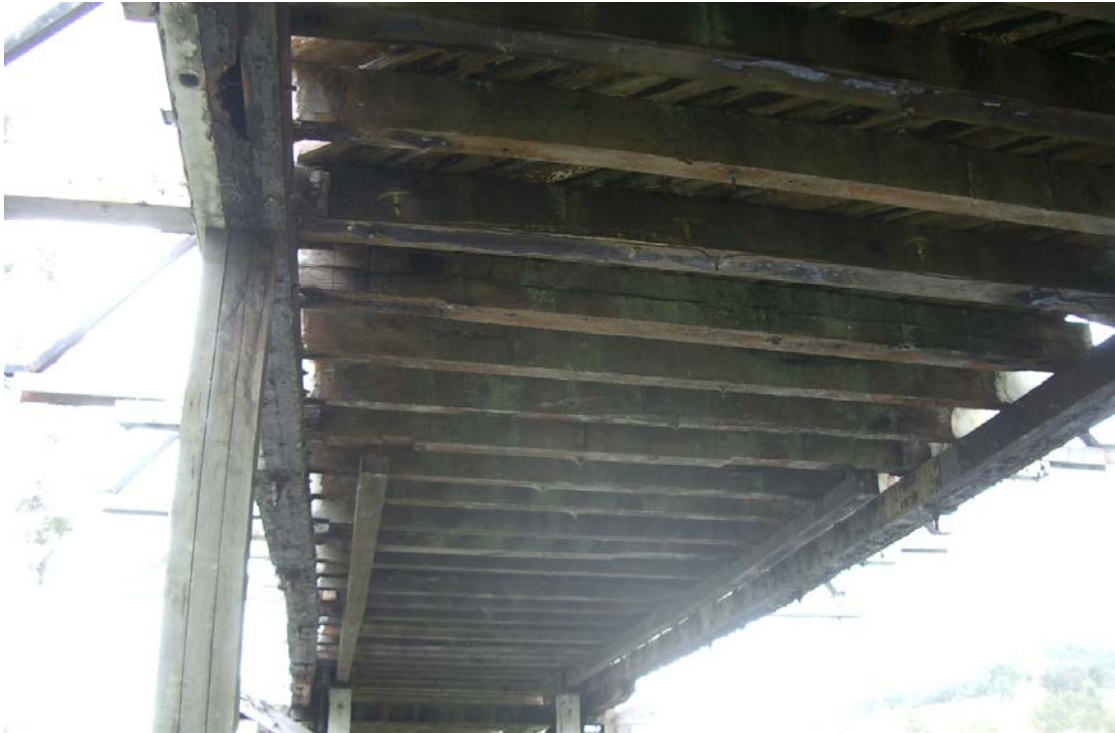
Figure 3-7: Photo showing poor condition and alignment of bottom chord.

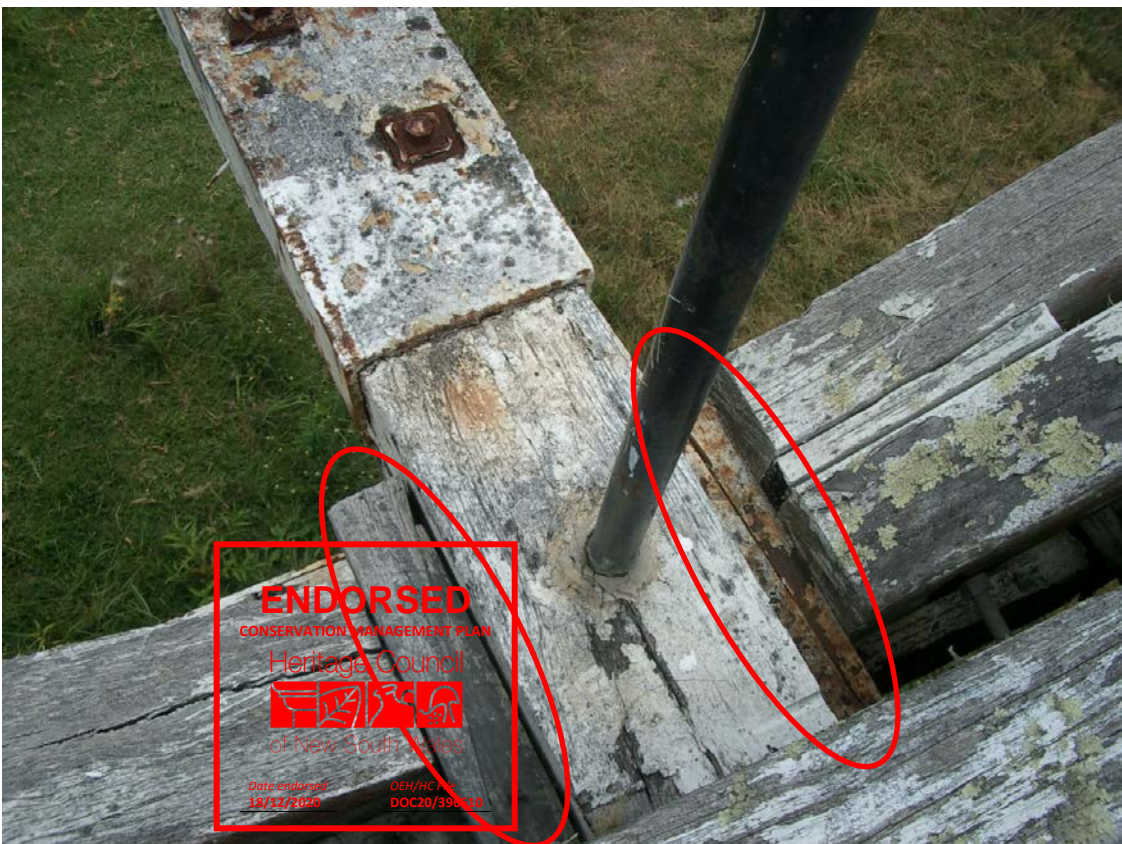
Figure 3-13: Photo of additional timber & metal wedges at base of diagonal.

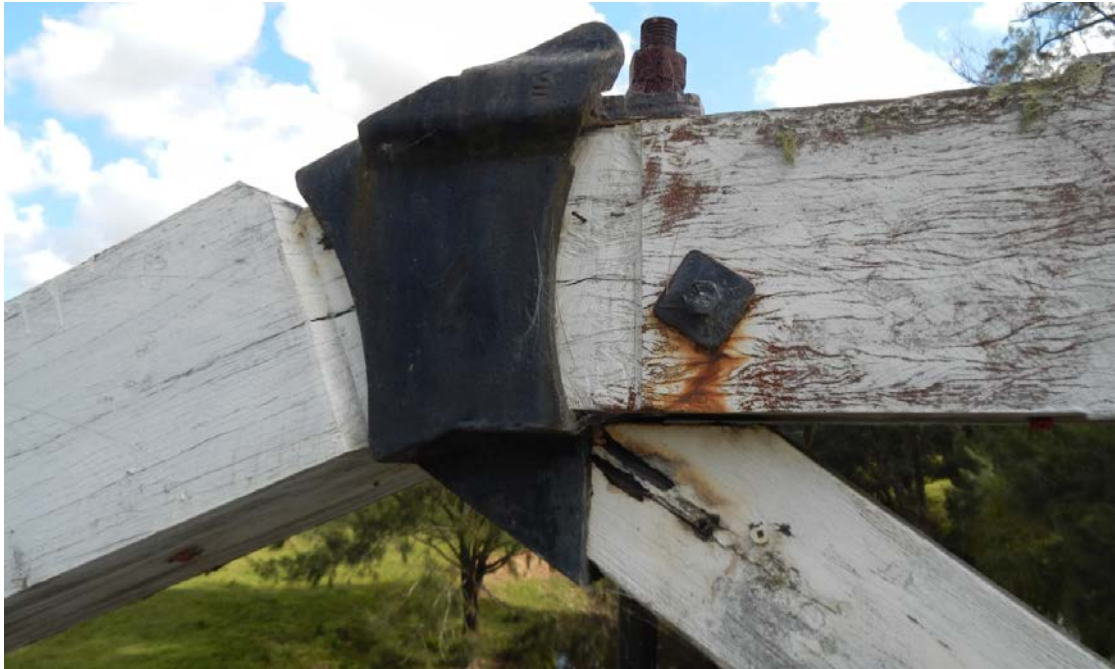
Figure 3-15: Photos of typical top chord cast iron shoe.

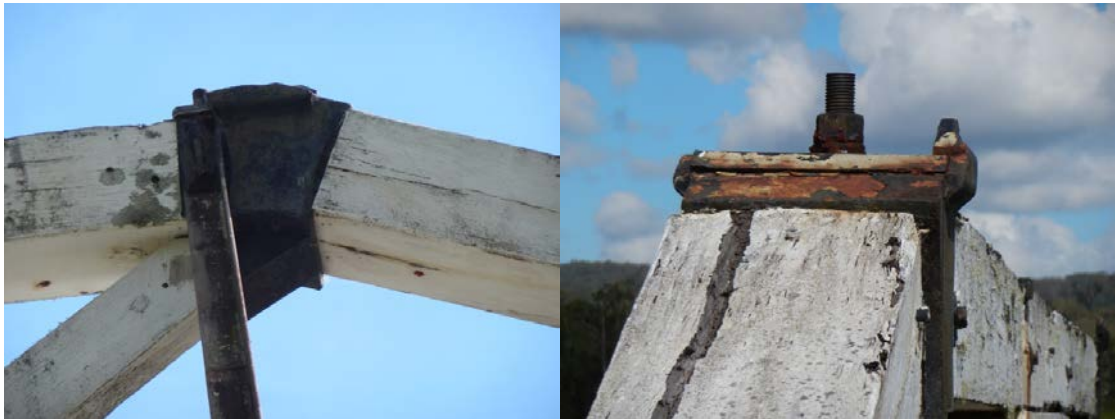
Figure 3-16: Photos of broken top chord cast iron shoes.

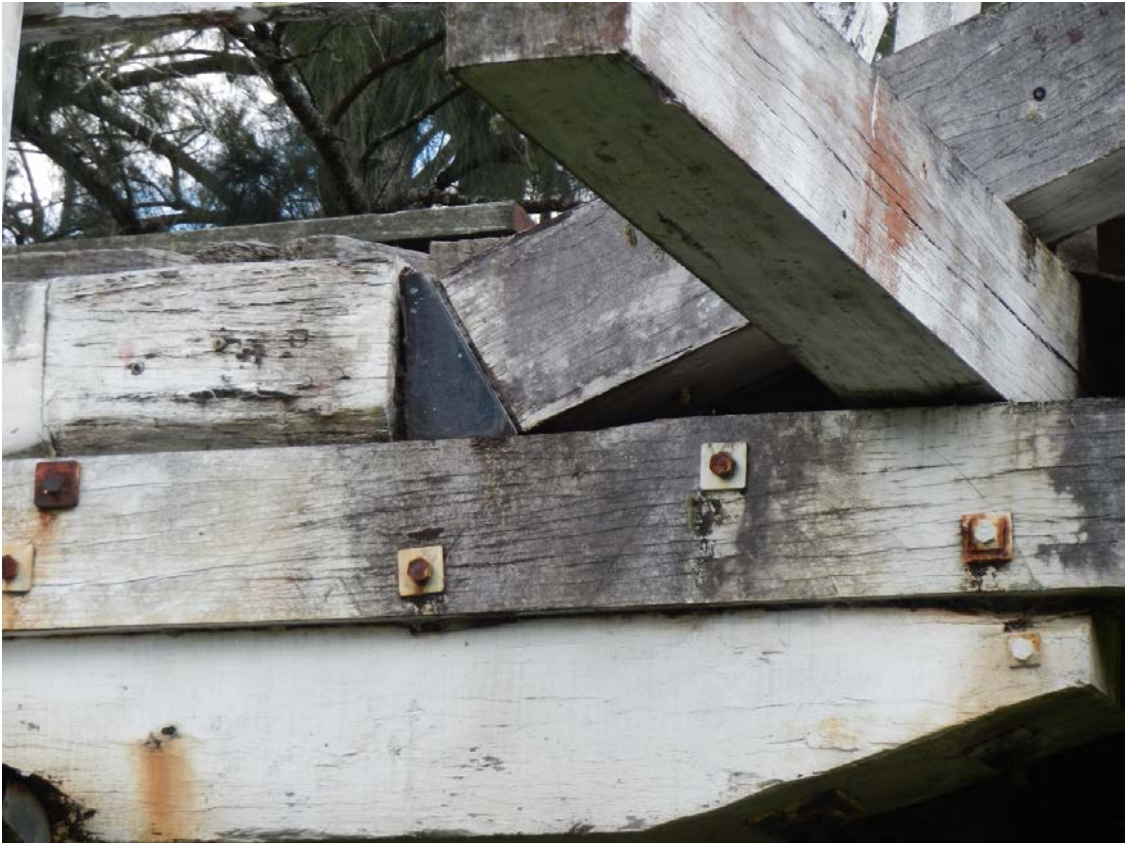
Figure 3-17: Photo of tear drop shaped cast iron shoe largely obscured.

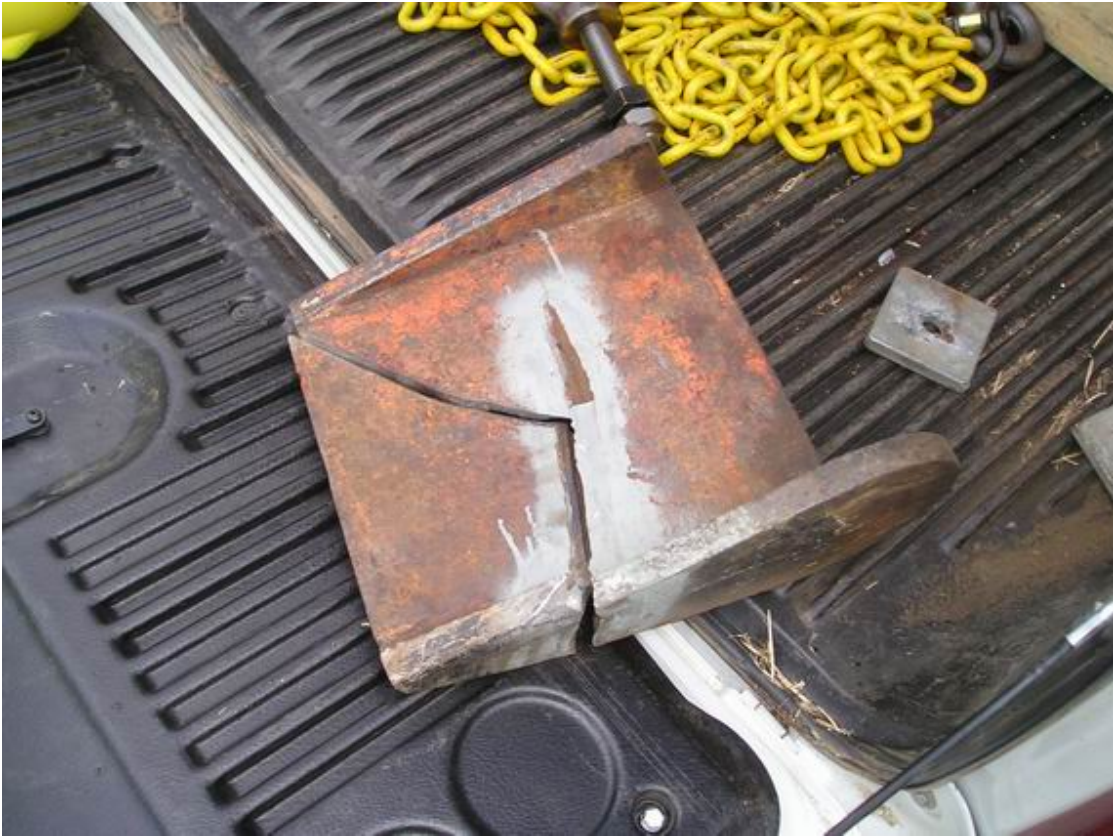
Figure 3-18: Photo of broken modified shoe removed from bridge.

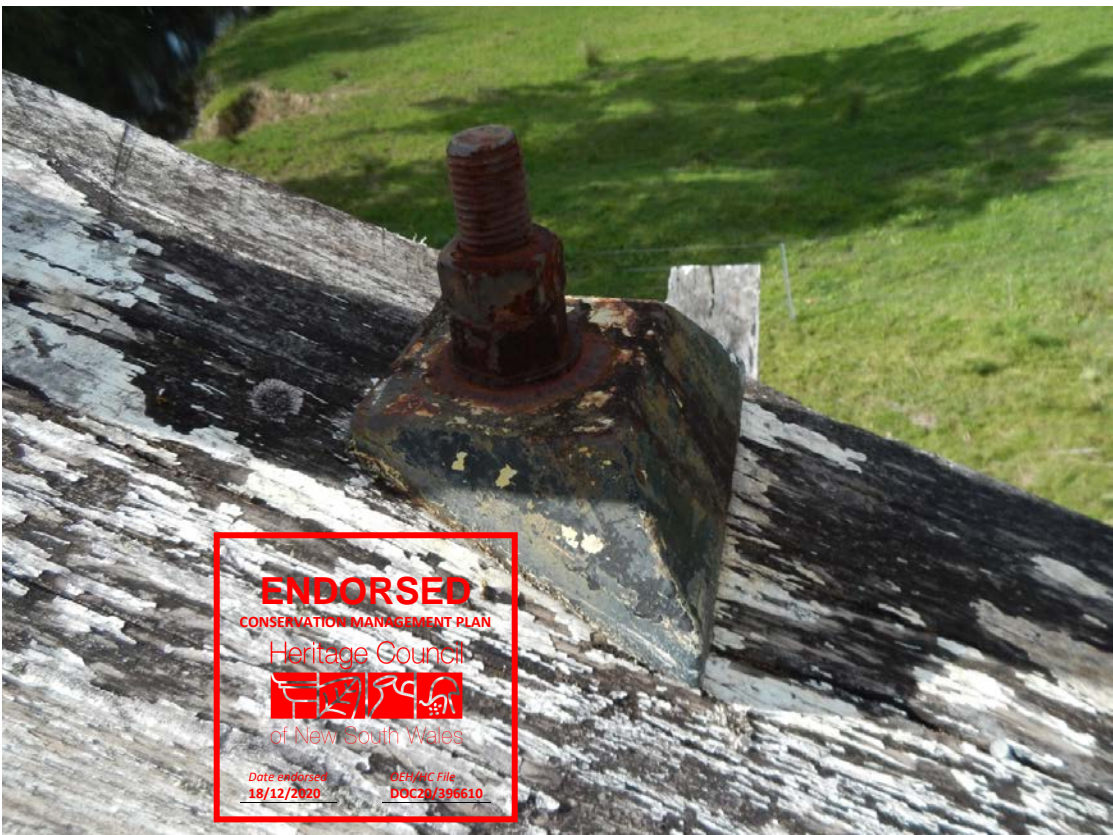
Figure 3-20: Photo of wrought iron bevelled washer and short tension rod.

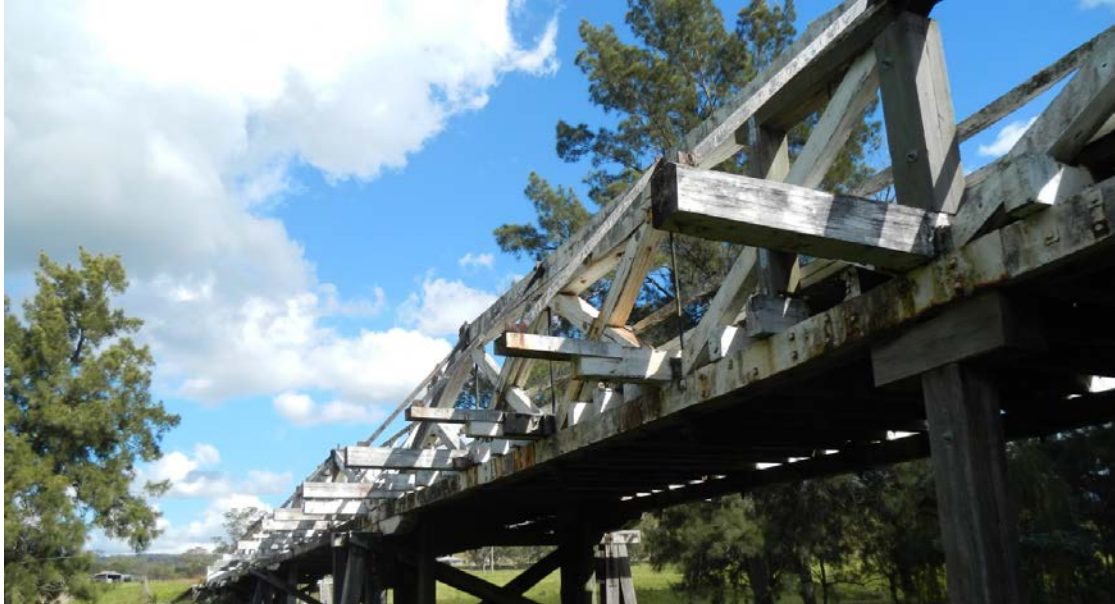
Figure 3-24: Photo of current metal sway braces and metal CG extensions.

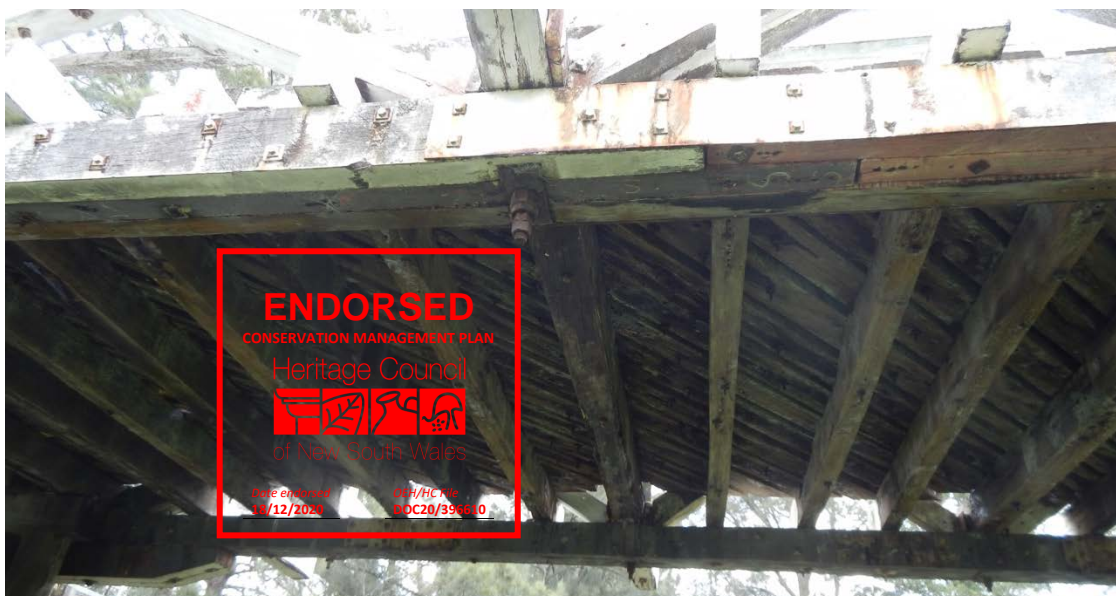
Figure 3-27: Photo of cross girders with no notching or stringers.

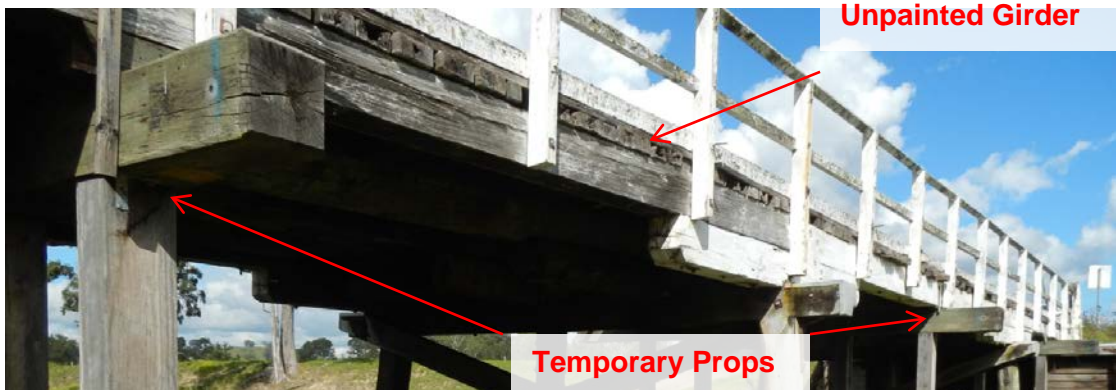
Figure 3-30: Photograph showing unpainted girder and temporary props.

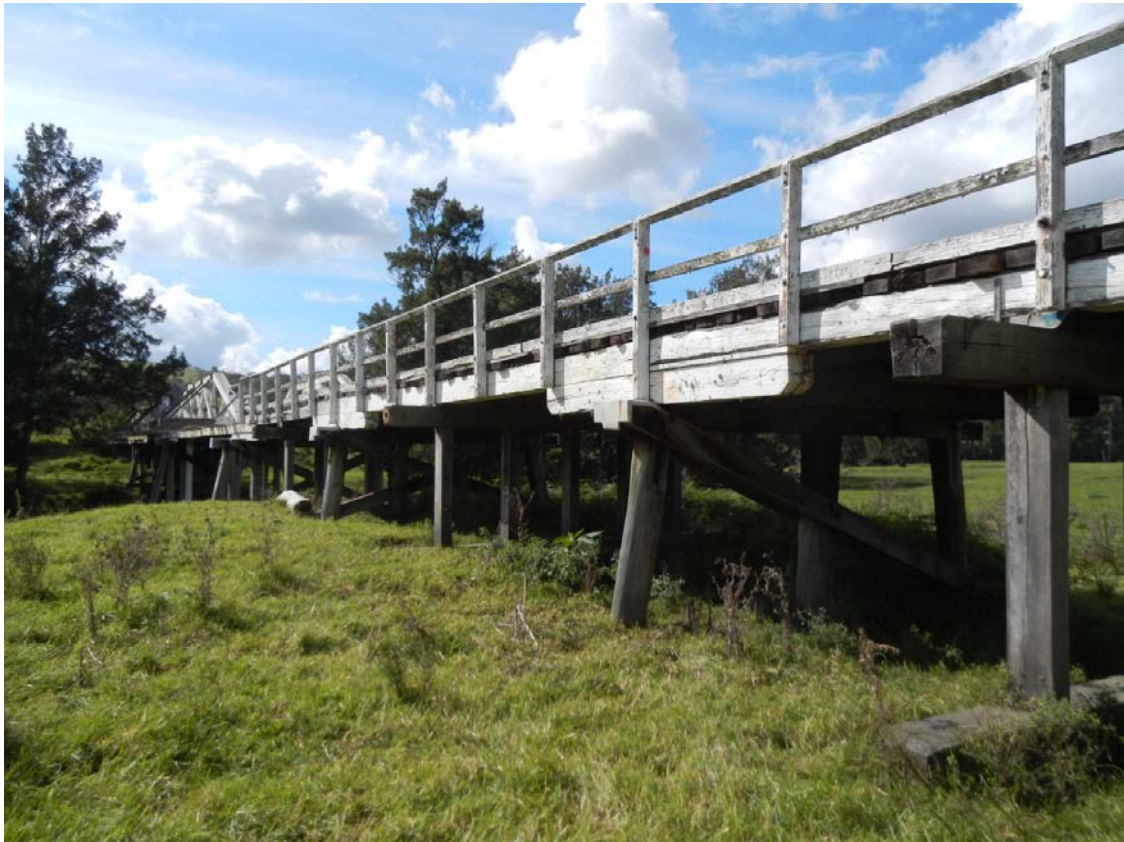
Figure 3-32: Photograph showing current detailing of approach spans.

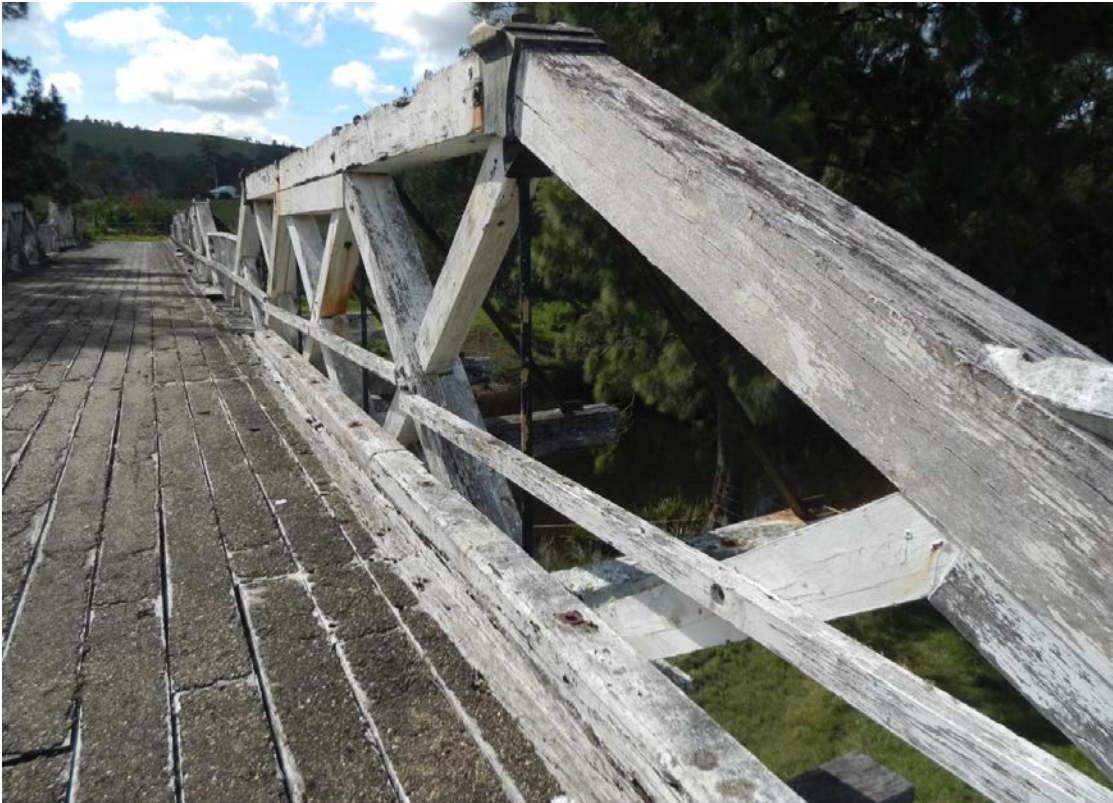
Figure 3-44: Photograph showing broken railings on truss span.

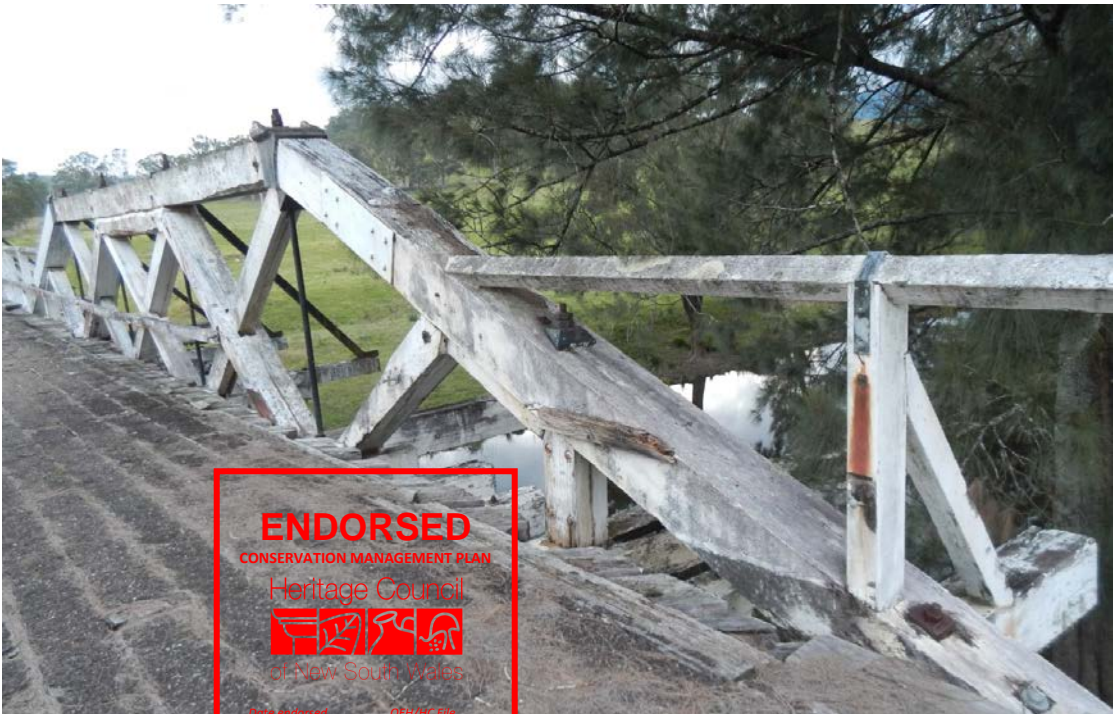
Figure 3-45: Photograph showing missing railings on truss span.

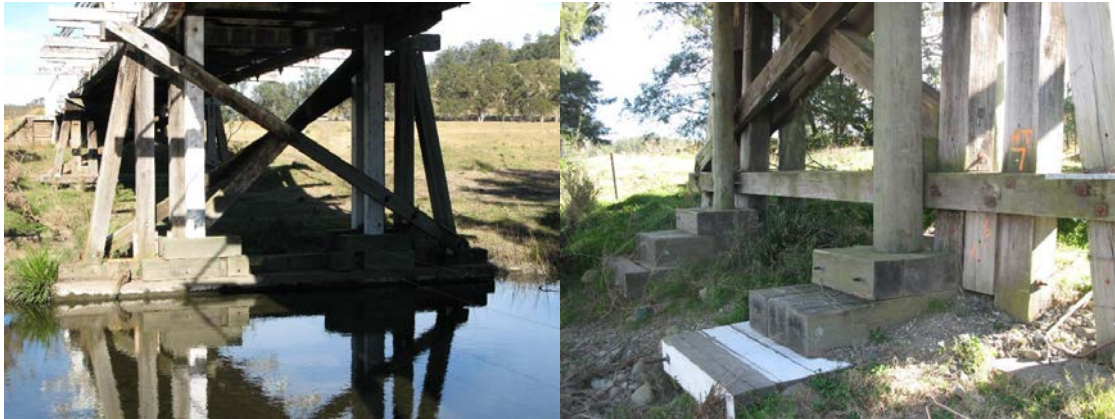
Figure 3-48: Photograph of messy modifications to piers 4 & 5.

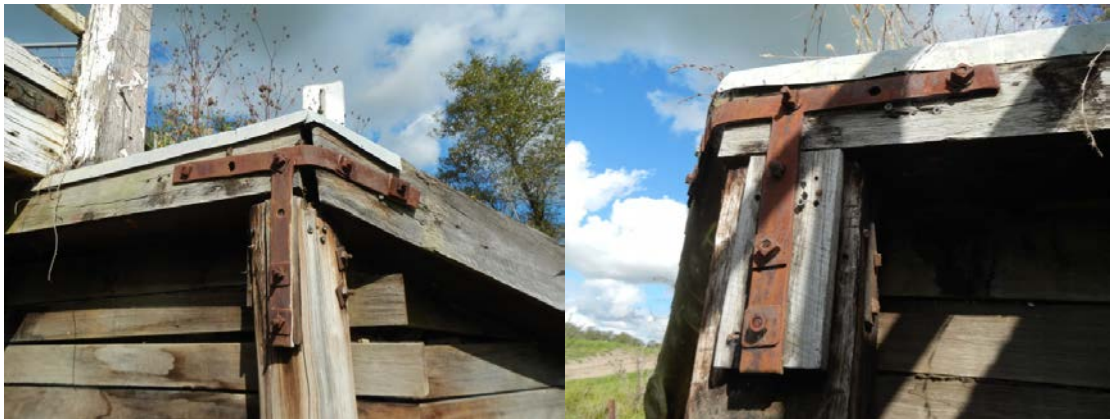
Figure 3-49: Metal straps on Abutment A possibly original fabric.

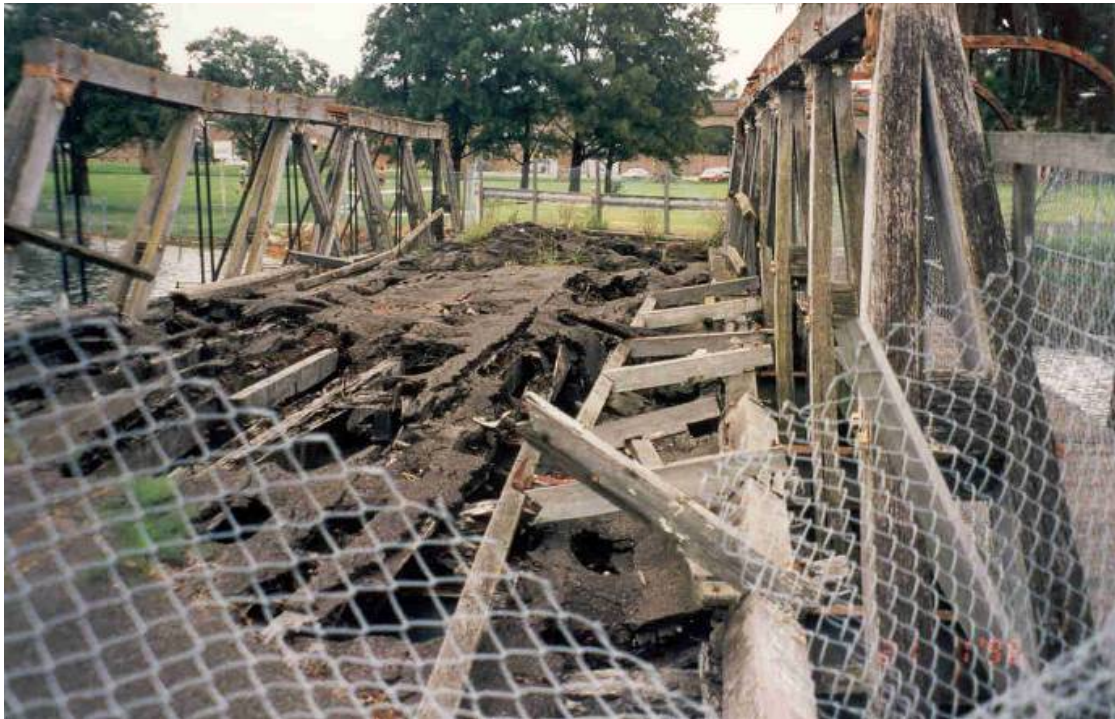
Figure 5-2: Johnston’s Creek Bridge, failed pedestrian bridge at Glebe.

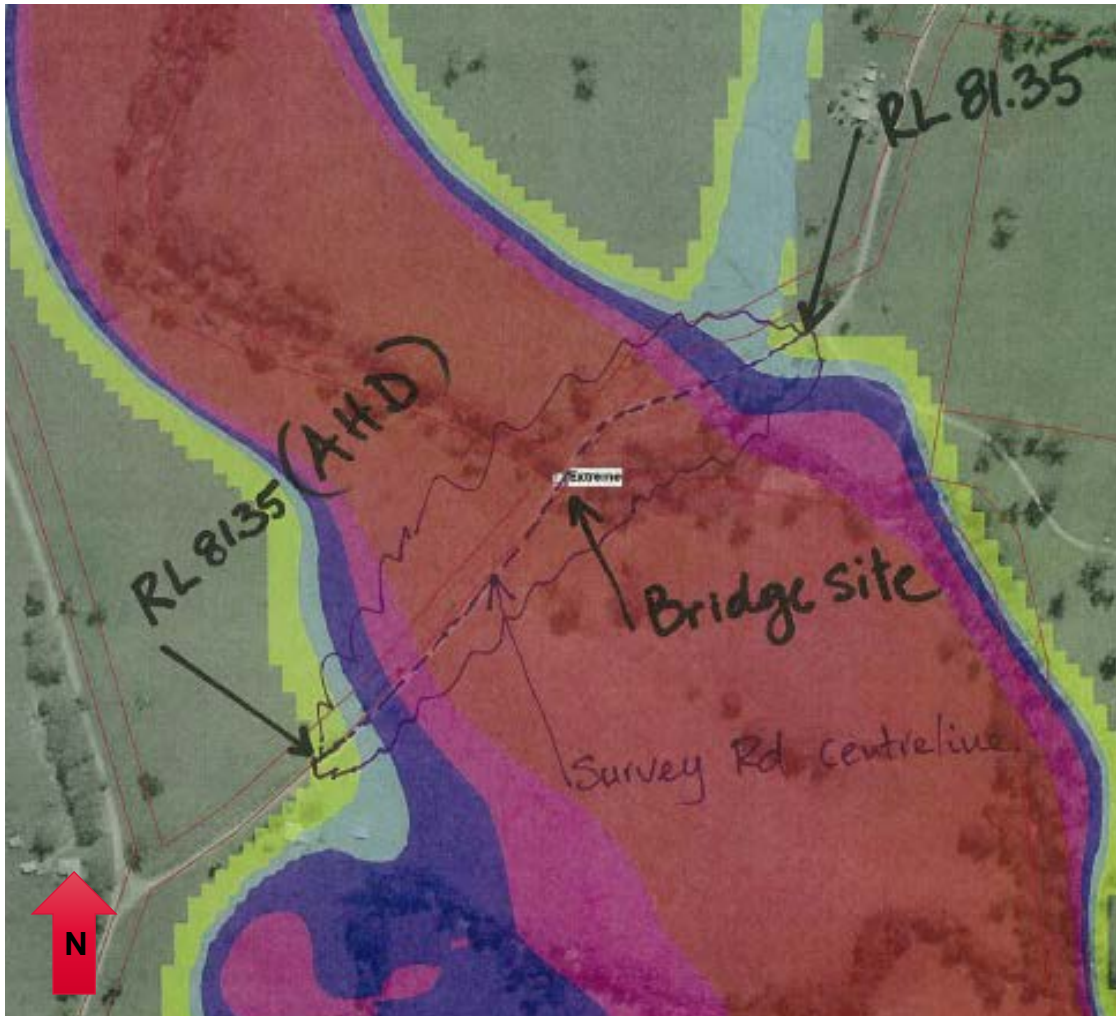
Figure 6-2: Flood study results for Monkerai Bridge.
