# TIMBER TRUSS BRIDGE MAINTENANCE HANDBOOK

DEPARTMENT OF MAIN ROADS NEW SOUTH WALES

***TIMBER TRUSS BRIDGE  
MAINTENANCE HANDBOOK***

OUTLINES OF TIMBER TRUSS TYPES FOR BRIDGES CONSTRUCTED  
1860 - 1936

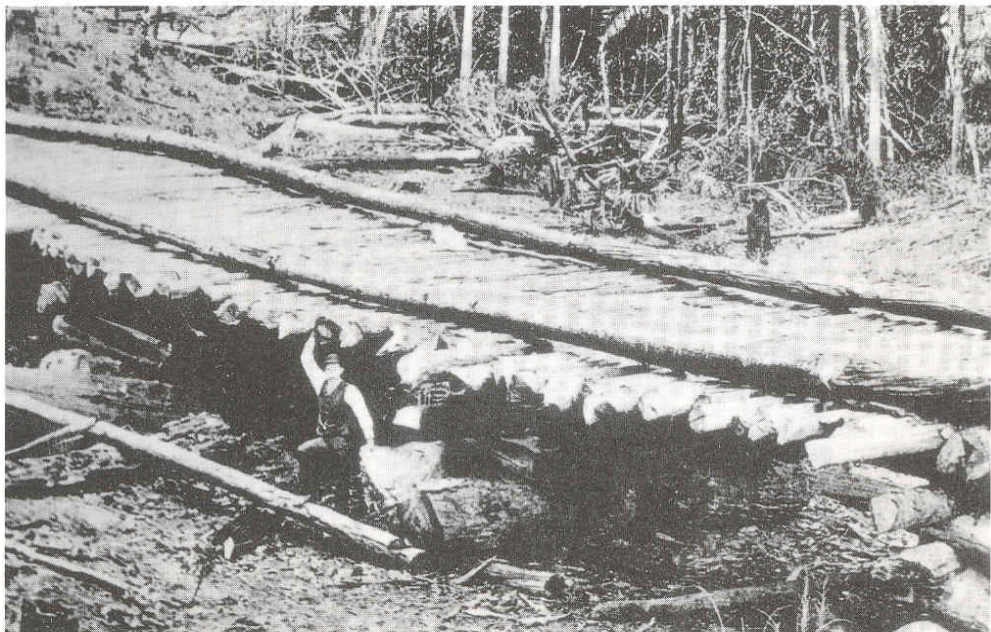
**"An early Timber Corduroy Bridge."**

Unfortunately Lennox's bridges were but shining exceptions in the otherwise dismal conditions of roads and bridges at the time. Some stone arch bridges had been built by others, but none have survived. Timber bridges were, of course, also built. Some were primitive log bridges, called corduroy bridges made from heavy longitudinal logs with cross-logs. It was customary to cover the deck with a layer of road material to improve the ride. Better quality timber beam bridges were also built but they were low-level crossings and suffered from the ravages of floods and the tonnes of debris so typically carried down Australian rivers in flood. Overall, satisfactory bridges were few and far between.

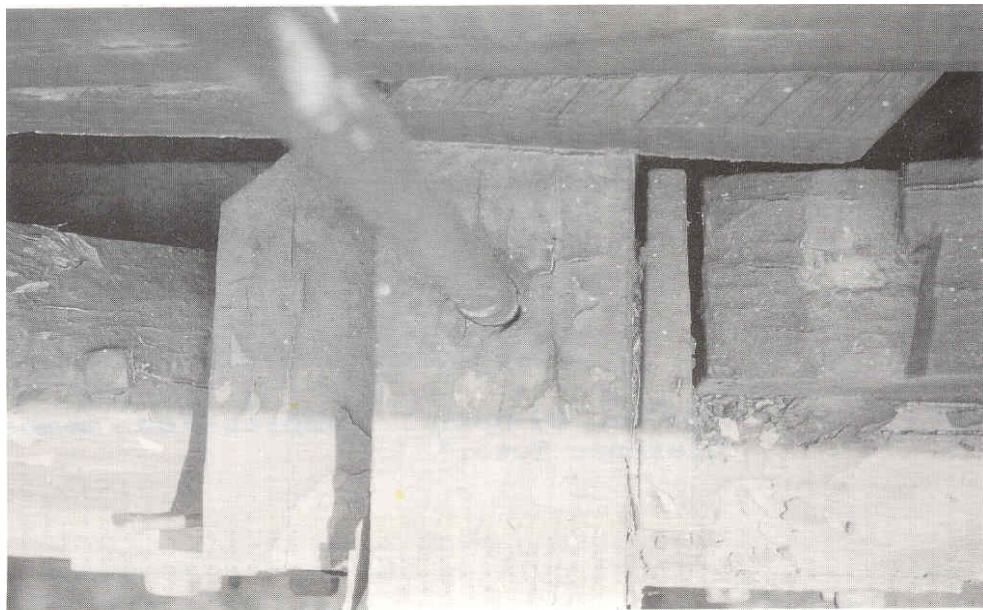
**“Shrinkage in the bottom chord connected with wedges.”**

The joint details of these early trusses were formed simply by shaping the ends of the timbers so as to bear against each other. At some joints, smaller bolts were used to hold the members together and so ensure the structural integrity of the joint, but not the joints for the diagonal members. It was assumed they would always bear against the sides of the cross-girders and remain snug for load transfer. Unfortunately, a characteristic of the local hardwoods was their considerable distortions due to shrinkage and creep, so much so, that the bottom chord joints opened up thereby making effective structural action very difficult to obtain. It was not possible to tighten up the truss in order to close the joints hence attempts were made to fill the gaps with wooden wedges.

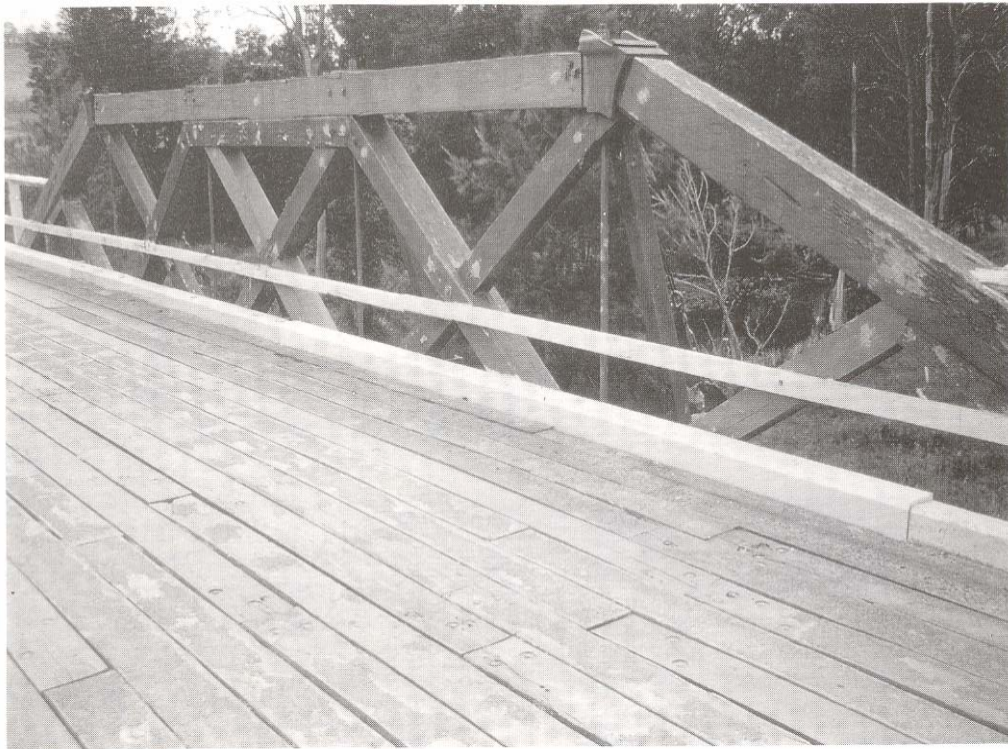
There were some improvements of course in this adaptation from roof truss to bridge truss, for example metal plates were incorporated at the two main compression joints, the shoulder joint and the joint above the trestle. The earlier practice of allowing timber to bear against timber had proved to be unsatisfactory. Each panel was cross-braced in the vertical plane to account for reversal of force in the diagonals, the splice plates (called fishplates) were included wherever joints occurred within the length of a member.

**“Note the additional top chord pieces bolted either side of the central diagonals.”**

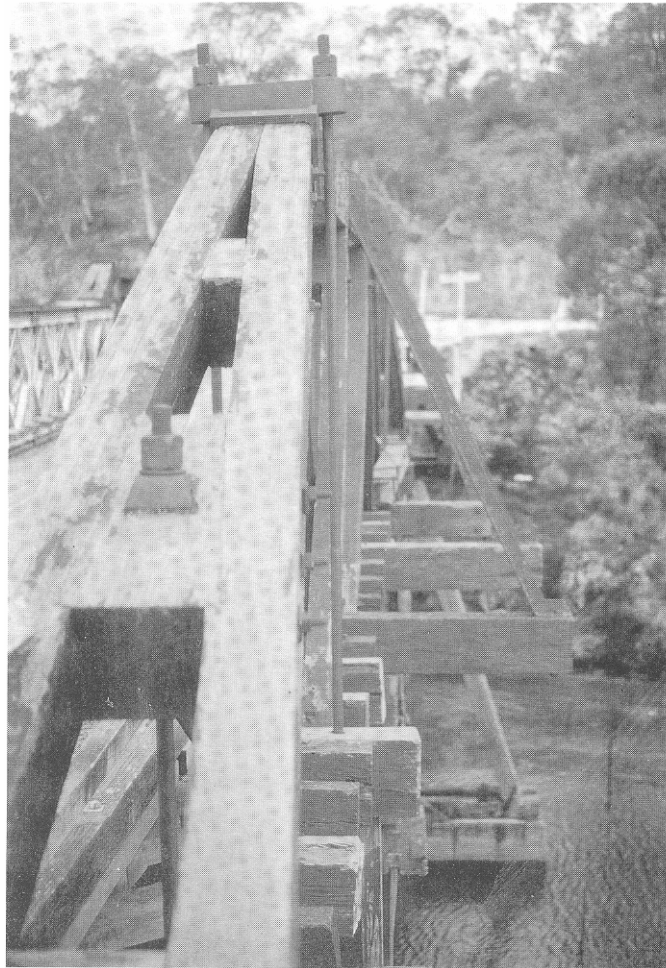
1. The sloping end-struts (principals) were made from two lengths of timber, spreading apart towards the supports but tied together by space pieces. These units thus act as spread columns of greater strength, providing some lateral support at the ends of the chords.

**“Sloping principals made from two lengths of timber, spread apart towards the supports, but tied together by spacer pieces.”**

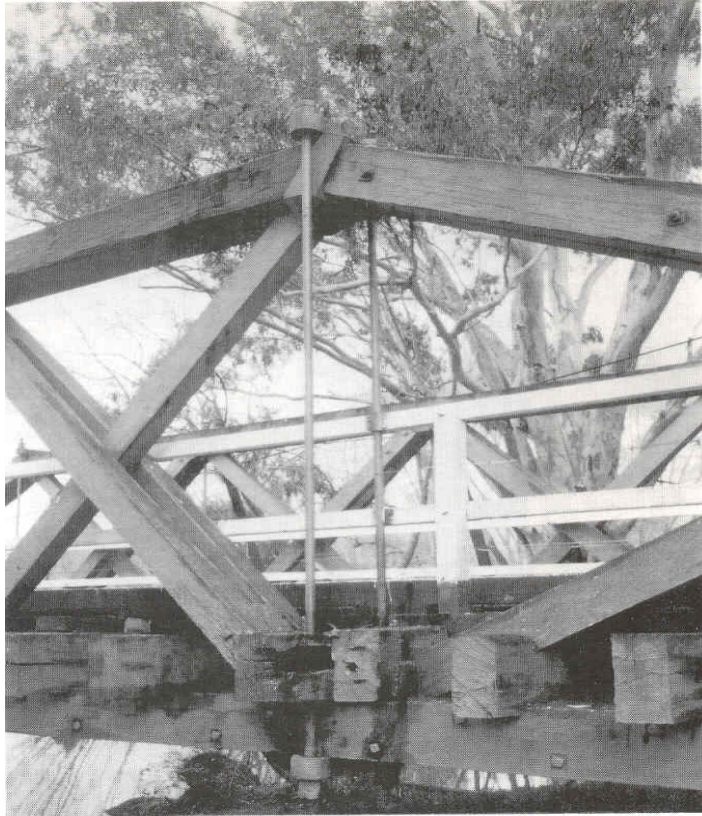
2. Suspension rods were of increased sectional area with additional vertical rods incorporated at the shoulder joints by using bridging plates across the top and bottom chords, enabling the rods to be located outside the timber. This increased shear strength and made it a little easier to replace component members.

**“Suspension roads in pairs either side of the timber.”**

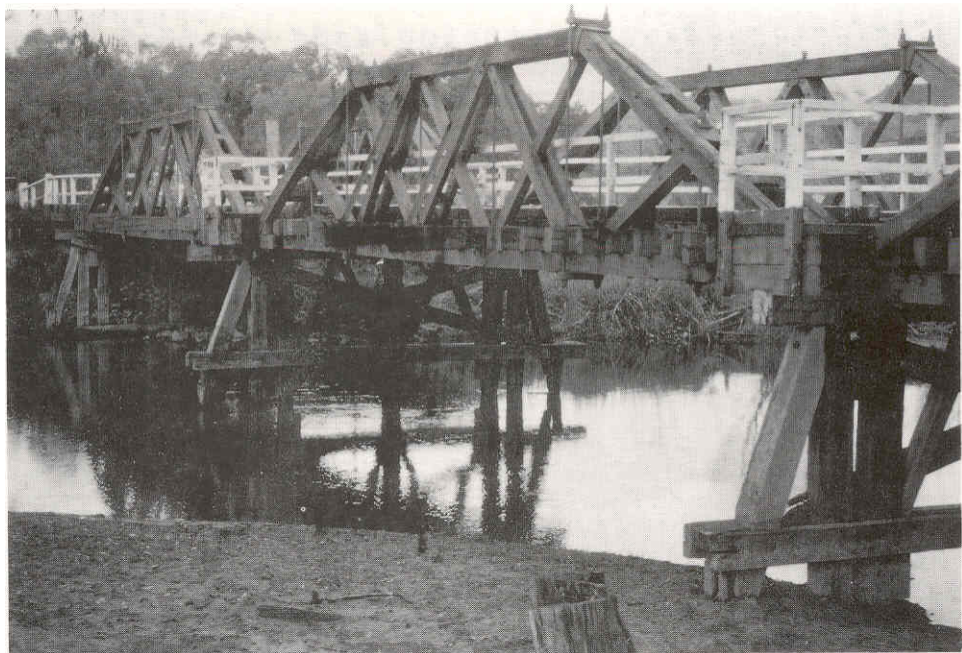
**“Some diagonal members are single timbers, some are double timbers.”**

3. The diagonal web members were a mixture of single and double timbers, which provided greater stability, and allowed for partial renewals without losing the structural integrity of the web.

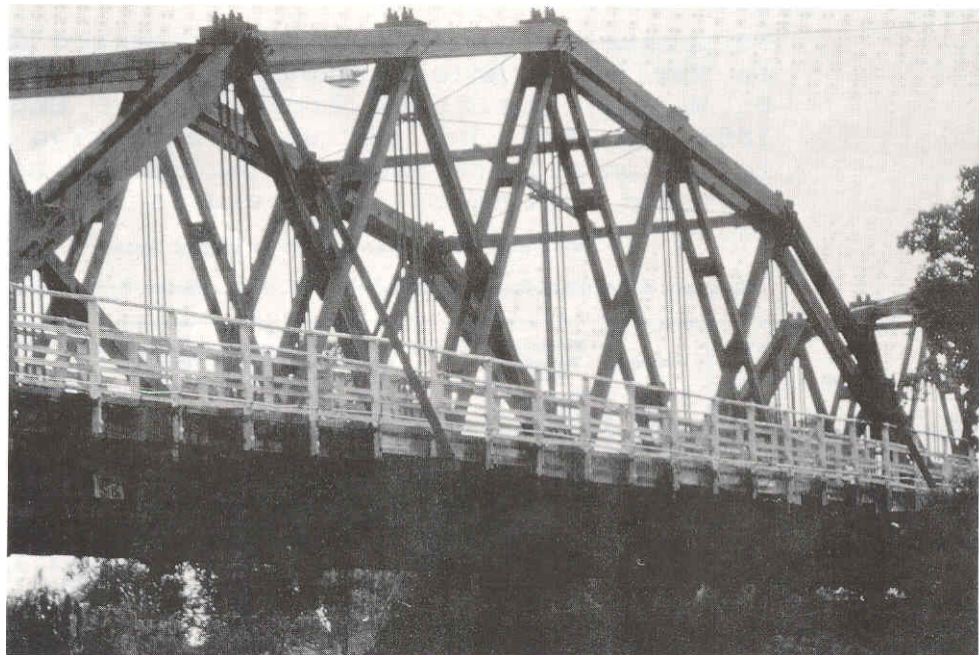
**“ McDonald truss at Cowra showing principle features.”**

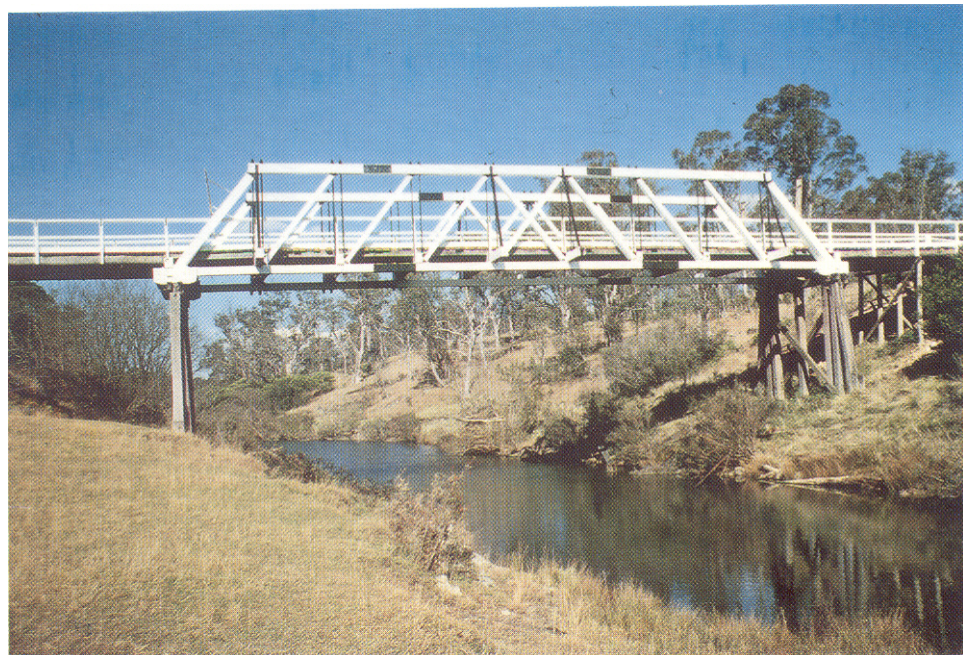
**“Allan Truss over Molonglo River at Burbong.”**

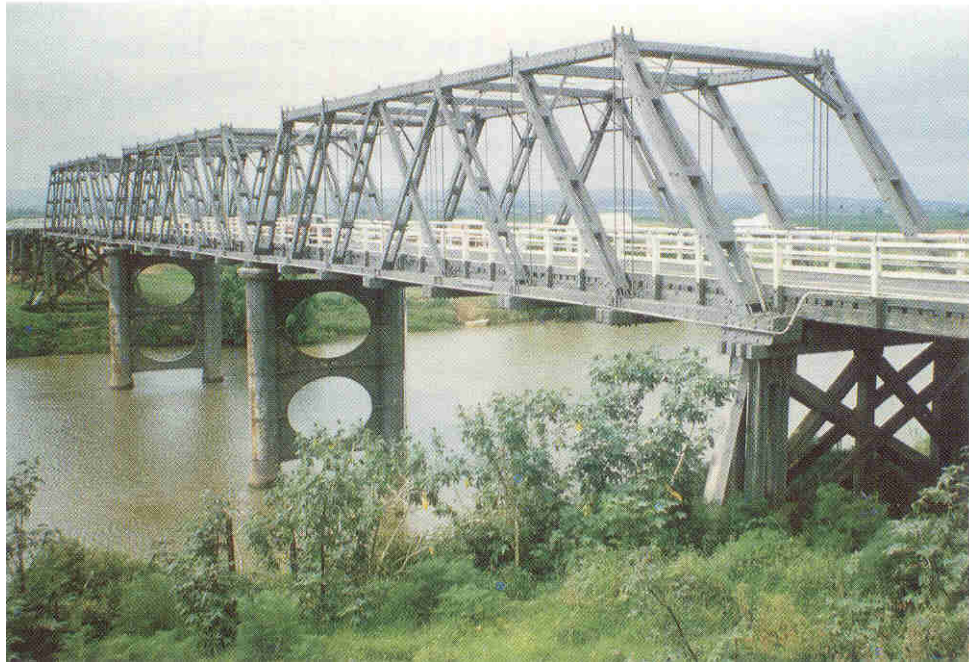
**“Bridge over the Hunter River at Morpeth.”**

An on-site inspection of remaining overhead bridges shows that Allan was able to vary the amount of material to suit varying amounts of strength required throughout the structure. For example, in the Morpeth bridge, it can be seen that there are three vertical rods in the first panel where the shear force is a maximum. As the shear force decreases towards mid-span so the number of rods decreases to two and then to one. Throughout the structure there is a changing and efficient use of materials, and yet the overall appearance is one of uniformity.

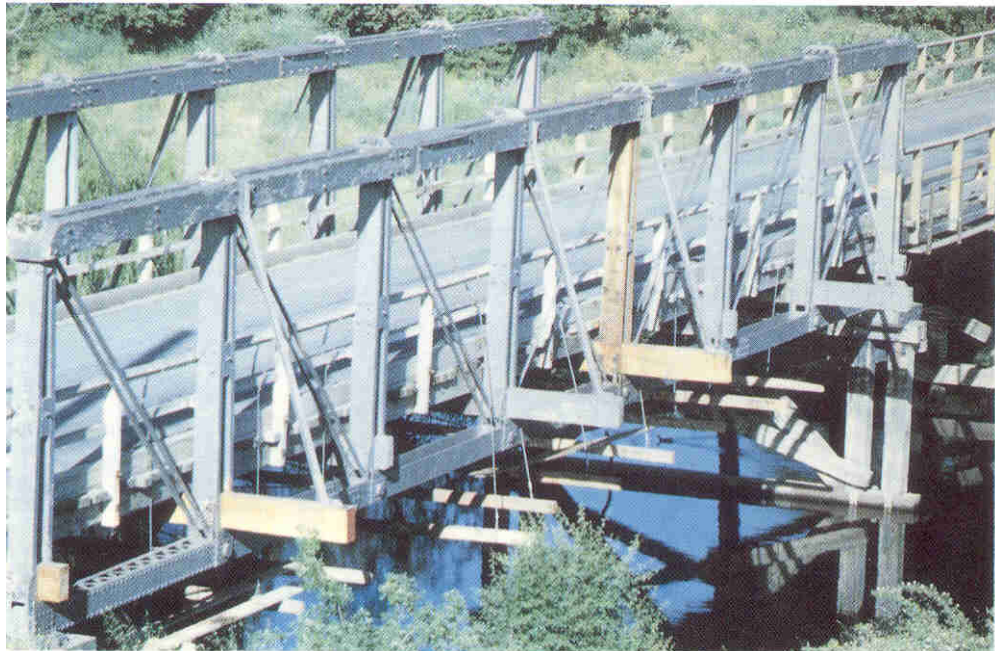
**“Pratt type truss, designed by De Burgh, over Mulwaree Ponds, Goulburn.”**

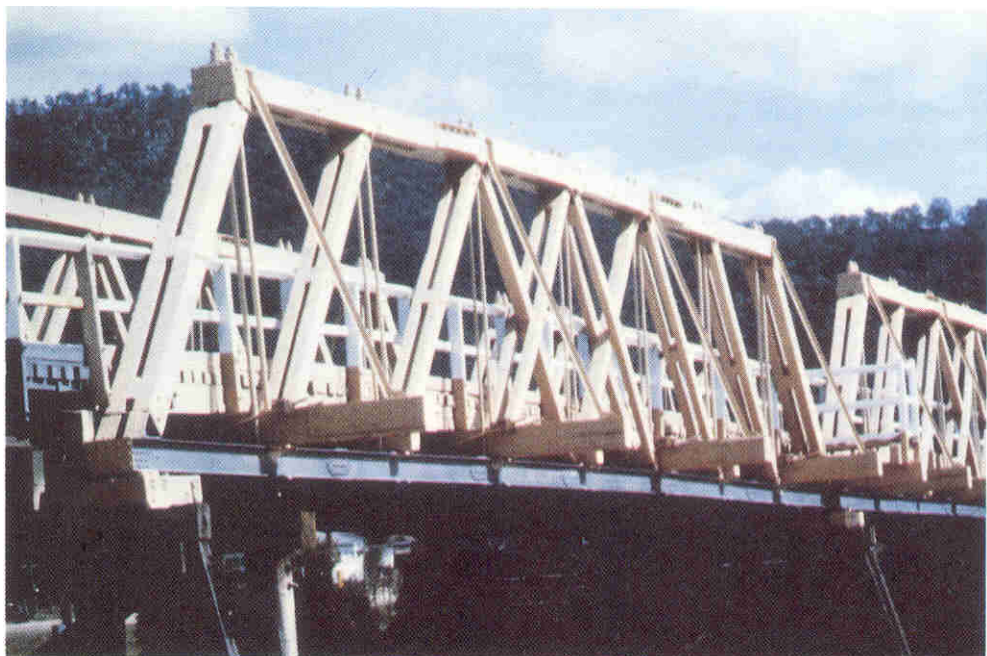
**“Howe type truss, designed by Dare, over Wollombi Brook at Bulga.”**

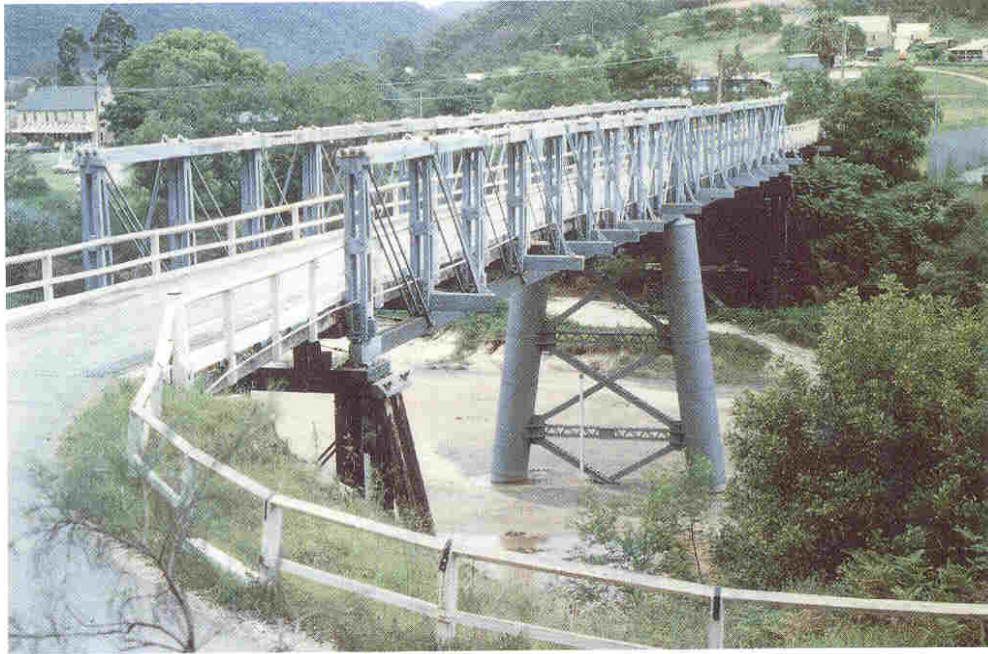
**“De Burgh trusses over MacDonald River at St.Albans.”**

span. At St. Albans over the MacDonald River there are two 36m trusses, the largest spans without overhead bracing.

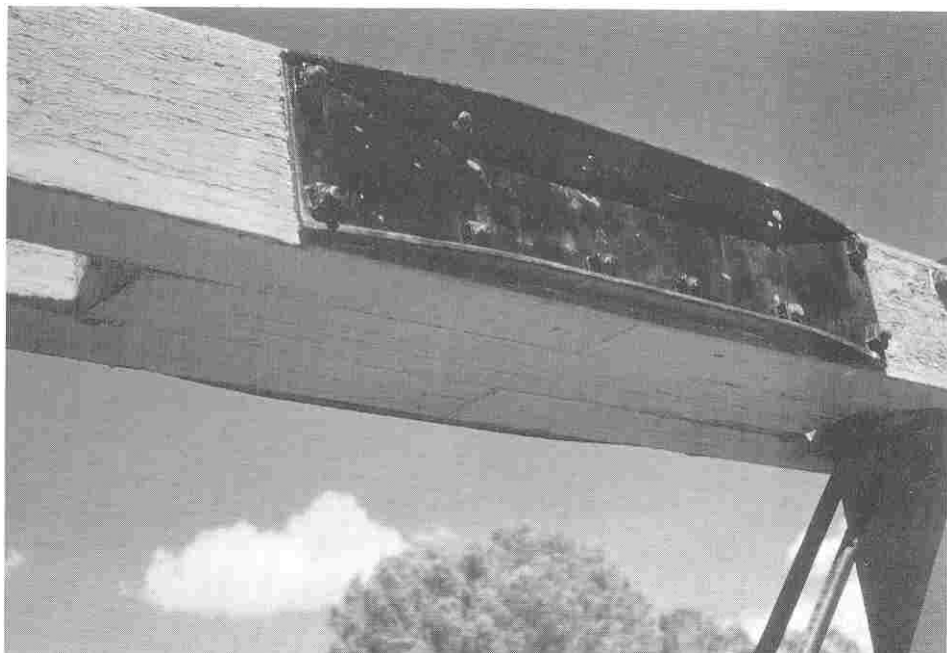
**“A new design for splice plates.”**

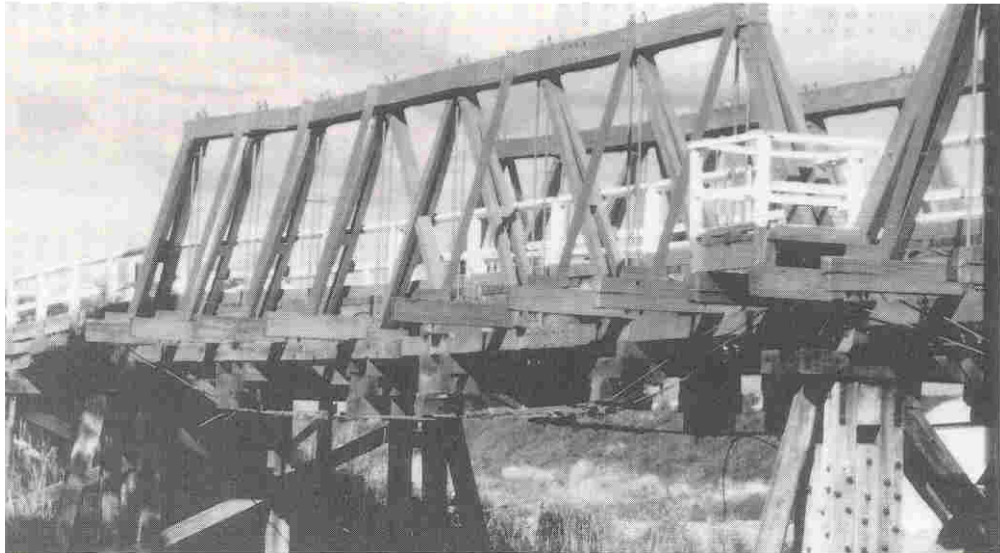
**"This Allan truss over Wybong Creek on the Denman to Sandy Hollow road typifies the problems with timber trusses. The combination of creep, shrinkage and heavier faster traffic renders the bridge structurally inadequate, hence the strengthening by underslung cables. This bridge was replaced by a continuous steel girder structure in 1984."**

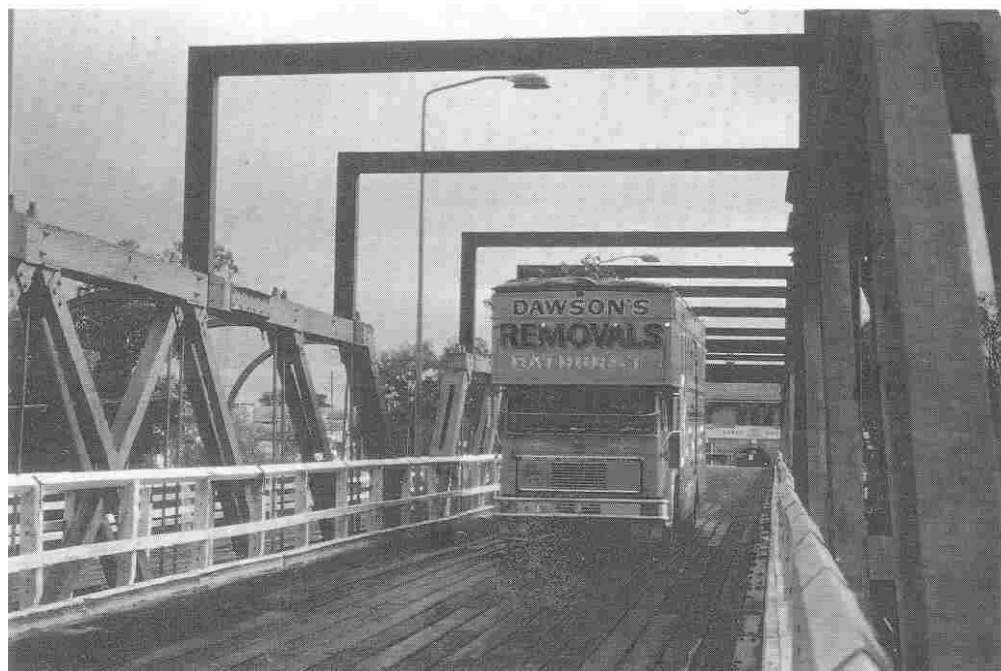
- 6) Some designs were showing shortcomings. For example a problem with pony trusses (i.e. trusses not tall enough to allow overhead bracing) was inadequate lateral stability of the top (compression) chords. At some locations the top chord has buckled out of line. In extreme cases, the top chord has required strengthening by the addition of overhead portal frames.

**"Overhead portal frames stabilise the top chords."**

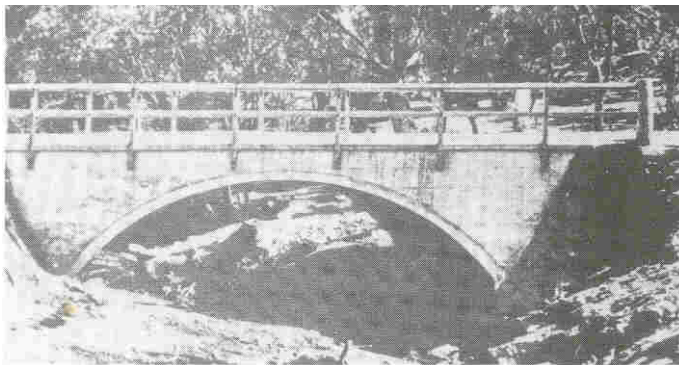
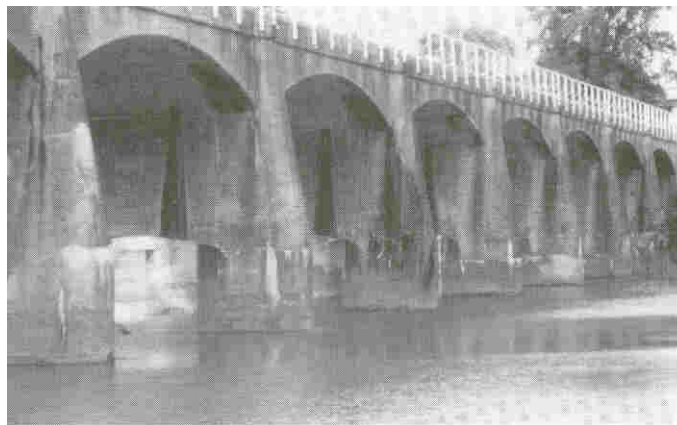
**“The early reinforced Concrete bridges were Monier arches such as the single span railway overbridges, the 1900 arch at Moonbi and the 1905 multiple spans over the Hawkesbury River at Richmond. The economy and durability of these structures added to the rapid decline in the use of timber bridges.”**

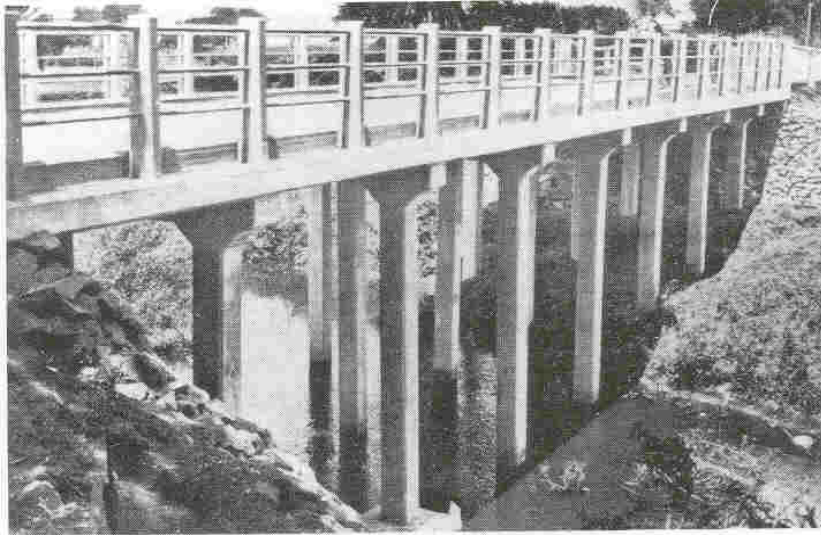
**“The concrete Monier arches heralded a new era of road bridge construction, but their use was short-lived because few sites were suitable for arches. On the eve of World War I reinforced concrete beams and slab bridges, such as this 1914 structure over American Creek near Figtree (replaced in 1982), were displacing timber beam bridge ridges and the shorter timber trusses.”**
