McKanes Bridge over Coxs River

Conservation Management Plan

Author:	Amie Nicholas
Date:	March 2021
Version:	5
Reference:	McKanes Bridge Conservation Management Plan
Division:	
Review Date:

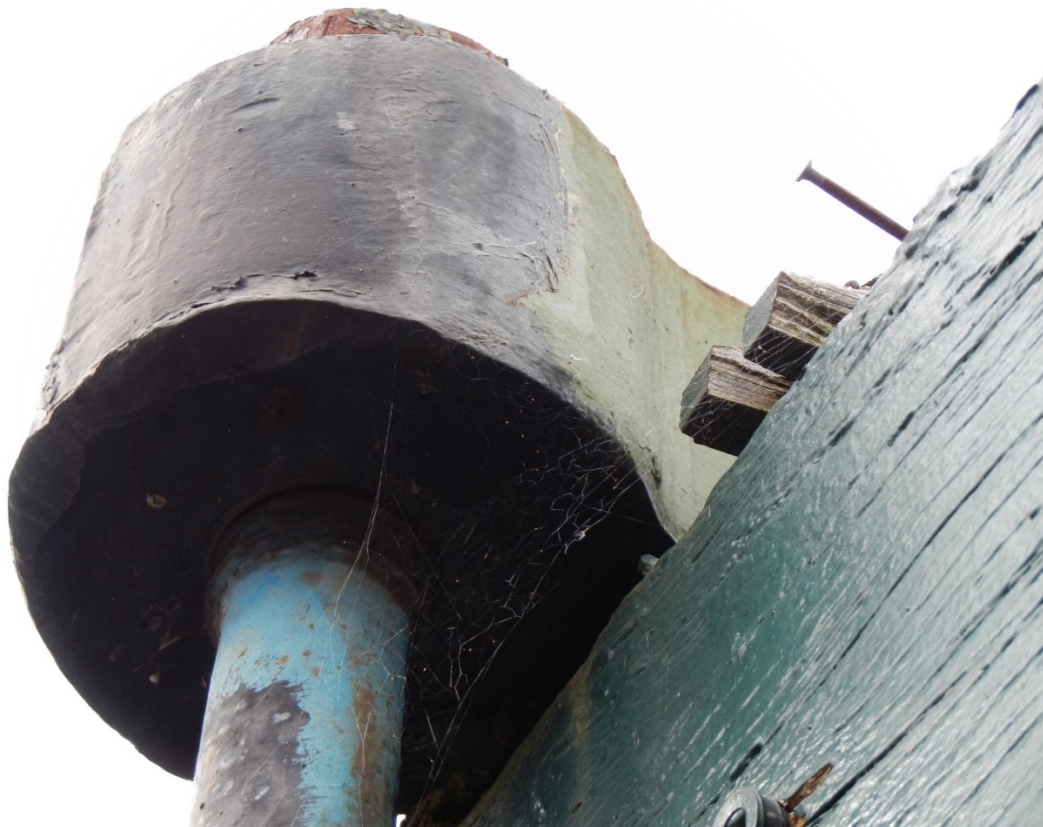
Figure 3-27: Photograph showing paint loss and corrosion of tension rod.

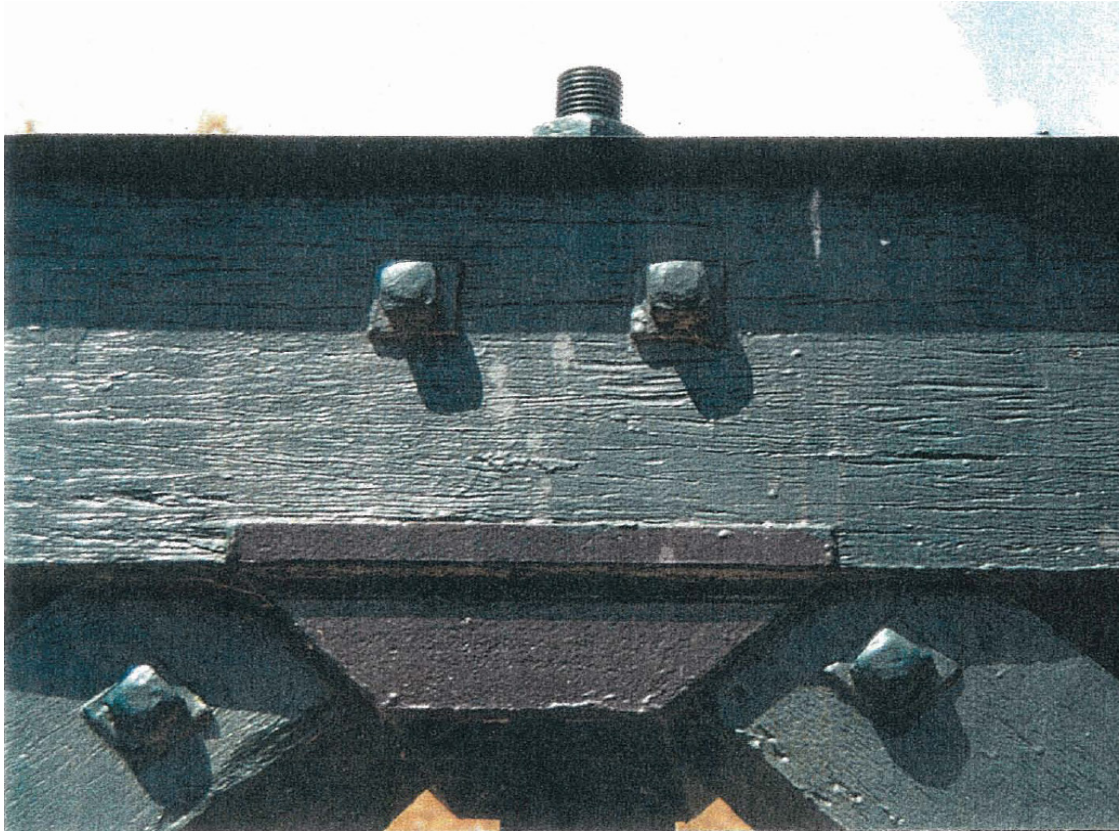
Cast iron components are susceptible to brittle fracture, so some of the original shoes have probably broken in the past but appear to have been replaced with new elements fabricated to the original design. The most recent inspection rated all cast iron shoes as condition state 1.

Figure 3-32: 1998 Photograph of cast iron shoe with two double diagonals (similar today).¹⁰¹

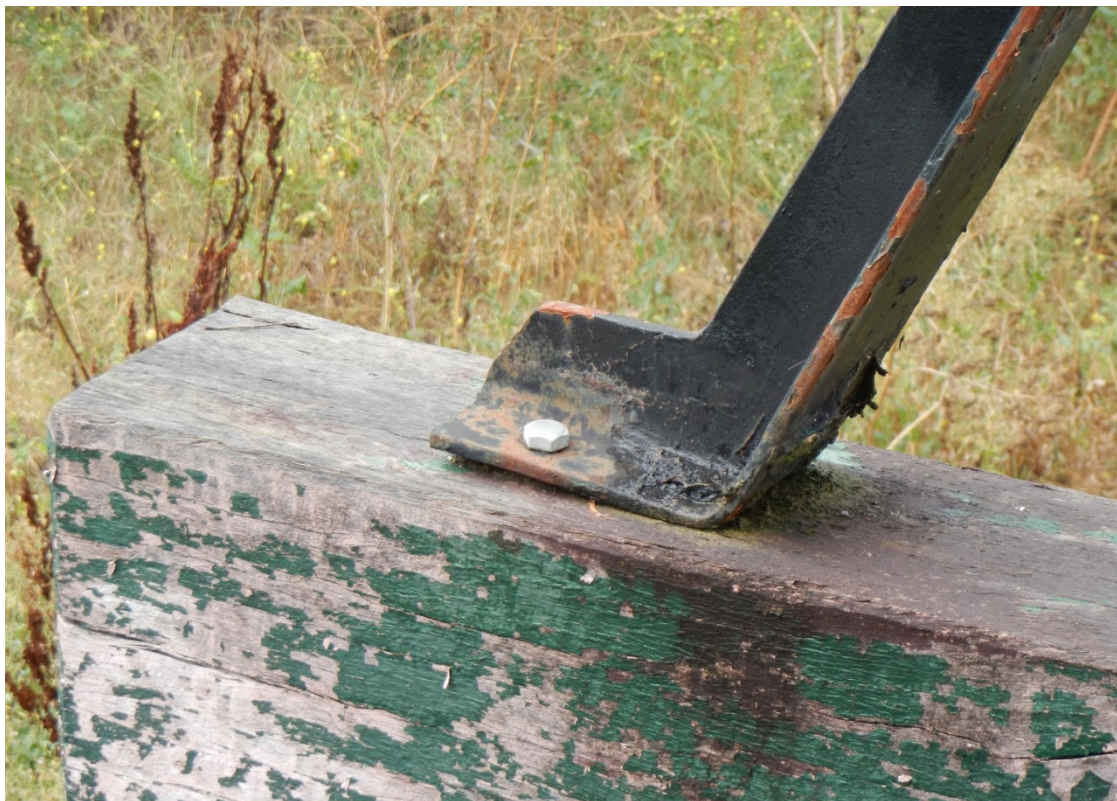
The sway braces at McKanes Bridge appear to be of the original design dimensions and detailing, and they are located in their original locations (ie. no additional sway braces have been added, and sway braces have not been lengthened as has been attempted on other bridges). The most recent inspection has rated all the sway braces as condition state 1, although inspection has revealed that all the sway braces are suffering from various levels of corrosion, especially around connections.

Figure 3-35: Photograph of base of typical sway brace at McKanes Bridge.

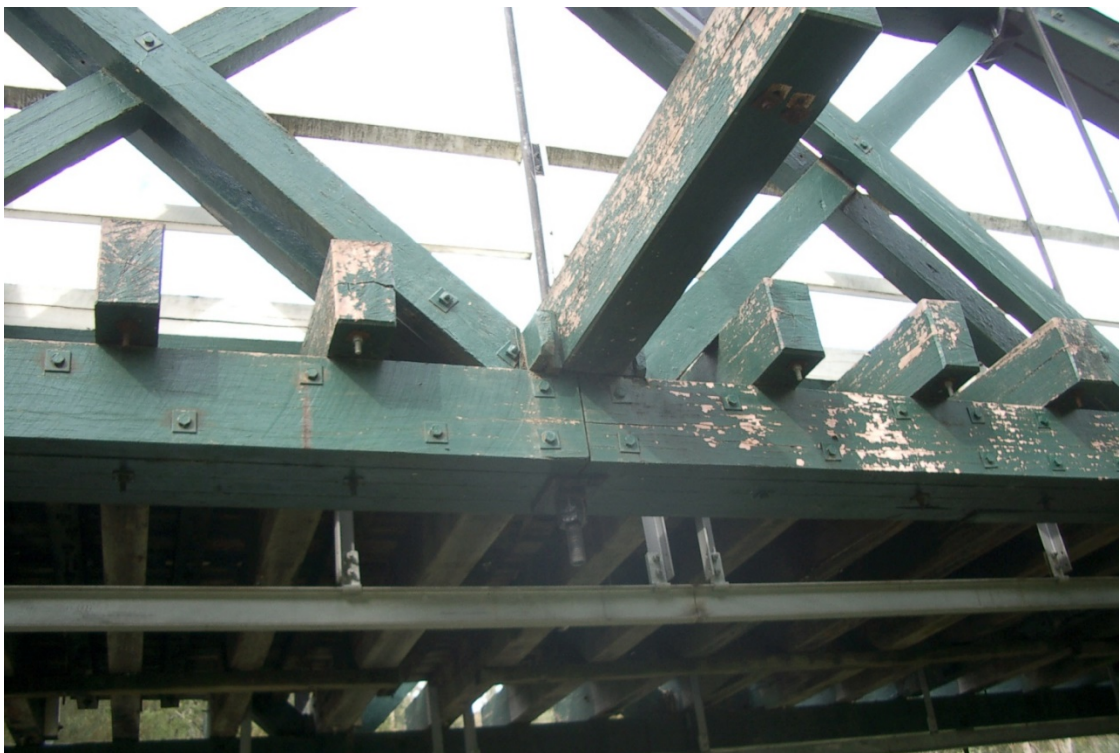
It is possible that some or all of the metal wedges are original fabric, with all suffering corrosion. None of the timbers in the primary or secondary cross girders are original fabric, but they are all still NSW hardwood. While the original timber used would have been sourced from old growth timbers, the existing timber cross girders are sourced from timbers available today. These timbers, sourced from younger trees, are significantly more susceptible to shrinkage than the original.

According to the most recent inspection most of the cross girders (primary and secondary) have a condition rating of 1 or 2, indicating that the timber is in reasonable condition, but four of the cross girders have a condition rating of 3 and require replacement primarily due to rotting from the ends.

Figure 3-37: View of larger primary and smaller secondary cross girders.

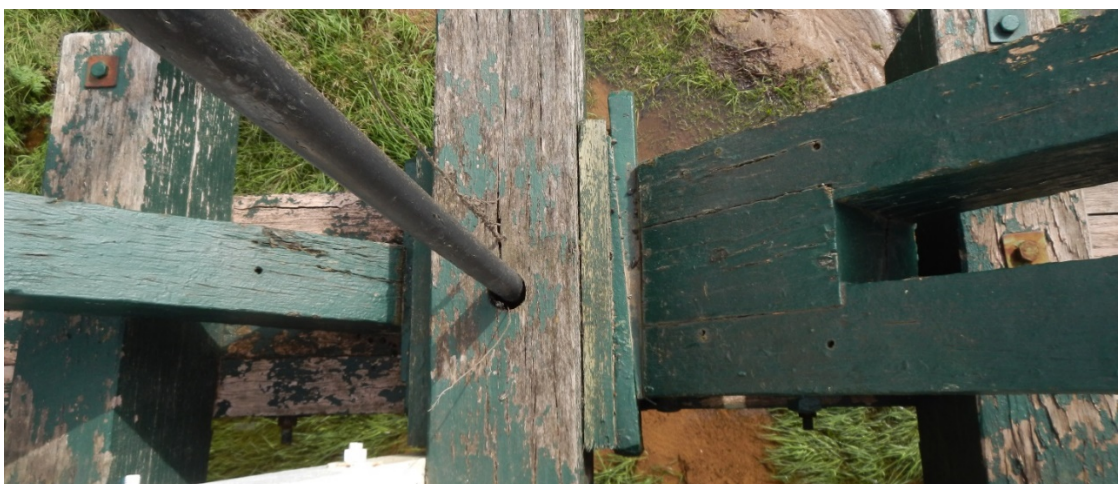
Figure 3-38: Extra timber packing to make up for shrinkage of cross girder.

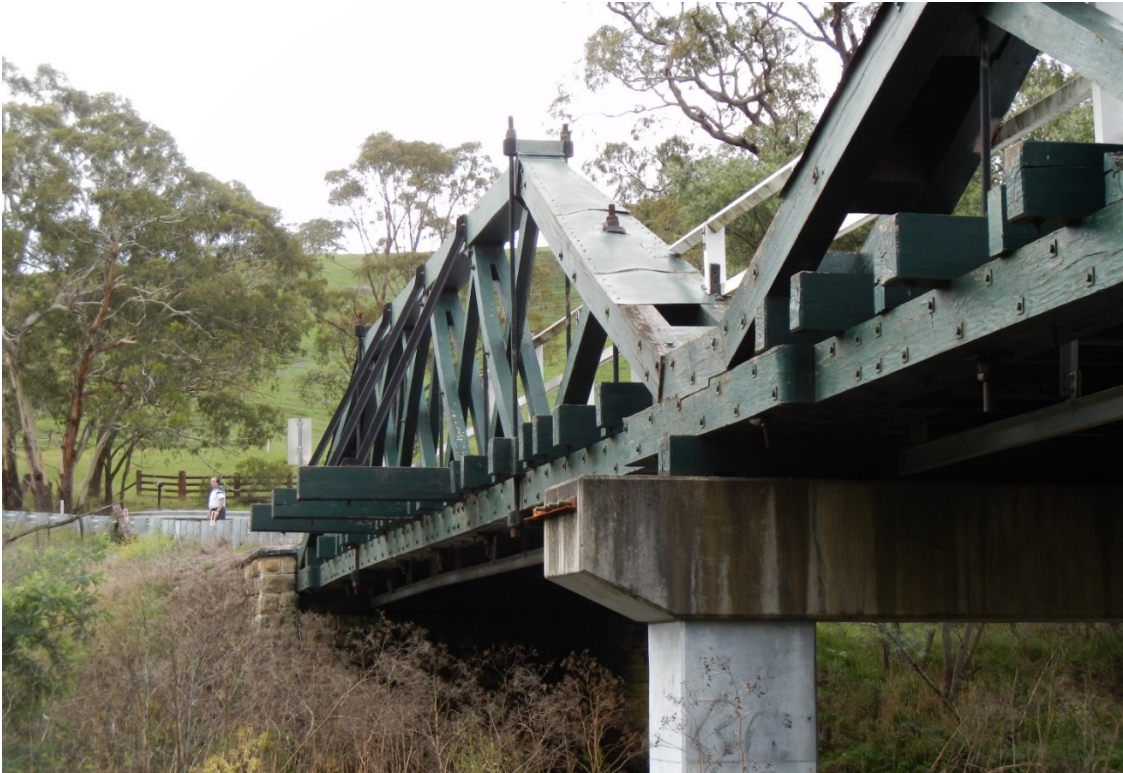
Much of the original detailing has been lost. There is no notching of the bottom chords at primary cross girder locations and there is only very limited notching of secondary cross girders. There are no stringers keeping cross girders in position and the dimensions of the cross girders are not original in cross-section or in length. Part of the reason for this would be the excessive shrinkage of available timber making these original details ineffective. Another reason for these modifications is simply ease and cost of maintenance. The fact that the primary cross girders are no longer adequately secured in position has contributed to the loss of geometry of the trusses as a whole.

Figure 3-41: Photo of irregular and non-original lengths of all cross girders.

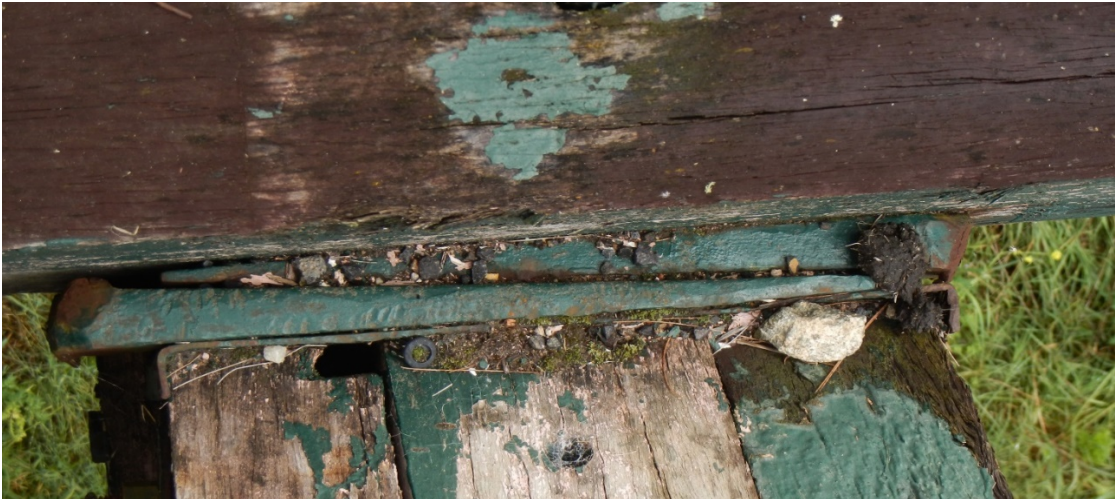
Figure 3-42: Photograph of typical metal wedges next to cross girders.

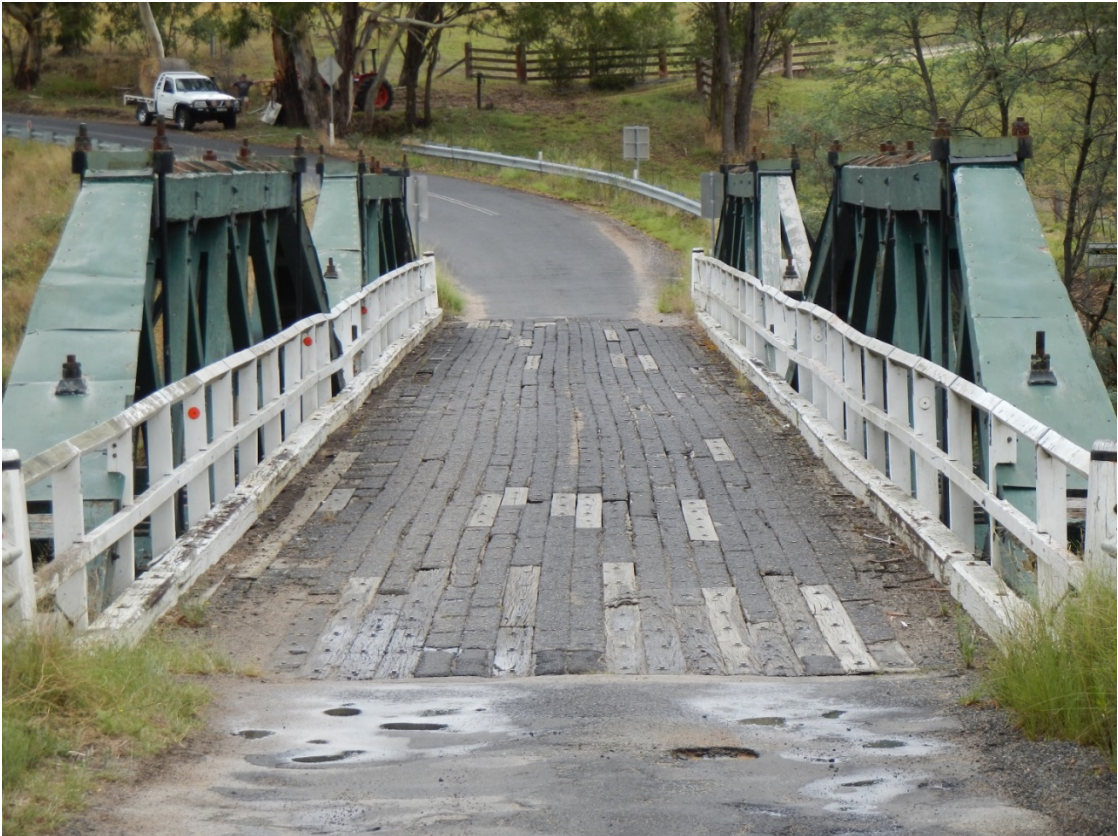
None of the deck is original fabric. According to the most recent inspection, most timber decking is rated as condition state 3, with some in 1 and 4, indicating that the decking is in poor condition.

The decking has been considerably modified so that it does not reflect the original design intent or the original aesthetic of the McDonald trusses. The heritage integrity is very poor with intrusive modifications. The decking currently consists of longitudinal timber decking approximately 125 mm thick, bolted to a system of transverse and longitudinal bolting planks introduced under the deck. The decking has been coated with a bituminous spray seal incorporating aggregate to provide a wearing surface, except for more recently replaced timbers which have not yet been sealed.

Figure 3-44: View of existing timber decking as seen from above.

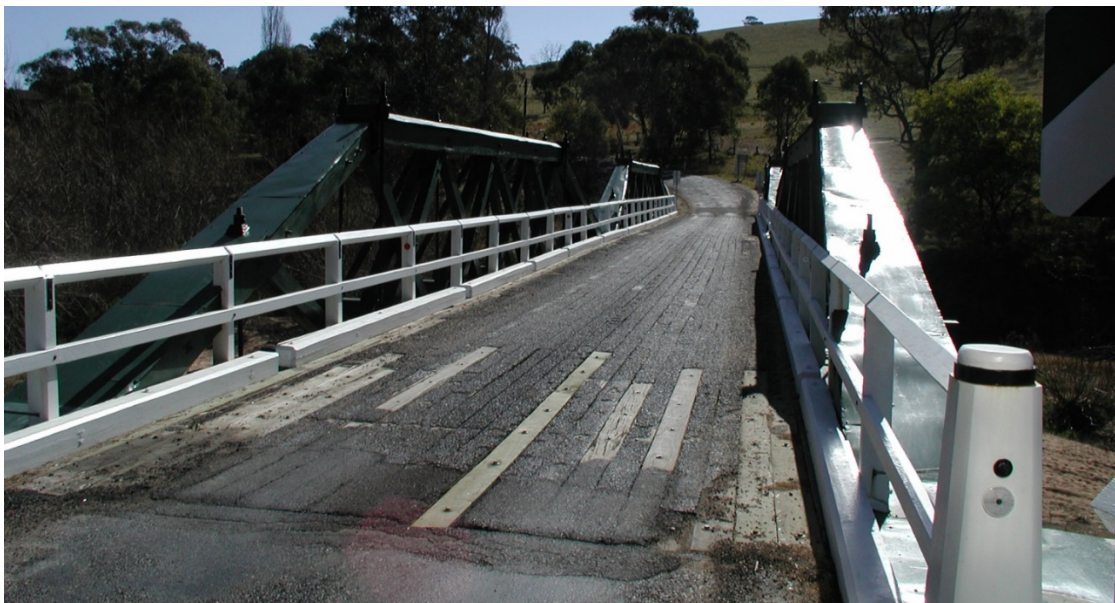
None of the railing is original fabric. According to the most recent inspection, all timber railings are in condition state 2, the timber being in relatively good condition but requiring repainting.

Figure 3-48: Photo of new railing installed after major works in 2001.

As part of the major refurbishment works undertaken between 1999 and 2001, new timber railings were installed on the bridge using detailing which is more typical of later truss types (Figure 3-48). Timber posts were introduced along the length of the bridge so that the rails no longer connected directly to the trusses. The top rail was changed from a rectangular rail to a diamond shaped rail, with black metal straps used to attach these new top rails to the new posts. Also at this time, large end posts with black round hoop straps at the tops were introduced at each end of the bridge. Gaps were introduced in the kerbs, and the kerbs were installed in a straight alignment along the length of the bridge rather than the original curved alignment of McDonald's kerb design.

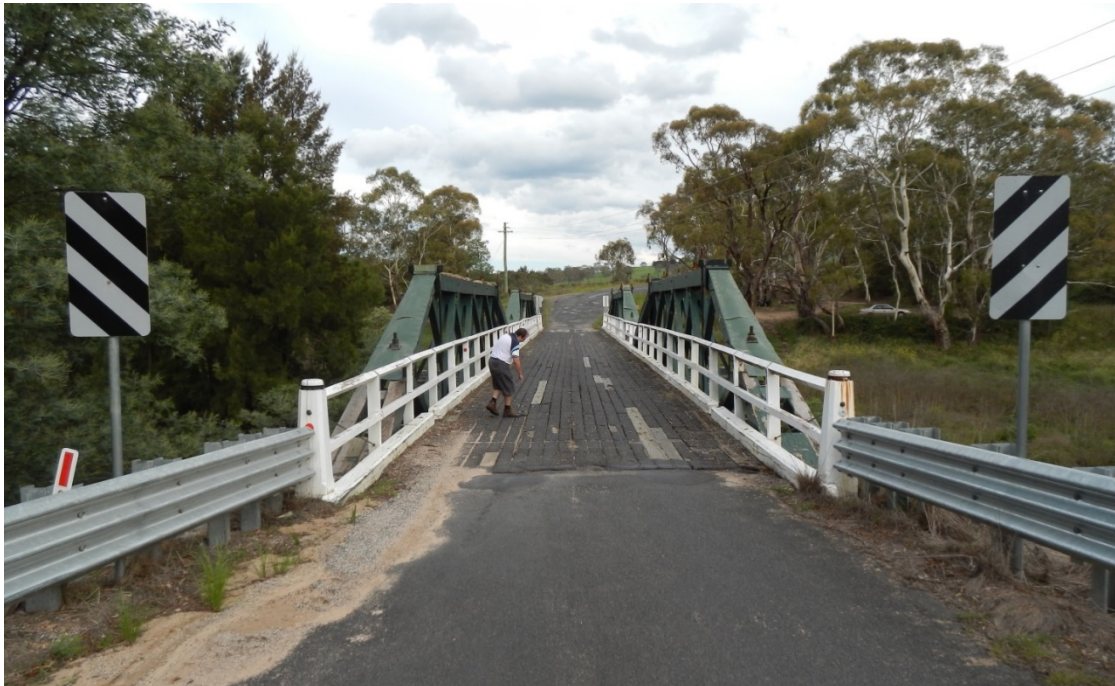
Figure 3-49: Photo showing new thrie beam guardrail on road approaches.

The original design for McKanes Bridge showed the timber railings extending well beyond the bridge to the ends of the road embankments on the approaches on both sides (see Figure 3-26). This timber rail appears to have been removed at some stage, and was first replaced with W-beam guardrail, and then more recently with thrie beam guardrail transitioning to W-beam further from the bridge. While this thrie beam looks quite solid, it is largely ineffective due to the fact that this type of guardrail relies on structural continuity for its effectiveness, and so at the point of greatest need (just where the bridge begins) the guardrail is least effective as it has nothing to connect to (the large timber end post having no capacity to resist loads). The galvanised metal guardrail so close to the bridge also detracts somewhat from the timber truss, being visually incompatible.

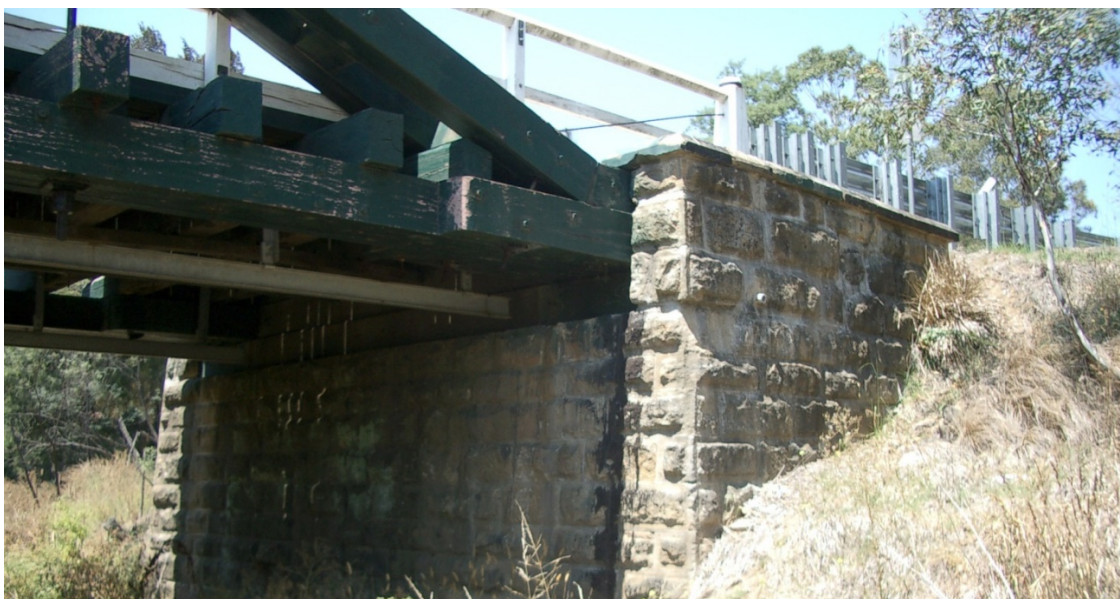
Both abutments appear to retain their original configuration and are largely original in fabric. According to the most recent inspection both abutments are in good condition, having a rating of 1. The abutments did suffer some damage in the 1986 flooding, including cracking of some stone and movements of part of the side walls in both Abutment A and Abutment B. Due to the configuration of the original design, part of the masonry has to be removed in order to replace timber elements resting on the abutment, so it is possible that some damage has also occurred during repair works.

Figure 3-51: Photograph of masonry abutment largely as original.

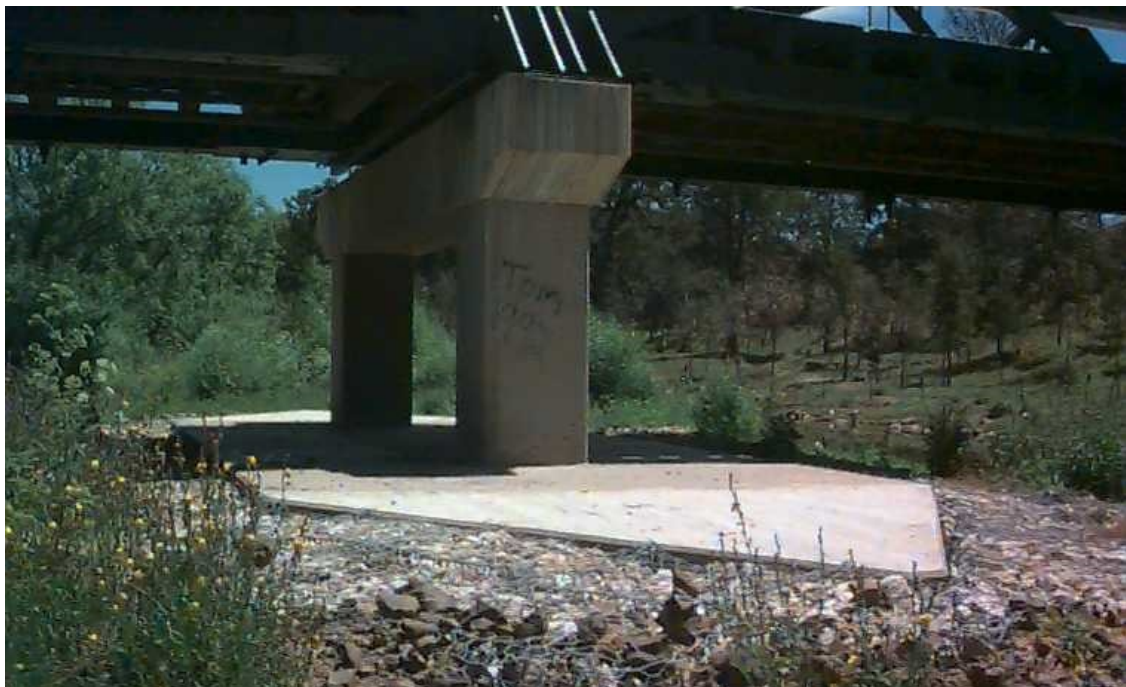
The original pier was destroyed in the 1986 flood and was replaced with a new concrete pier. According to the most recent inspection the pier is in good condition, having a rating of 1.

The existing pier bears no resemblance to the original except that it is in the original location.

Figure 3-53: Photo of new pier taken between 1987 and 1999.

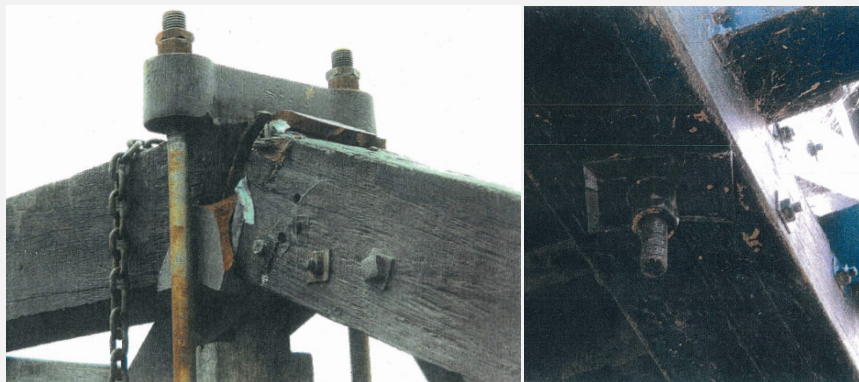
Cast Iron Shoes	Some of the cast iron shoes and washer plates on the truss spans appear to be original, although some have been replaced with replicas. Original cast iron shoes and washer plates in McDonald trusses are brittle and subject to sudden failure (as shown in photographs) and therefore pose an unacceptable safety risk.
-----------------	--

Options considered for replacement of shoes include welded steel replicas and ductile cast iron replicas. Although ductile cast iron replicas are significantly more expensive than welded steel, they are seen as a better heritage outcome and are therefore proposed for this bridge. All work on Transport for NSW timber truss bridges is completed in accordance with the relevant specifications and for ductile cast iron components, this is QC Specification 2386. The washer plates are to be replaced with machined steel plates to match the original dimensions of the iron washer plates.

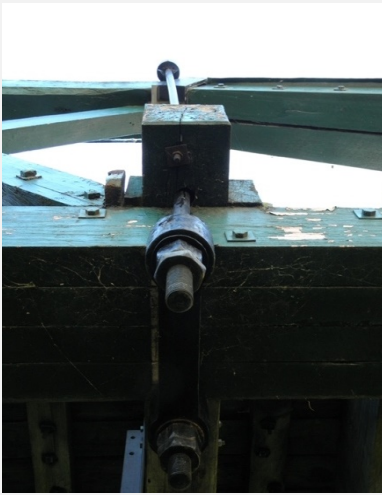
Some of the tension rods appear to be original wrought iron tension rods, although some have been replaced with steel. The tension are all suffering from corrosion at the threaded ends (which is the most highly stressed and fatigue susceptible location and the hardest to paint), and some tension rods have been damaged due to loss of truss geometry (see photo of bent tension rod). It is proposed to replace all the tension rods with new steel tension rods of the same size as the original wrought iron tension rods. On this bridge the original diameters of the tension rods are sufficient, so no upsizing is required.
