Victoria Bridge at Picton

Conservation Management Plan

Roads and Maritime Services | October 2018

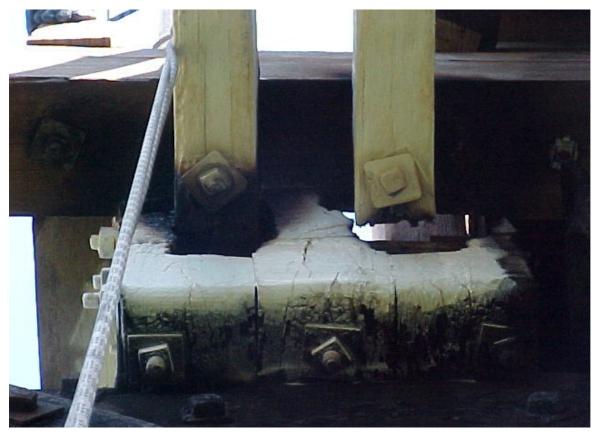
Figure 2-43: 2003 fire damage showing bottom chord damage

Another fire occurred on the evening of Friday 5th September 2003, apparently caused by a careless throwing of a cigarette butt from a car window, and was in the area where the principal from two trusses come together over the pier. Wollondilly Council was called out and erected barrier to stop traffic using the bridge. RTA staff carried out a preliminary assessment on the Saturday morning and as a consequence the bridge was closed to traffic and concrete barriers were erected to prevent unauthorised use of the bridge. The pedestrian footway was left open at that time, but a detailed inspection of the pier was carried out by rope access on Tuesday 9th September. This inspection established that a significant proportion of the bottom chords and the timbers that transfer the load form the truss to the pier had been burned. Figure 2.43 is a photograph taken that day, and shows that one of the bottom chords hard burned right through and the other was badly damaged, meaning that the bridge could easily have completely collapsed. As a consequence, fences were erected preventing pedestrian access to the bridge also.¹⁰⁴

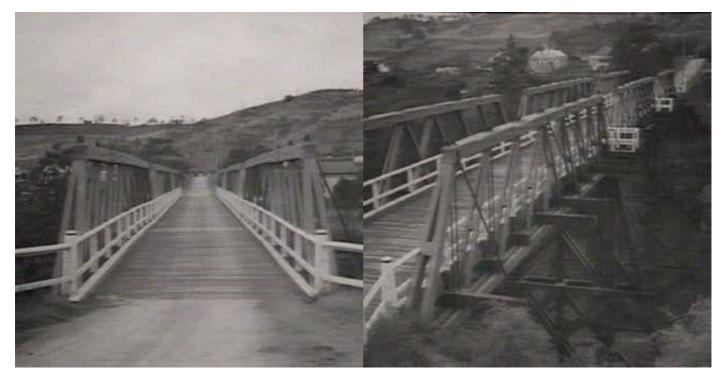
Figure 2-44: 1948 photographs of Victoria Bridge at Picton

Originally, the bridge did not have designated pedestrian facilities except for two pedestrian refuges which can be seen in Figure 2.44. That appears to have been sufficient, given the volume and speed of the traffic, but would have been an issue with motorized vehicles. It took until 1979 when a guardrail was installed along the bridge to provide a designated pedestrian facility. The guardrail remains today (see Figure 2.45).

A comparison between Figure 2.44 and Figure 2.49 shows that by 1948, the decking was very irregular, loose and rough. By 1951, the noise from vehicles crossing the bridge was causing sleepless nights for residents and much reduced quality of life. A letter from Shire Clerk to the Divisional Engineer stated that the condition of the decking was such that the spikes when hammered down loosened after the passage of only a small number of vehicles. The raised spikes caused damage to tyres and the noise of the loose planks to ratepayers was "extreme".¹¹¹

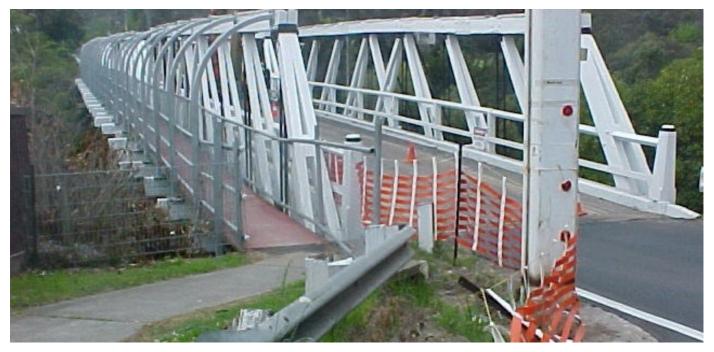
Figure 2-46: Temporary external footway during 2004 repairs

While it was seven months before the bridge could be reopened to vehicular traffic, provision was made for pedestrians a little earlier by moving the footway temporarily from the inside of the truss to the outside (the temporary external footway provided after the 2003 fire is shown in Figure 2.46). This was achieved by replacing the short cross girders with longer cross girders as well as removing the original sway braces and installing a larger number of modified sway braces.

It is possible that the sway braces are original fabric, but a higher level of deterioration would be expected for metal of that age, so they may have been replaced with new sway braces to the original design. It is known that the sway braces have been removed in the past (for example, see Figure 2.46 showing temporary replacement of straight sway braces with curved sway braces).

- The provision of a suitably designed visually recessive permanent external footway would remove the need to install the visually intrusive temporary external footway every time there is a long closure required for bridge repairs (see Figure 2.46).

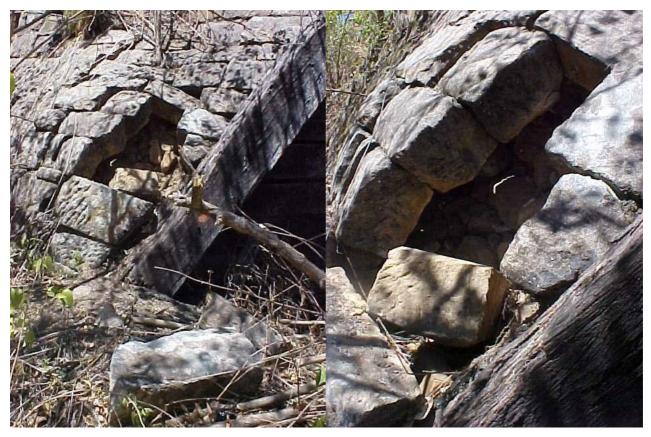
Figure 2-47: Signs of failure of embankment beginning in 2003

More recently, it has not been fire that has been the problem but water. As early as February 2003 some bulging of the stone pitching at the eastern abutment had been noticed (Figure 2.47). Voids had developed behind the stones allowing backfill to settle and water to ingress and weaken the fill material. In 2007 there was a severe slip which damaged the abutment beyond repair (Figure 2.48).

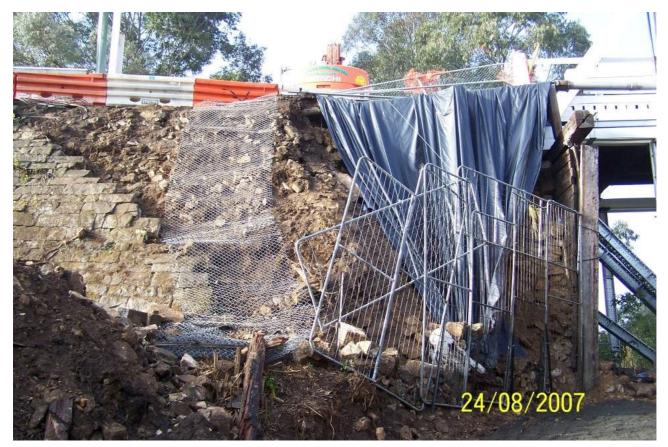
Figure 2-48: Failed abutment and embankment due to slip in 2007

Although the bridge is Roads and Maritime's responsibility, the embankment is owned by Council. As early as 1936 it was noted that stone pitching on the embanked formation had bulged out, and parts of it are still in poor condition today after various repairs have been made over the years.¹⁰⁵

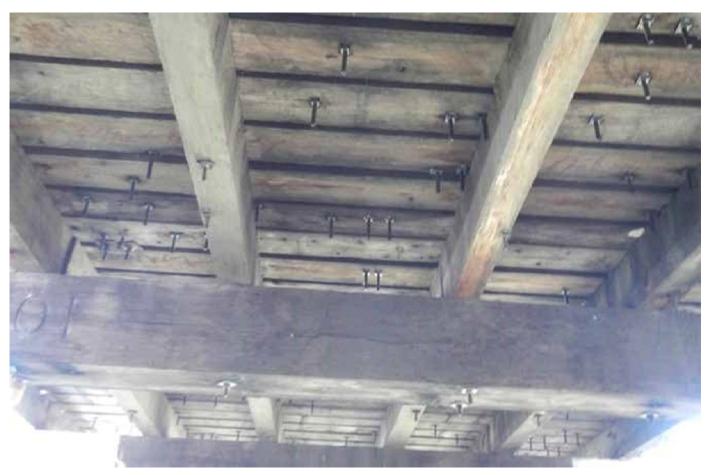
Figure 2-51: View of existing bolted deck from beneath Victoria Bridge

It was not long before the "possible disadvantage" was realised, and the decking underneath decayed with rapidity. To improve the durability of the bottom layer of decking, gaps were introduced (approximately 30-50 mm) between transverse decking planks to allow improved drainage and ventilation. When longitudinal sheeting was introduced, spiking was no longer suitable, but the longitudinal sheeting was bolted to the decking. From underneath the bridge, this arrangement of bolted and spaced diagonal decking can currently be seen (Figure 2.51).

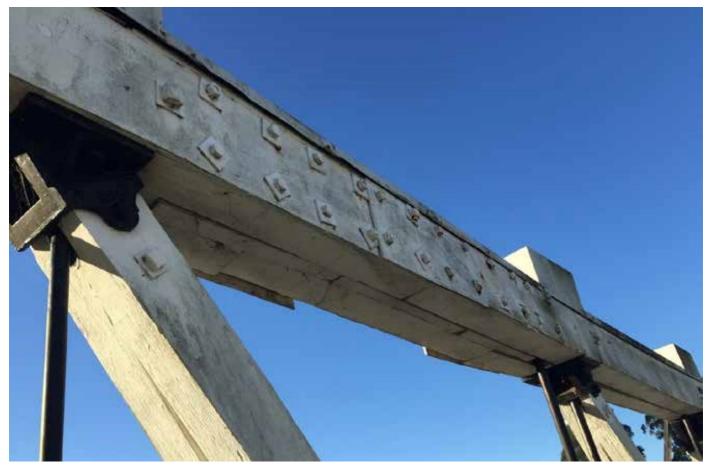
Figure 2-56: Additional splices at G-H in Span 2 Upstream

All of the top chord timbers consist of paired timbers as per the original design. However, only half of the tops chords retain their original configuration. The table below compares the original and existing splice locations for each of the six top chords. Span 2 has had additional splices added both upstream and downstream (top chords consist of two rows of four lengths rather than two rows of three lengths). The top chord layout of the downstream Span 1 truss has also been substantially modified. Photographs of additional splices in Span 2 are given in Figures 2.56-57.

Where additional splices have been added, additional timber spacers have also been introduced, as can be seen in Figure 2.56. This has a deleterious effect on the tops chords due to the number of additional timber to timber interfaces which have been introduced, which tend to exacerbate deterioration. Additional metal splice plates have also been provided at the new splice locations. These modifications detract from the structural integrity and the heritage integrity of the trusses.

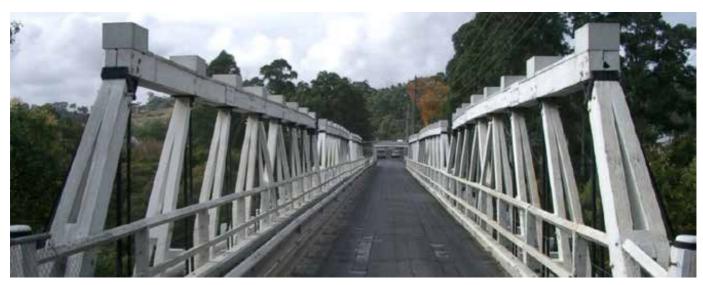
Figure 2-58: Visually dominant "castellated" flashing on top chords

Metal flashing has been added along the entire length in an attempt to protect the timber from water. It is likely that hidden deterioration would be occurring under the metal flashing. Flashing has been a popular experimental treatment for top chords of timber truss bridges, and Roads and Maritime has developed a number of different types of flashing which attempt to mitigate against the problems of moisture trapping and loss of air flow. However, it has become clear that flashing usually causes more problems than it solves. Flashing has a tendency to provide unwanted habitat for termites, wasps and micro bats, is an obstacle to regular inspections, it funnels water to gaps in flashing causing accelerated local deterioration and it detracts from the bridge aesthetics.

The flashing adversely impacts on the aesthetics of Victoria Bridge, particularly due to the large boxes which have been provided at tension rod locations, giving a castellated effect to the top chord which detracts considerably from the graceful curves of the original Allan truss design.

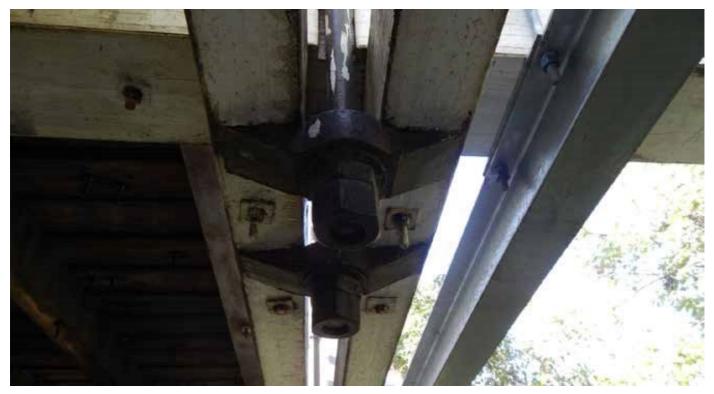
Figure 2-65: Photograph of thin nuts and main nuts only partially threaded

Figure 2.65 below shows the issue at Victoria Bridge. The photograph shows the bottom of a pair of tension rods under the bottom chord with the thin nut on top, fully threaded, but the main nut only half way connected to the tension rod, and therefore having only a fraction of the original capacity and also being at considerable risk of falling off as other nuts have been reported missing.

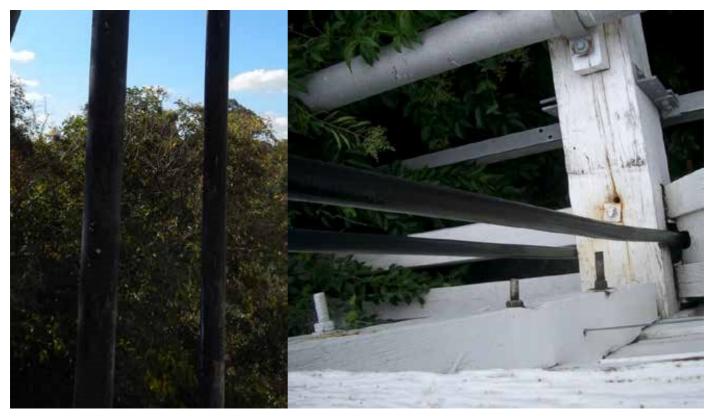
Figure 2-66: Photograph of unequal (left) and damaged (right) tension rods

However, it was noticed on site that one of the tension rods has been damaged and is bent out of shape (Figure 2.66), and also a minimum of four tension rods have been replaced with considerably larger tension rods (diameter approximately 10 mm greater than the original), one example of which can be seen in Figure 2.66 below. There are two examples of this on Span 1 and two on Span 3 both on the upstream side. The aesthetics of the unequally paired tension rods adversely impacts on the bridge as they detract considerably from the original design and are on the pedestrian walkway side, therefore more clearly visible for close inspection by the bridge users. The unequal diameter of tension rod is also a poor result structurally, since the larger tension rod will always attract considerably more load, thereby introducing eccentricities not in the original design. These modifications detract from the structural integrity and the heritage integrity.

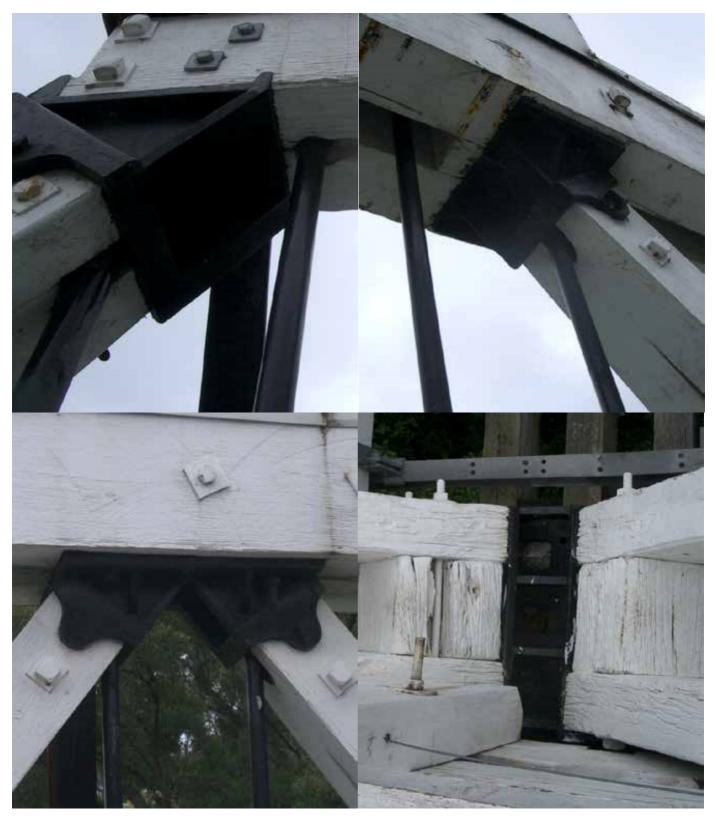
Figure 2-67: Photographs of various cast iron shoes at Victoria Bridge

Some of the cast iron shoes are probably original fabric. According to the most recent inspection most of the cast iron shoes are in condition state 1, although five are in condition state 2, two are in condition state 3 and one is in condition state 4 (this refers to a broken bottom chord shoe in Span 3). Problems reported with regard to cast iron shoes in the most recent inspection include minor cracking, loss of coach screws or bolts, looseness in connections and gaps opening up. Overall, the cast iron shoes appear to be in fair condition but the looseness is a structural concern.

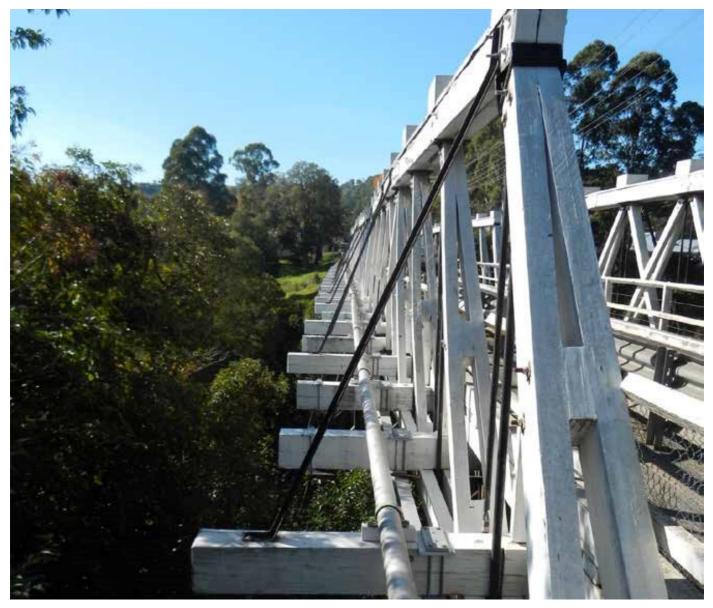
Figure 2-69: Photographs of upstream sway braces at Victoria Bridge

The sway braces at Victoria Bridge at Picton appear to be of the original design dimensions, and they are located in their original locations (ie. no additional sway braces have been added, and sway braces have not been lengthened as has been attempted on other bridge). The sway braces were not covered in the most recent inspection, but they appear to be in good condition.

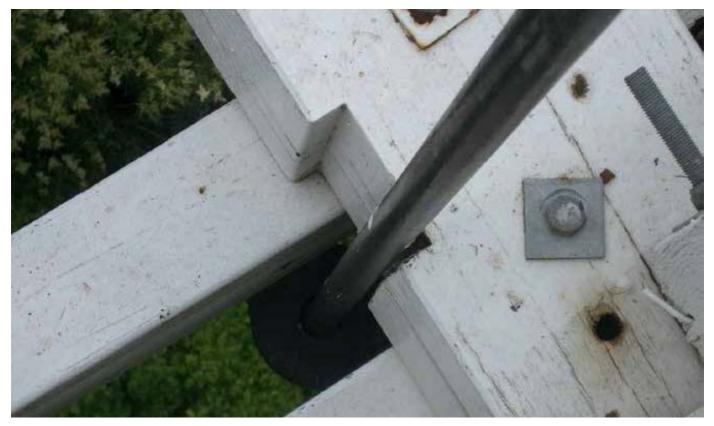
Figure 2-72: Unsightly notching of cross girders at tension rod locations

The original design had 13" (330 mm) spacing of tension rod pairs. This left a minimum ½" clear space each side of each cross girder at the larger tension rods, and ¾" clear space each side of each cross girder at the smaller tension rods. Now, some of the tension rods have been replaced with larger tension rods and many of the cross girders have been replaced with wider cross girders which have been notched in a rather unsightly manner to accommodate the tension rods.

Not only have many cross girders been replaced with wider cross girders as can be seen in Figure 2.72, but also the shorter cross girders have been replaced with longer cross girders and painted white so that the view of the side of the bridge is considerably changed (compare Figures 2.73-74). The reasons for the longer cross girders include support of the maintenance monorail (Figure 2.75) as well as provision for external footways to be economically provided during maintenance works.

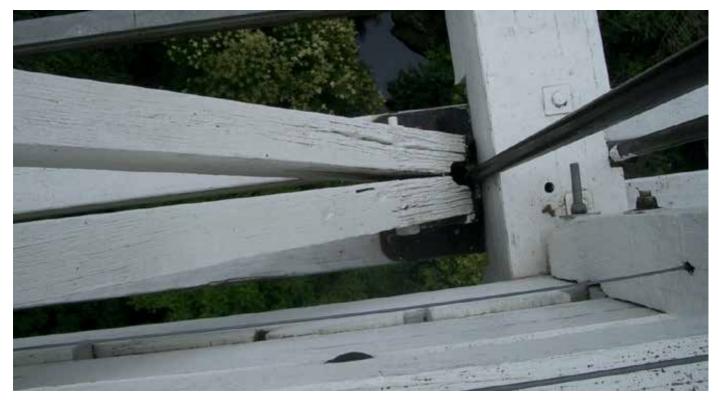
Figure 2-76: Unsightly notching of cross girders at bottom chord locations

Furthermore, some cross girders have been replaced with new cross girder deeper than the original cross girders, and so they have been notched over the bottom chords (Figure 2.76).

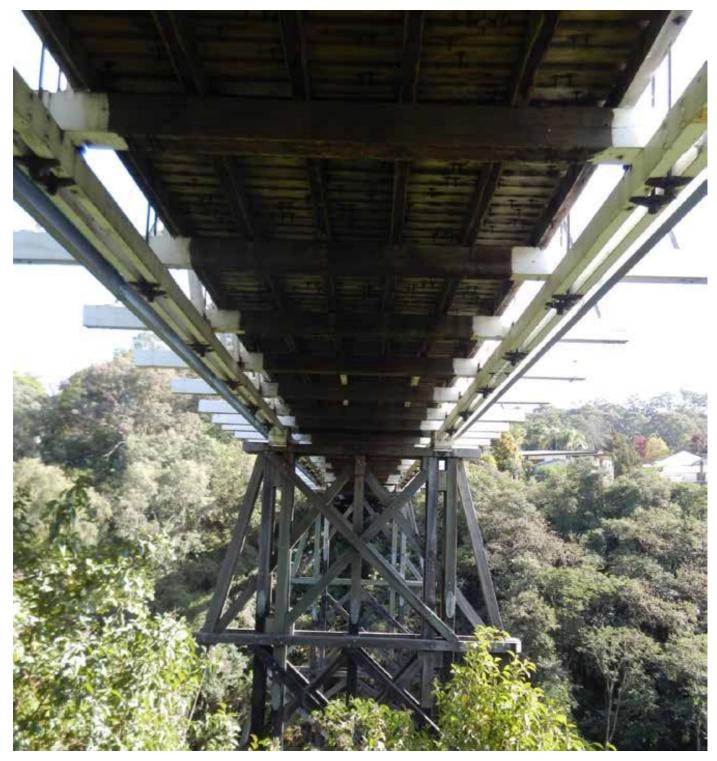
Figure 2-78: Photo of existing stringers and spaced transverse decking

The stringers and especially the decking have been considerably modified so that they currently reflect very little of the original design intent or the original aesthetic of the Allan trusses. The heritage integrity is very poor, with a number of intrusive modifications as outlined below. While the stringers (which can be seen in Figure 2.78 below) still consist of six rows of sawn timbers, the original sizes have been lost along with the cambered deck Allan took such care to provide.

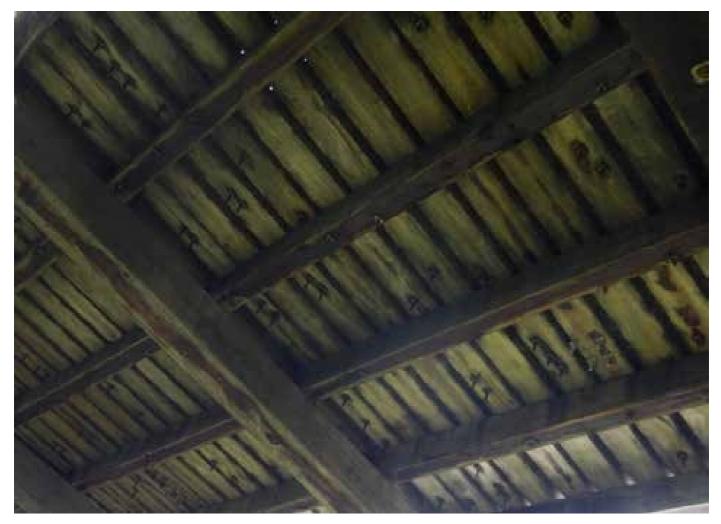
Figure 2-79: Bolted and spaced decking

Originally the deck was tightly spaced (allowing no light through) and completely smooth with a 38 mm camber for drainage and a black tar surface on top. The iron spikes which connected the decking to the stringers and cross girders were hammered flush with the top of the timber and were covered with the tar thereby making them effectively invisible. Currently the decking is spaced, allowing some light (and much water) through the deck, and a large number of bolts have been added, as can be seen in Figure 2.79. The current decking competes somewhat with the aesthetic of the trusses with the strong longitudinal lines of the sheeting and the irregular spacing of the protruding bolt heads and joints in the sheeting when viewed from above.

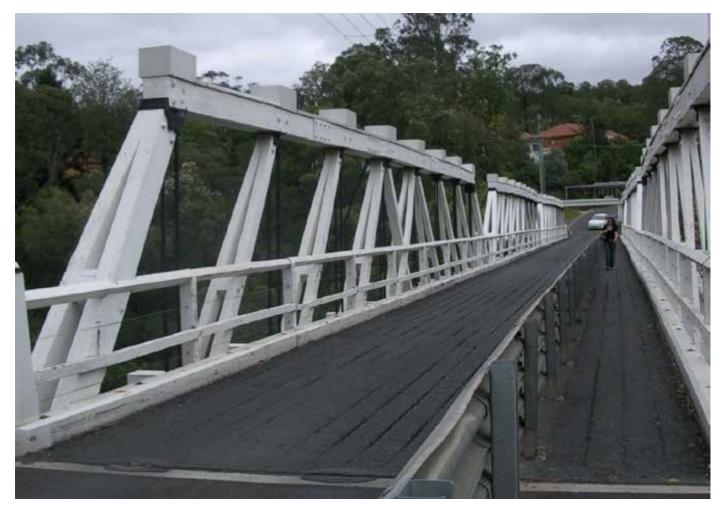
Figure 2-80: Photo of existing longitudinal sheeting viewed from above

The existing timber kerbs and rails reflect something of the original form, containing white timber posts and rails, although the original black metal fixings are now painted white (see Figure 2.80). The kerb has been raised in level so that it sits above the longitudinal sheeting rather than directly on the transverse decking, thereby modifying the geometry of the fence in relation to the truss.

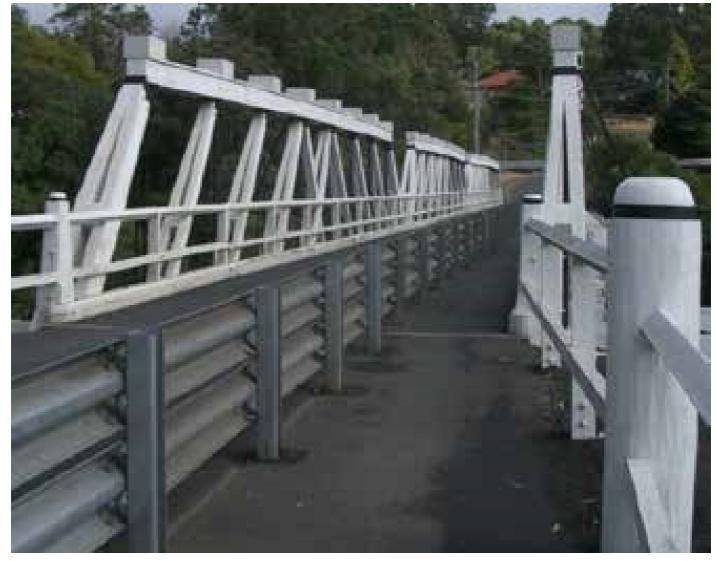
As can be seen in Figure 2.81, by far the most considerable modification to the railings is the addition of a modern steel guardrail along the length of the bridge to provide a safe passage for pedestrians. The guardrail consists of two W-beams attached to metal posts. This is a non-original feature which detracts from the aesthetics of the bridge. Furthermore, since the guardrail is a flexible barrier system, it has very limited ability to redirect an errant vehicle, and so its function is more delineation than protection of pedestrians.

Figure 2-81: Guardrail

- A suitably designed visually recessive external footway would allow the removal of the existing visually intrusive internal footway which was installed in 1979 (see Figure 2.81).

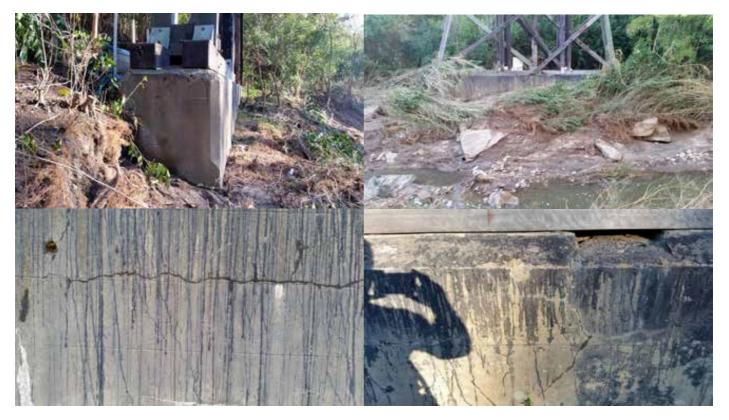
The concrete bases are also in variable condition with evidence of cracking at some locations.

Figure 2-83: Photographs of condition of concrete bases at piers

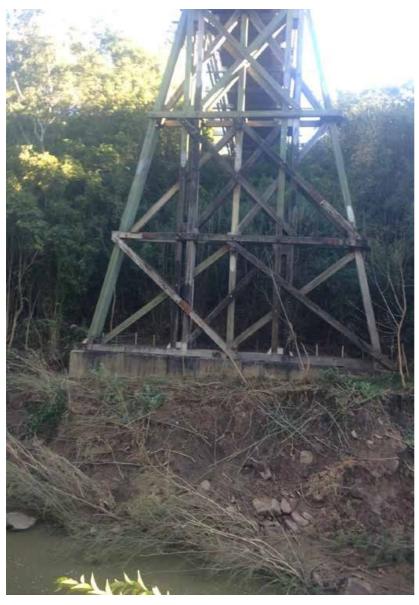
Although not currently directly impacting upon the condition of the bridge fabric, another issue is the scour of the creek bed which occurred during a flood in 2016. The ground level has dropped by up to two metres at some locations, and the steepness of the banks has increased very close to the piers. The extent of the 2016 scour is shown in Figures 2.84 and 2.85. If further scour such as this were to occur the piers might be undermined.

Figure 2-85: Steep embankment due to scour

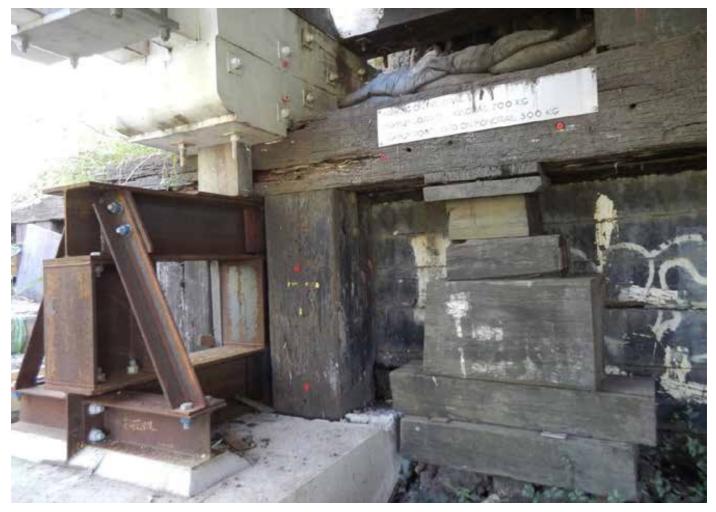
Abutment A is a much less visible and accessible abutment, being considerably shorter than Abutment B, and also being located in a cutting, rather than an embankment, so it is rather hidden. Modifications to Abutment A include addition of concrete at the bases of some piles and also under some temporary props. There are also fabricated steel props as well as piles of timber packing and sand bags. Due to deterioration and various modifications, the ends of the bottom chord on the upstream side is currently somewhat buried in sediment and therefore at risk of deterioration.

Figure 2-88: Photograph of Victoria Bridge Abutment A downstream side

According to the most recent inspection, Abutment A (which is being temporarily supported with various props) is almost entirely in condition state 4, indicating considerable structural risk and Abutment B is in condition state 1, having been replaced in 2007 with an entirely new abutment. Photographs of the condition and temporary propping of Abutment A are on the following page.

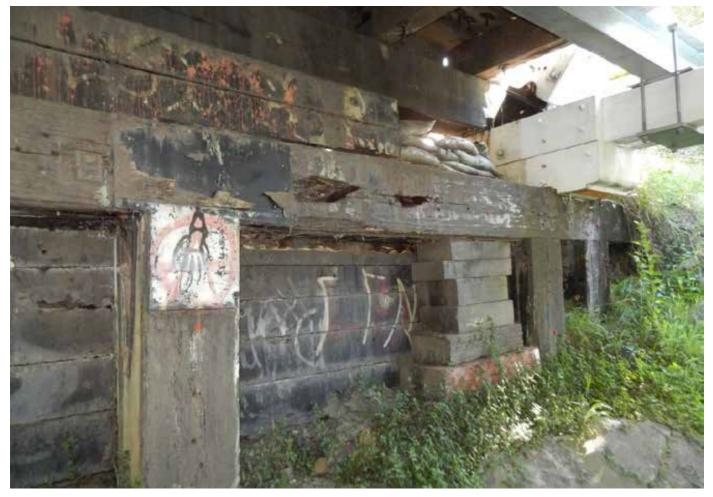
Figure 2-89: Victoria Bridge Abutment A upstream side

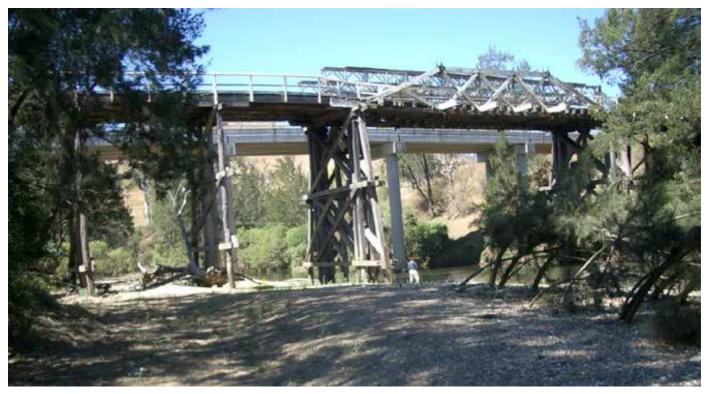
Figure 5-2: Five Day Creek Bridge (since demolished) with concrete bridge

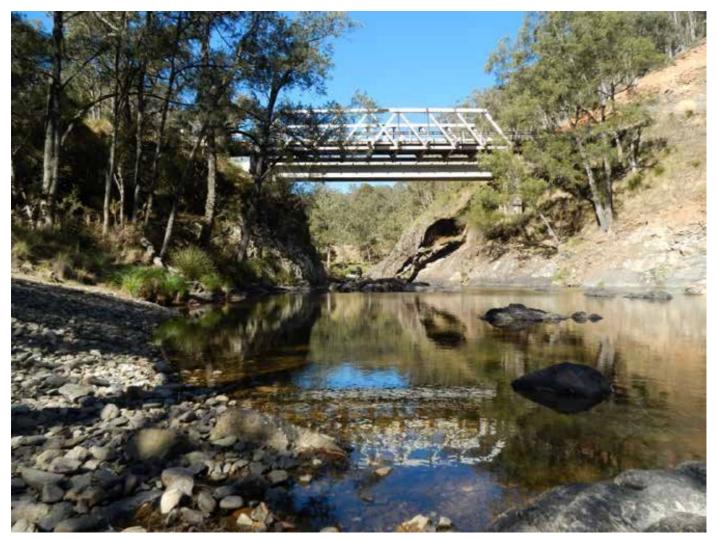
Figure 5-3: Styx River Bridge with visually intrusive new concrete bridge
